## ***Brightwood Neighborhood Walk Assessment Springfield, MA***

November 18, 2015

**MAKING MASSACHUSETTS MORE WALKABLE**

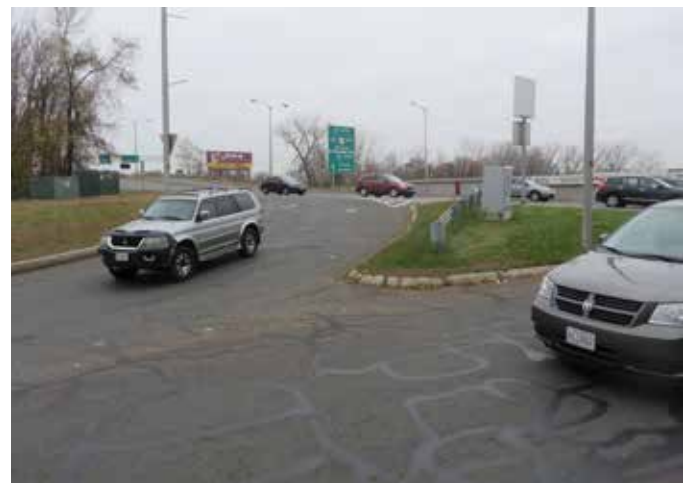
*A right-turn slip lane without any crosswalks currently enables westbound traffic on Route 20 to turn north onto Plainfield Street at high speeds without slowing down, creating a risk of vehicular and pedestrian accidents.*

- Create a complete crossing with curb ramps and sidewalk extensions across Plainfield Street along the north side of the intersection
- Consider eliminating the right-turn slip lane onto Plainfield Street to slow traffic speed by re-routing all westbound traffic through the signalized intersection

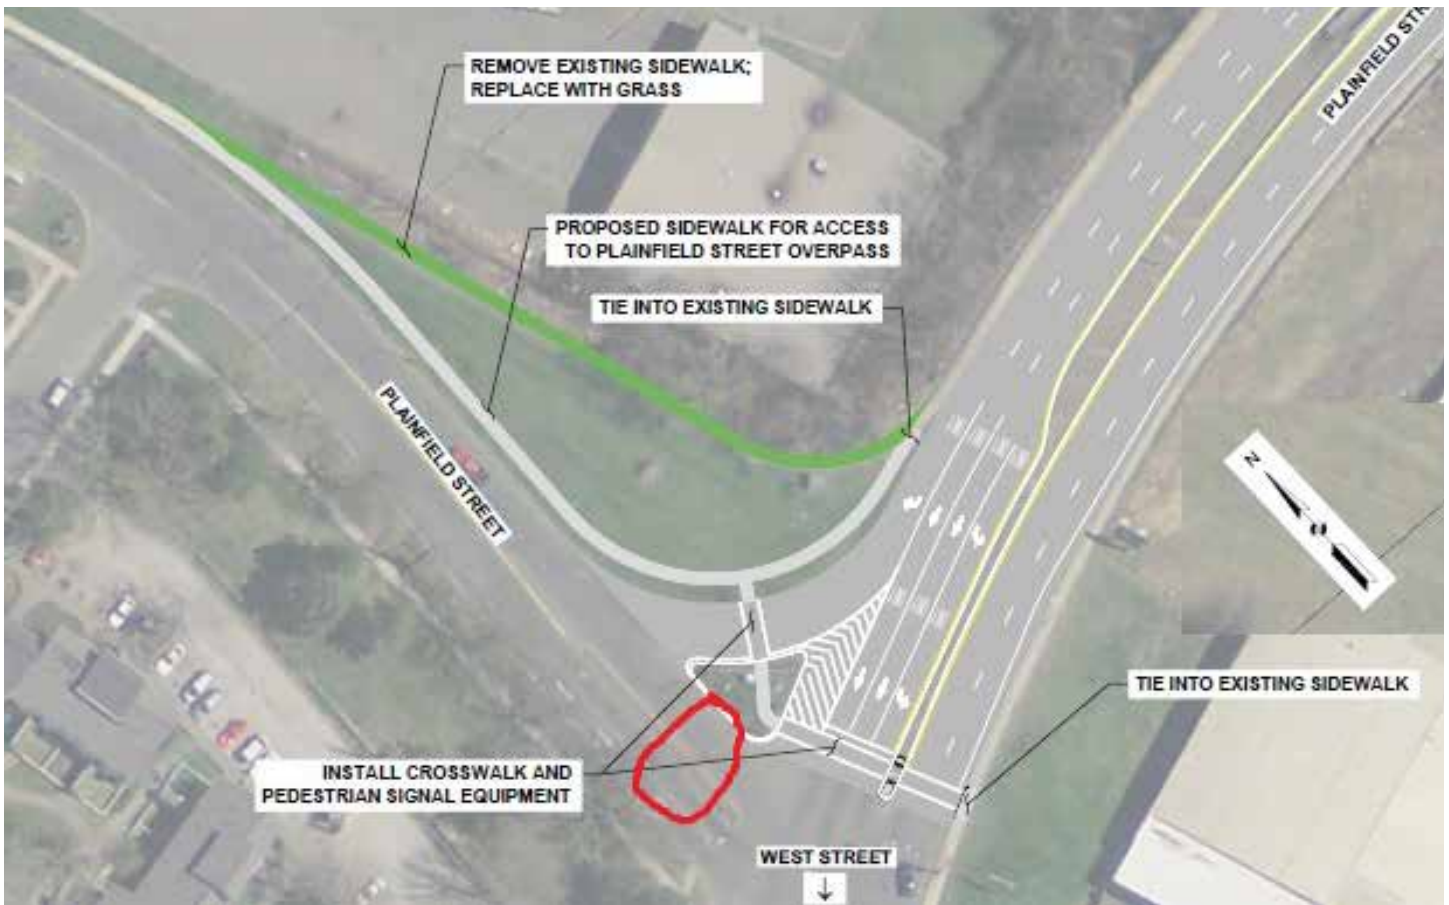
MGM's plans for improvements at Route 20 and Plainfield/West/Avocado Streets create a crossing across the existing right-turn slip land at Plainfield Street, but fail to create complete crossing across Plainfield Street along the northern edge of the intersection. The lack of a complete crossing is highlighted above in red (source: MGM Springfield Final Environmental Impact Report, pg. 3-88).

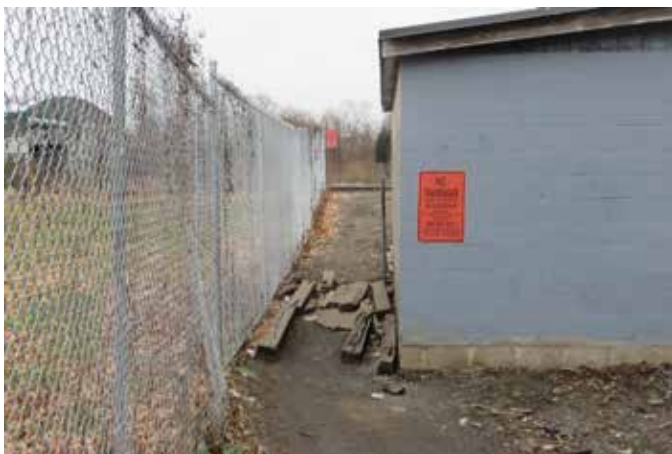
The current pedestrian access path to the railroad crossing from Plainfield Street

A narrow, unmarked dirt path across railroad tracks and through overgrown and trash-strewn lots with a high prevalence of drug activity is one of the only ways for pedestrians to enter and leave the Brightwood neighborhood and access Birnie Avenue and Main Street. Many students and their families currently use this unsafe crossing to get to and from Chestnut Middle School. The City of Springfield currently provides police presence and periodic clearing of overgrowth and trash along the railroad crossing path, but a long-term infrastructure solution is necessary to ensure safe passage for pedestrians. Expecting pedestrians to walk along Plainfield Street all the way to Route 20 to get to Main Street is not a viable solution, given the long distance involved to access desired destinations and the significant pedestrian safety challenges at the convergence of Plainfield Street and Route 20, which are documented elsewhere in this report.

WalkBoston recommends that the City continue to work with MassDOT to advocate for the proposed underground Amtrak railroad crossing. The City should also work to ensure that both ends of the underground passageway have safe, aesthetically pleasing and easily navigable connections to Birnie Avenue, Plainfield Street and the broader Brightwood community. The passageway must also be well lit at all hours.

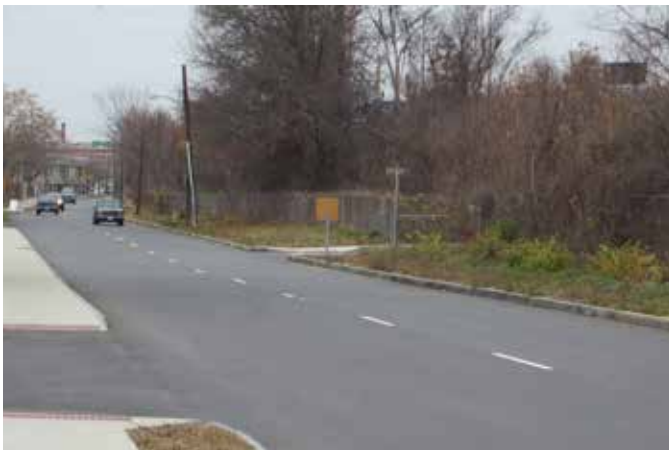
There are currently no crosswalks across Birnie Avenue for pedestrians trying to get from the Brightwood community to goods and services on Main Street and vice versa. To ensure that pedestrians can safely cross Birnie Avenue, WalkBoston recommends installing new crosswalks with ladder design and curb ramps across Birnie Avenue at Huntington and Arch Streets. The City should also consider installing a Rectangular Rapid Flashing Beacon at the crosswalk determined to be the more dangerous and/or frequently used crossing.

*The view of Birnie Avenue at Huntington Street. German Gerena Community School is in the background.*

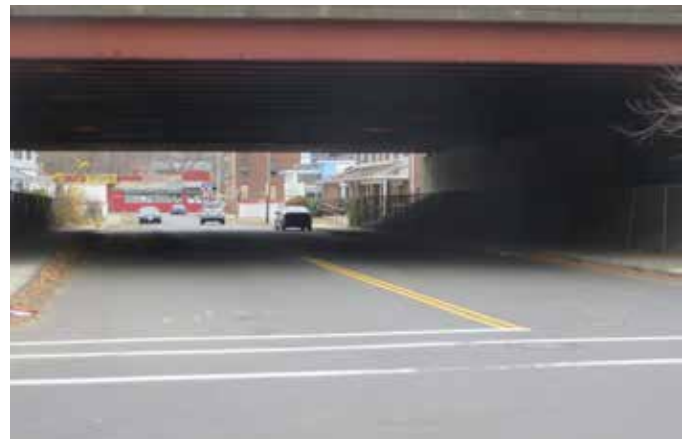
Street connections along Huntington and Arch Streets between Birnie Avenue and Main Street are currently uninviting to pedestrians, with wide travel lanes that encourage high traffic speeds and poor lighting of the I-91 underpasses. In addition, the lack of a buffer between high-speed traffic and the existing sidewalk on the Birnie Avenue ramp approaching Route 20/ Plainfield Street creates additional potential hazards for pedestrians.

*The I-91 underpasses along Huntington Avenue and Arch Streets are currently poorly lit and uninviting to pedestrians, even during the day. The wide travel lanes on these streets encourage fast vehicular traffic.*

- Install lighting in I-91 underpasses along Huntington and Arch Streets (between Birnie Avenue and Main Streets)
- Put in fog lines on Huntington and Arch Streets to narrow travel lanes and slow traffic speed
- Upgrade all existing crosswalks along Huntington and Arch Streets from standard to ladder design
- Shift and widen sidewalk on western side of Birnie Avenue to create a grassy buffer between pedestrians and high-speed traffic along approach to Route 20/Plainfield Street. Consider installing additional landscaping features along and around grassy buffer (trees, plantings, etc.)

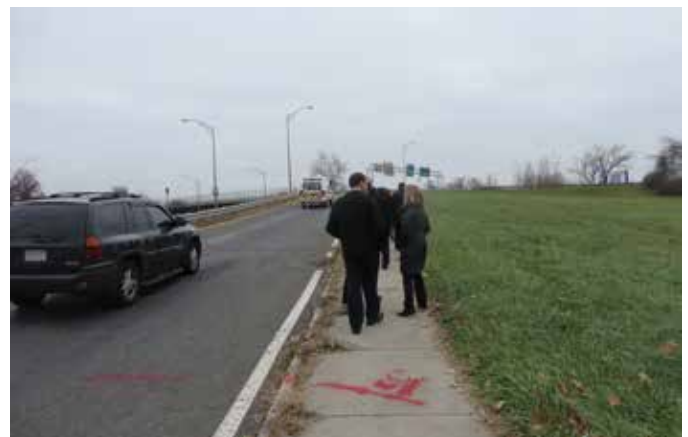
*No buffer exists between pedestrians and high-speed traffic along the Birnie Avenue ramp on the approach to Route 20/Plainfield Street.*

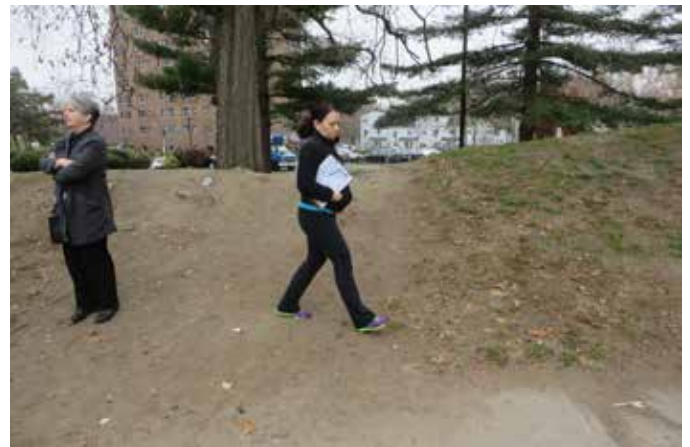
In addition to the mid-block crossing recommended above, additional improvements are needed to ensure safe pedestrian access and crossings along West Street. Of particular note, pedestrians walking on Riverside Road and other areas near the western edge of the Brightwood neighborhood do not have convenient access to a safe crosswalk across West Street. In addition, residents of the Edgewater Apartment Complex and the broader neighborhood lack clear paths to West Street. WalkBoston therefore recommends the following additional measures:

*Lacking clear paths from local housing developments to West Street, pedestrians walk over grassy strips and embankments to create their own improvised dirt paths, which are largely inaccessible to seniors and persons with disabilities, and in inclement weather conditions.*

- Work with owners of housing developments north of West Street to create paved pathways to West Street (see also US Route 20 Corridor Road Safety Assessment, pg. 31)
- Install pedestrian countdown signals at new and existing crosswalks and update signal timings to ensure sufficient time for pedestrian crossings
- Upgrade all existing crosswalks from standard to ladder design
- Consider installing wayfinding signage at the corner of Riverside Avenue and West Street directing pedestrians to WalkBoston's recommended midblock crossing on West Street

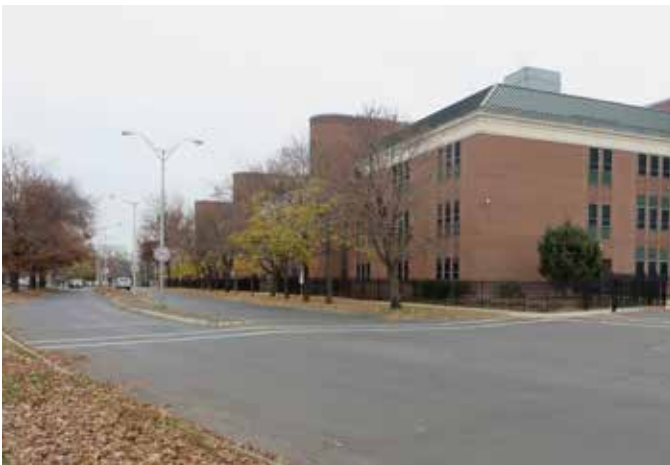
The current crosswalk to access Chestnut Middle School across Plainfield Street leads directly into a driveway and lacks safety features like ladder design, pedestrian refuge islands and sidewalk access. To enhance pedestrian safety and access, WalkBoston recommends improving the crosswalk across Plainfield Street at Chestnut Middle School in the following ways:

*The existing crosswalk at Plainfield Street and Chestnut Middle School*

- Relocate the crosswalk north so it no longer directly abuts the school driveway
- Create a curb extension at the driveway just south of the newly shifted crosswalk
- Upgrade the newly shifted crosswalk to ladder design and include an in-street pedestrian crossing sign
- Construct new curb ramps and sidewalk extensions leading up to the newly shifted crosswalk on both sides of Plainfield Street
- Create a pedestrian refuge island in the existing median strip

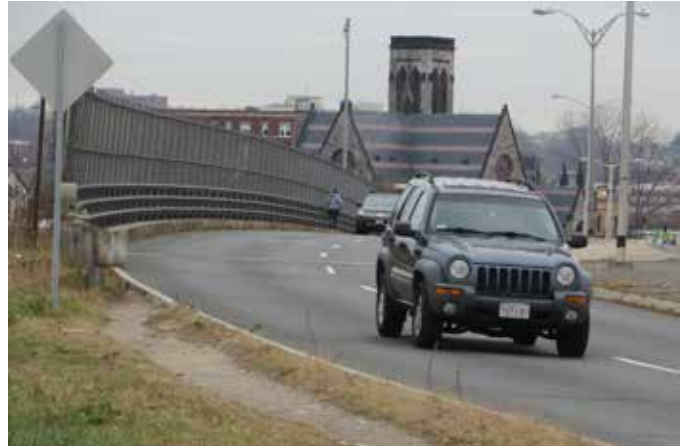
The convergence of the Birnie Avenue ramp with Route 20/Plainfield Street is extremely inhospitable to pedestrians and bicyclists. At this location there are no pedestrian crossings from the sidewalk-less northern side of the Route 20/Plainfield Street bridge to the sidewalk on the southern side of the bridge. As a result pedestrians and bikers often engage in risky and unsafe behavior, either by crossing to the southern side of the bridge to access the sidewalk there despite the lack of a protected crossing, or by walking or biking along the northern side of the bridge against the flow of traffic, with no sidewalk and no physical separation from oncoming high-speed motor vehicles.

*A lack of pedestrian facilities at the convergence of the Birnie Avenue ramp with Route 20/Plainfield Street leads to risky and unsafe pedestrian and bicyclist behavior.*

WalkBoston recommends that the City of Springfield follow up the Road Safety Assessment process to push for pedestrian accommodations at the convergence of the Birnie Avenue ramp with Route 20 and Plainfield Street, including potential pedestrian crossings across the Birnie Street ramp and across Route 20/Plainfield Street, as well as the potential addition of a sidewalk along the northern side of the Route 20/Plainfield Street bridge. The RSA team made these same recommendations as well (US Route 20 Corridor Road Safety Assessment report, pg. 30). Constructing a sidewalk along the northern side of the bridge in particular will give residents in the Edgewater Apartment Complex and the broader neighborhood around West Street a much safer and more direct route to access goods and services on Main Street.

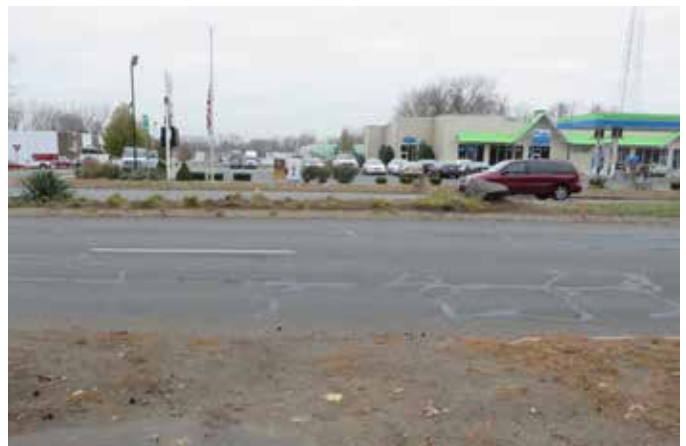
*A sidewalk in poor condition along the northern side of West Street opposite the Pride Service Station.*

Ensuring that sidewalks are in good condition and that pedestrian areas are well-lit at night throughout the Brightwood neighborhood are critical to ensuring a safe, easily navigable and pleasant walking environment. WalkBoston recommends that the City of Springfield undertake a comprehensive survey of existing sidewalk and lighting conditions in Brightwood to identify key areas for improvements and to prioritize infrastructure upgrades accordingly.
