WalkBoston

Walkability Assessment Report Lincoln Elementary School, Melrose June 14, 2012

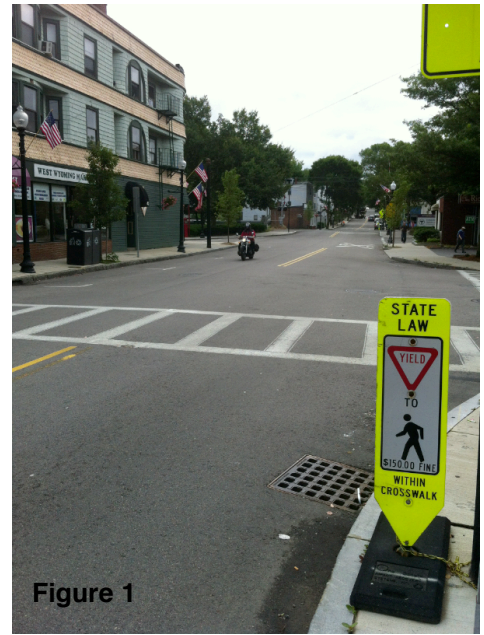
area to expect pedestrians crossing. Many of the crosswalks that cross West Wyoming Avenue have “yield to pedestrians” signs placed outside of the crosswalks on the curbs (Figure 1). This type of sign is most effective when located in the center of a roadway, where it is most visible to drivers.

- Place pedestrian crossing signage in the center of the roadway more often – not just when students are walking to and from the school – to remind drivers that this is an

- Calm traffic speeds by slightly raising the crosswalks (creating speed “tables”) adjacent to Lincoln Elementary, including the crosswalk immediately east of the school driveway (which also needs an ADA-compliant curb ramp) and the next crosswalk at the western edge of the school grounds. Install advance signage to alert drivers of the speed tables.
- Consider moving the crosswalk immediately east of the school driveway to the west of the school driveway. The current location forces pedestrians going to or coming from the school to cross over the school driveway, where vehicles may be coming and going.

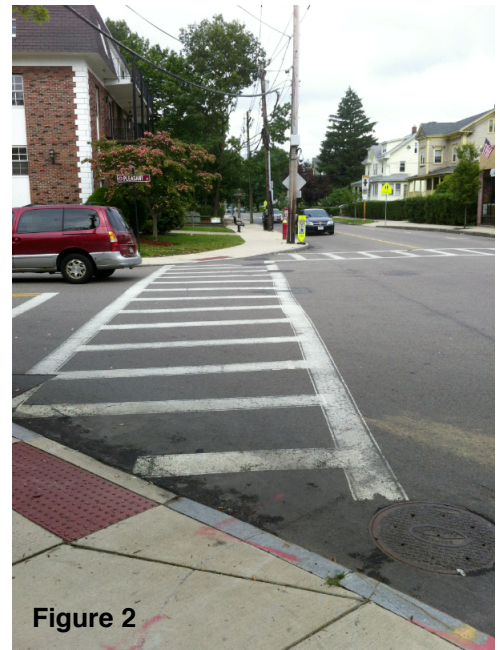
2. Observation: Pleasant Street curb radii too long, allows fast turns at West Wyoming and Pleasant

The intersection of Pleasant Street and West Wyoming Avenue has turning radii that allow vehicles to make onto Pleasant at a relatively high speed (Figure 2).

- Tighten the corners at Pleasant and West Wyoming. This not only slows the right turning movements, but it also shortens the crossing distance for pedestrians across both Pleasant Street and West Wyoming Street. The curbs can be extended into the intersection, forming more of a right angle, or placing barrels or bollards in the street can temporarily tighten the corners.

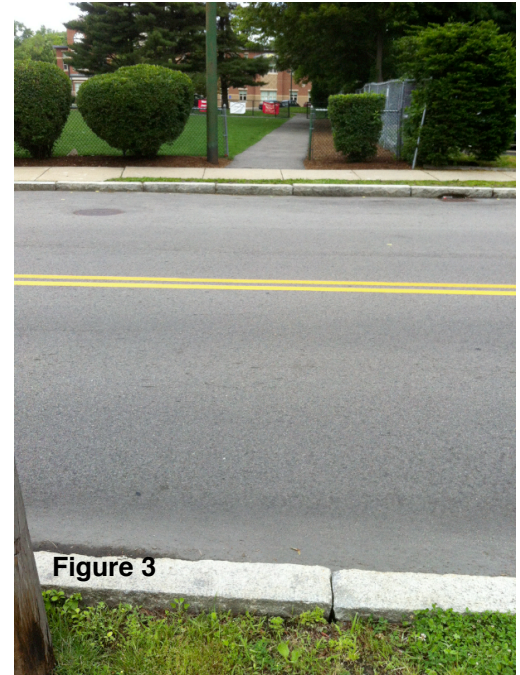
3. Observation: Crosswalk and curb ramps missing at Lincoln School field access on Pleasant Street

There is an access point to a walkway at the Lincoln School playing fields on Pleasant Street. This is a location where children are known to cross, despite the fact that there is no crosswalk (Figure 3). To the east of Pleasant Street, there is also what appears to be an informal “cut-through” to the platform at the Wyoming Hill MBTA station. The lack of a safe crossing here is especially problematic because this location is only 200 feet from the intersection of Pleasant Street and West Wyoming Avenue, where vehicles can turn onto Pleasant at high speeds.

- Install curb ramps and pedestrian crossing signage, and mark a crosswalk that connects the gate to the Lincoln School fields on the west side of Pleasant Street to the walkway of the apartment building on the east side of Pleasant Street.

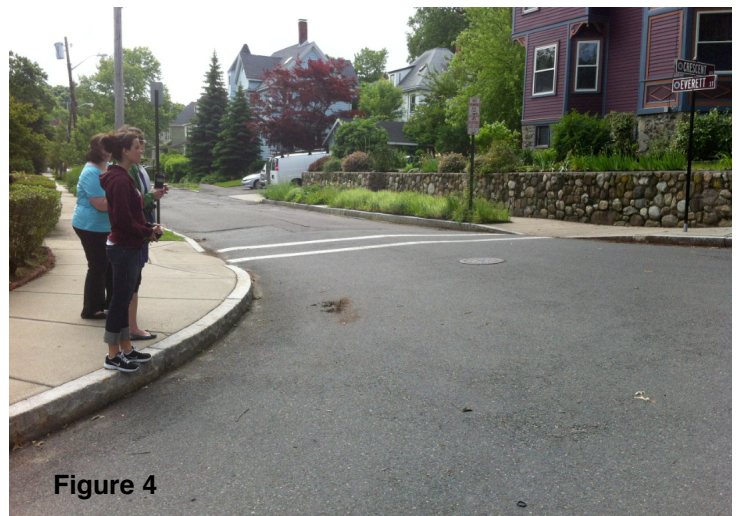
4. Observation: Crosswalk at Everett Street and Crescent Avenue is set back too far

Crescent Way, a residential local road many students use to access Lincoln Elementary, intersects with Everett Street just south of the rear driveway to the school. The crosswalk across Everett Street is set back about 15 feet from where a driver would realistically slow or stop to look for oncoming pedestrians or vehicles (Figure 4). This presents a safety hazard, especially during times when children are walking to or from the Lincoln School.

- Install a STOP sign and paint a stop bar in advance of the existing crosswalk so drivers have to slow down before encountering pedestrians crossing Everett Street.

- Install additional signage and/or pavement markings reminding drivers they are entering an area where there are children walking to and from a school.

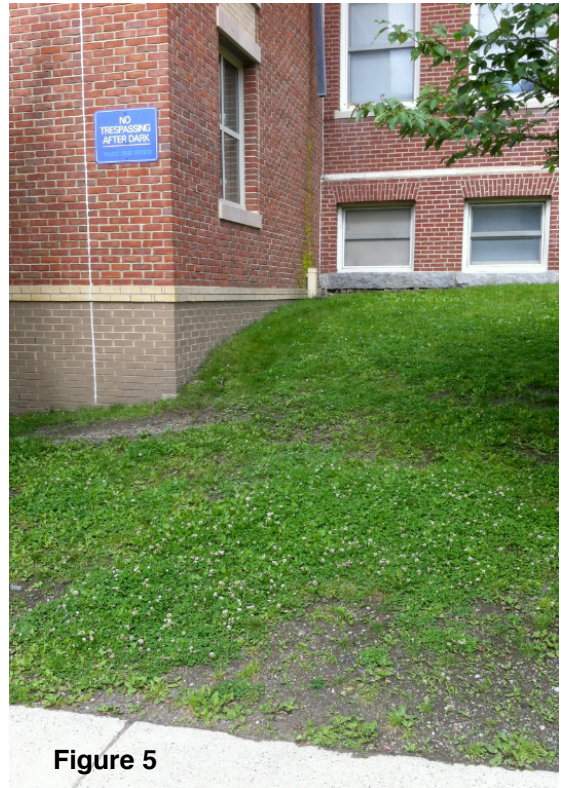
Figure 5

5. Observation: Water from Lincoln School storm water pipe collects on sidewalk beside school, freezes in winter

A storm water drainage pipe at the front of the school drops water on a steep grade (Figure 5). The runoff erodes a grassy area, and runs down to the walkway that leads to the school entrance. This can create muddy conditions, and in the winter, this water turns to ice and presents a safety hazard to students and faculty.

- Re-direct the downspout so it doesn't drain onto a walkway or place a rain barrel beneath the downspout.
