Bicycle and Pedestrian Infrastructure Assessments Holyoke, MA

Beech Street at Resnic Boulevard / W Franklin Street and Appleton Street Corridor between Sycamore Street and Chestnut Street

Walk/Bicycle Assessment
Appleton Street and
Beech Street at Resnic Boulevard
Holyoke, MA
May 2, 2017

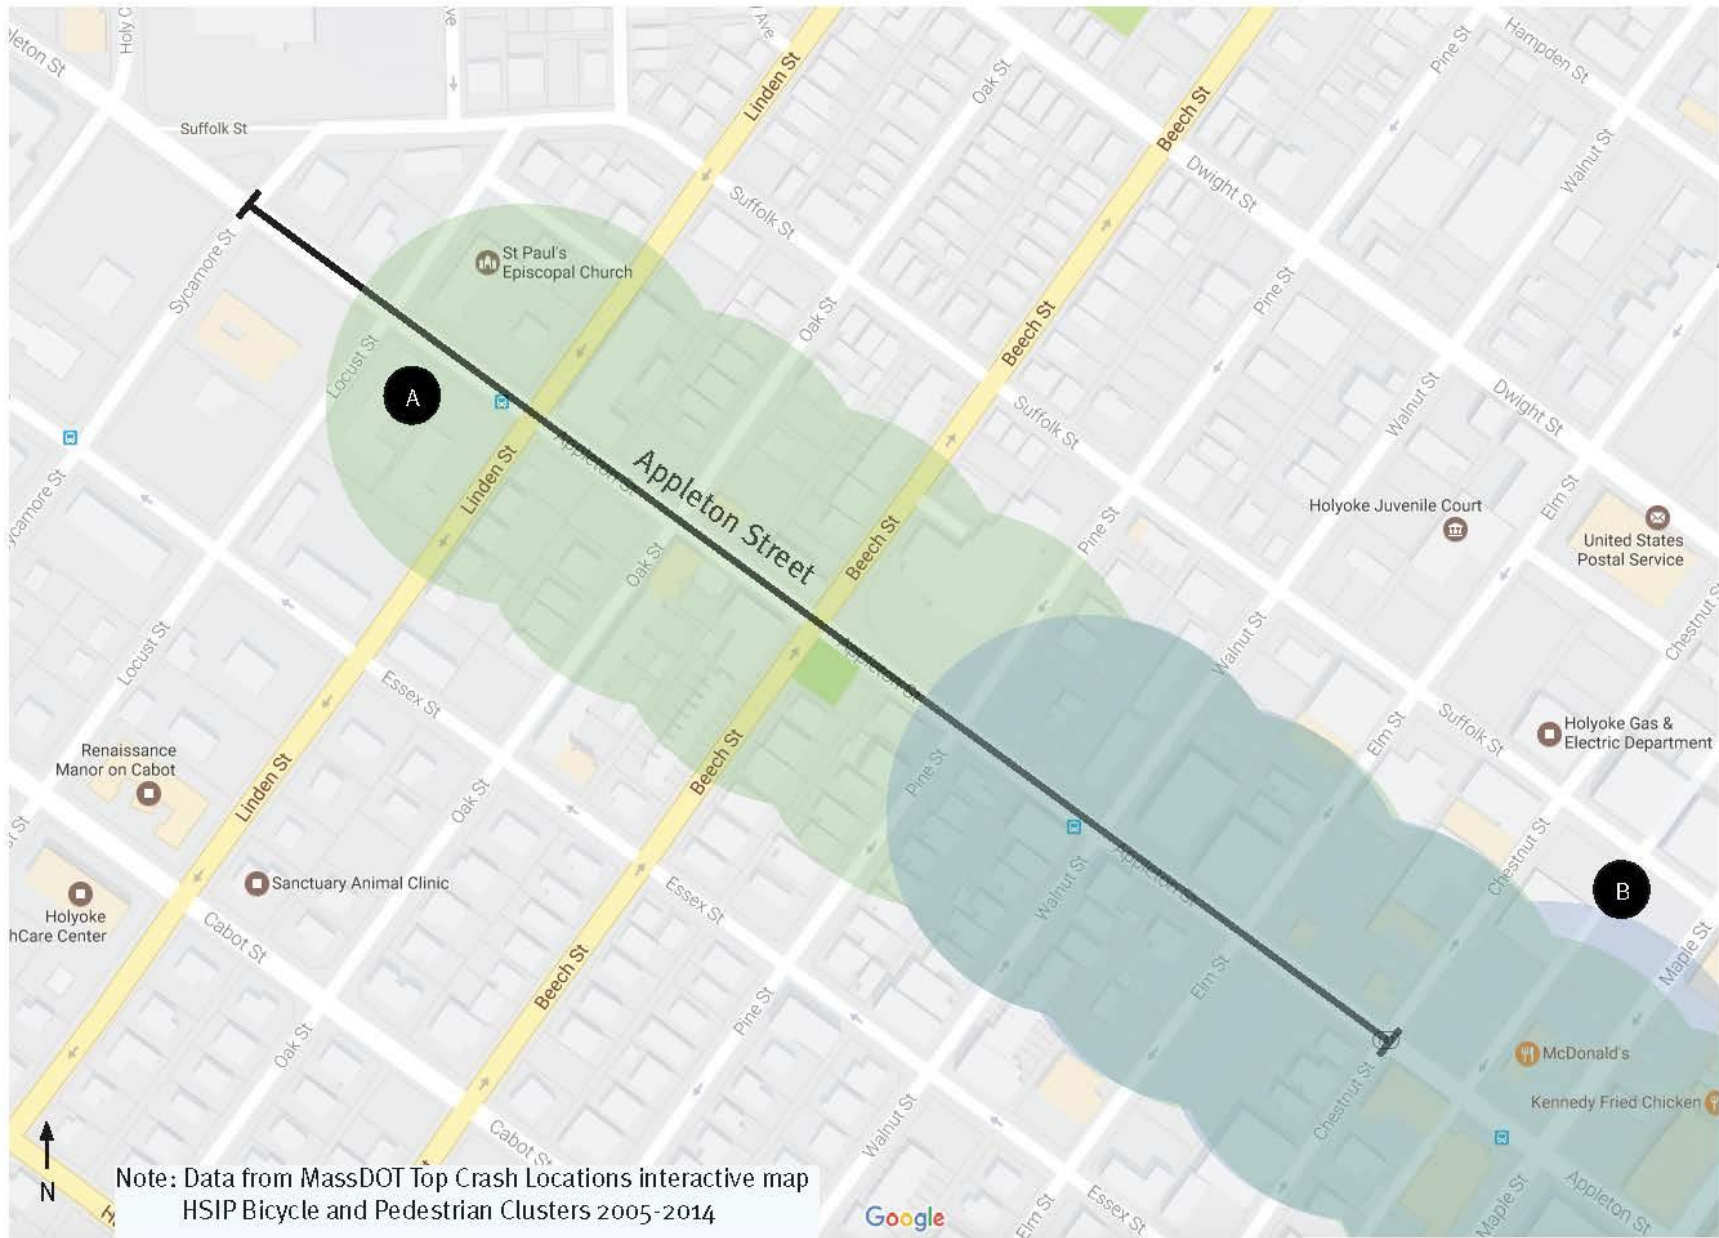
Figure 2: Appleton Street Assessment Map

HSIP Bicycle Cluster A	
Crash count	13
Fatal crashes	0
Injury crashes	9
Property damage crashes	4

HSIP Pedestrian Cluster B	
Crash count	19
Fatal crashes	0
Injury crashes	15
Property damage crashes	4

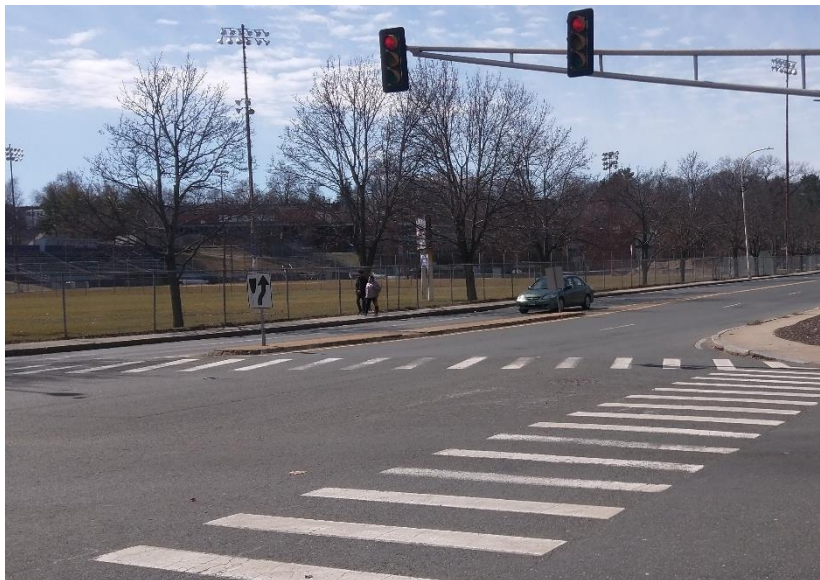
Resnic Boulevard and Beech Street connect directly to I-391 and I-91 and feel like extensions of the highway. Assessment team members noted that both roadways carry a relatively high volume of truck traffic; however, traffic counts were not provided. The assessment team described excessive speeds along these roadways. Crash data reviewed indicated high volumes of reported rear-end crashes (38%) on all approaches except for the southbound Beech Street approach; speeds may have been a contributing factor in these crashes. Beech Street

Image 1: Beech Street eastbound approach.

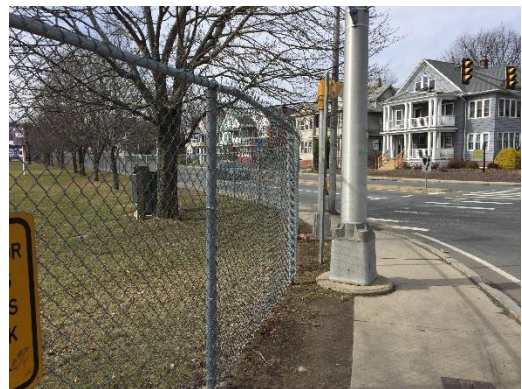
The existing fence and tree line on the southeast side of the intersection restrict sight lines between pedestrians and northbound motorists on Beech Street turning eastbound onto Resnic Boulevard. The poor sight lines and high motor vehicle turning speeds may have contributed to a reported crash where a bicyclist was struck while crossing in the crosswalk across Resnic Boulevard by a right-turning motorist from northbound Beech Street.

Image 2: Fence, light pole, and trees obstruct sight lines on the southeast corner of the Beech Street at Resnic Boulevard.

2. Consider adjusting the fence line to increase visibility between pedestrians and turning vehicles on the southwest corner of the intersection;
3. Consider reducing corner radii to slow motor vehicle speeds via flexposts and paint;

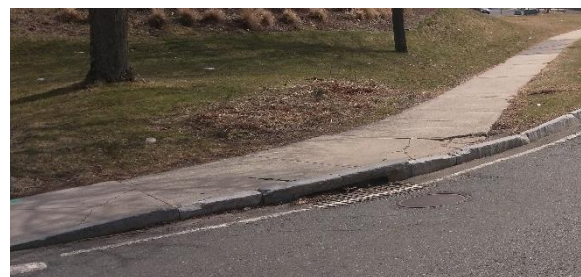
The assessment team noted that the right-turn slip lane on the westbound approach is yield-controlled, which does not meet current standards and will need to be upgraded with signals during any reconstruction work. There are no advanced pedestrian warning signs for the right-turn slip lane. The assessment team observed a large truck mounting the sidewalk as it made a right turn onto Beech Street northbound. The sidewalk has notable cracking and gaps along the slip lane. In the long-term, the assessment team discussed removing the slip lane and tightening of the curb radii to slow vehicular speeds. In the short-term, the assessment team recommended installing warning signs and evaluating the feasibility of closing the slip lane. The team discussed that this may be possible by narrowing travel lanes on all approaches, removing the hatched median on Resnic Boulevard, and potentially removing the concrete median island on Beech Street to provide adequate turning space for large trucks. In the long-term, the assessment team recommends considering removal of the slip lane

Image 3: Sidewalk deterioration along right-turn slip lane on Resnic Boulevard northbound approach.

and splitter island via reconstruction to shorten crossing distances for pedestrians and slow motor vehicle speeds.

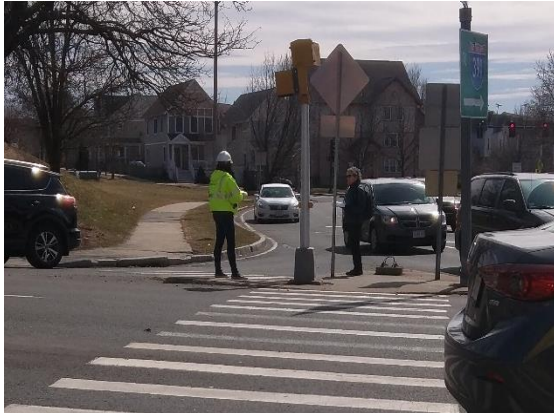
Image 4: Splitter island on Resnic Boulevard northbound approach with pedestrian signal heads rotated and missing light pole.

A light pole located within the splitter island for the right-turn slip lane on the Resnic Boulevard westbound approach was recently struck and was missing. In addition, the pedestrian signal pedestal to cross Beech Street is not operational and the signal heads were rotated and facing away from the pedestrian direction of travel. The assessment team also noted that because the slip lane is yield controlled, there are no pedestrian signal heads to indicate to pedestrians when to cross the slip lane.

5. Reinstall the missing light pole located within the splitter island for the right-turn slip lane on the Resnic Boulevard approach;

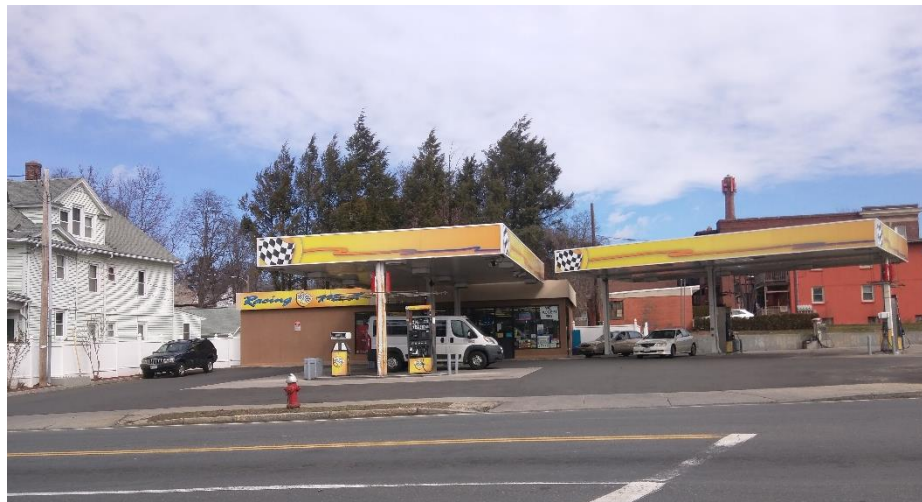
There are three wide curb cuts providing access to the gas station on the northeast corner of the intersection, one on Beech Street and two on W Franklin Street. The team recommended removing the center curb cut on W Franklin Street closest to the intersection to reduce pedestrian exposure and conflicts within the intersection.

Image 5: Curb cuts on W Franklin Street at gas station.

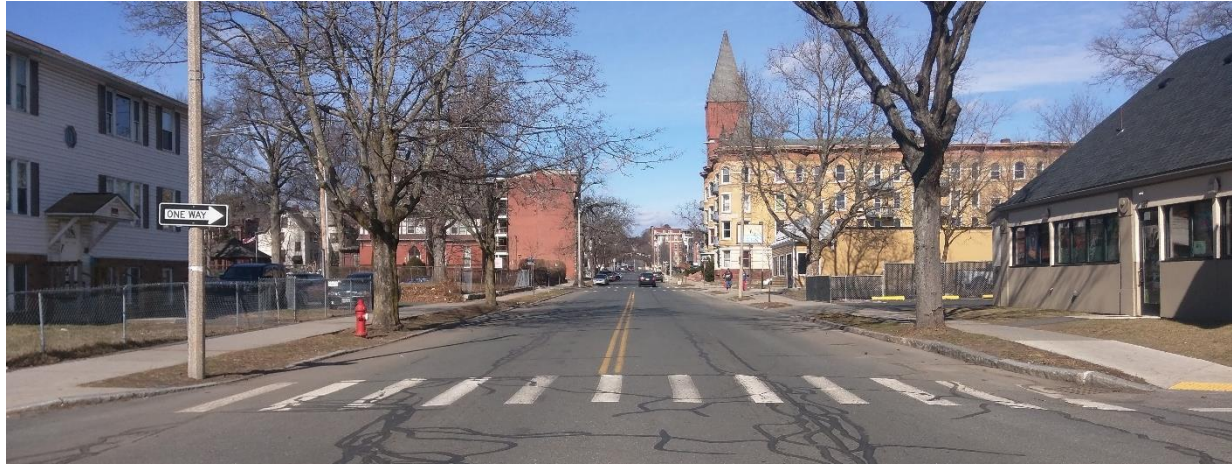
one-way and stop controlled. There are three signalized intersections within the study area. Average daily traffic volumes for Appleton Street were not provided at the assessment.

Image 6: Appleton Street Corridor facing eastbound.

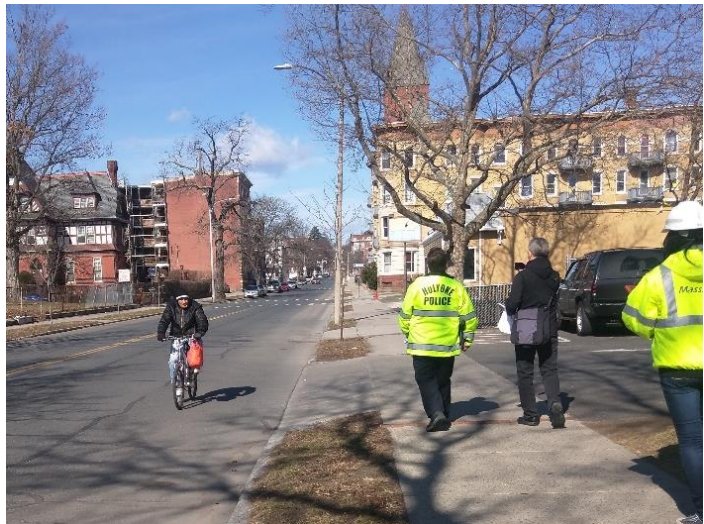
Currently there are no existing bicycle facilities along Appleton Street although team members noted that Appleton Street is a major connecting east-west bicycle route through the City. Bicyclists were observed riding on sidewalks and against traffic during the assessment.

Image 7: Bicyclist riding against traffic on Appleton Street.

Members of the assessment team suggested installing bicycle facilities by consolidating parking to one side of the street. The assessment team discussed different alternatives for bicycle facilities, including standard bicycle lanes on each side of the street,

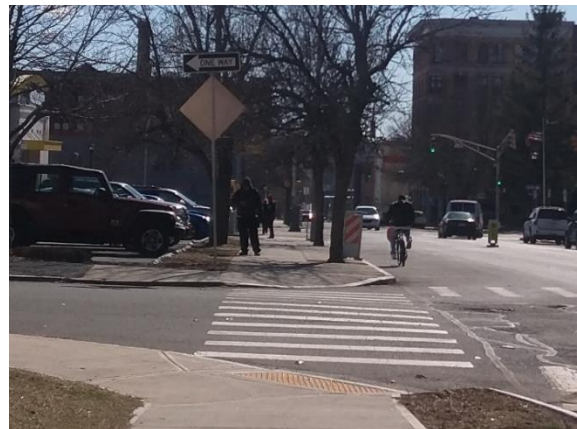
Members of the assessment team noted that most of the pedestrian ramps within the study area do not meet accessibility standards, however select ramps along the corridor were recently reconstructed and do appear to be compliant with accessibility requirements. Note a full accessibility assessment was not conducted. New and old ramps throughout the corridor are apex style. Apex ramps guide pedestrians into the middle of the intersection and can be confusing for pedestrians with visual impairments. The team discussed that separate curb ramps for each crosswalk should be provided. In addition, consideration should be given to installing curb extensions to reduce crossing distances, however in the location and design of curb extensions should consider and minimize impacts to bicycle facility access.

Image 8: Curb ramps on Appleton Street.

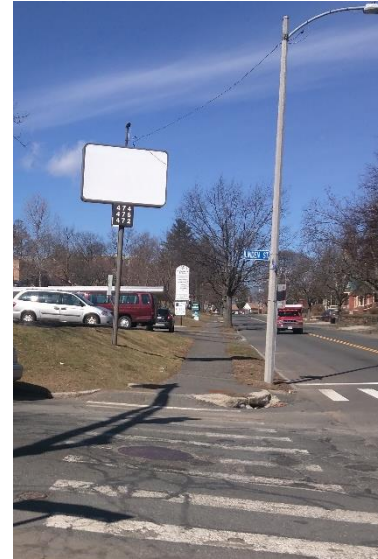
Appleton Street at Linden Street is a signalized four-way intersection with three approaches as Linden Street is one-way southbound. Linden Street provides two lanes and on-street parking. Crash reports indicated there was one bicycle and one pedestrian-involved crash at this intersection. The pedestrian was struck after exiting her vehicle and accessing the sidewalk. The bicyclist launched from the parking lot at 474 Appleton Street on the southwest corner of the intersection, went airborne onto Linden Street, and struck a motorist travelling southbound on Linden Street.

Image 9: Asphalt sidewalks on the south side of Appleton Street north of Linden Street.

- A. Consider reconstructing the sidewalk on the south side of Appleton Street west of Linden Street as concrete and to meet accessibility requirements.

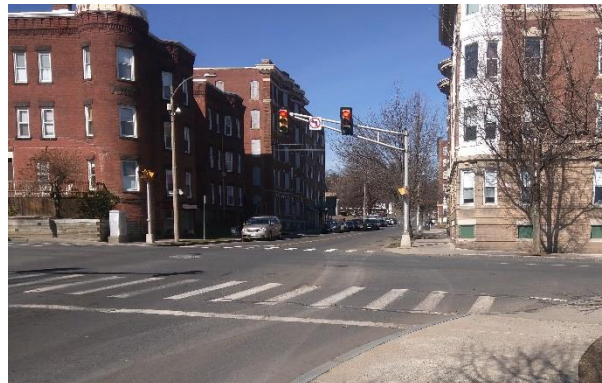
There are three crosswalks at the intersection with a missing crosswalk on the north side of the intersection across Beech Street. Assessment participants noted that pedestrians walking westbound on the north side of Appleton Street will not cross three legs of the intersection to continue straight along the corridor, but rather they will cross the approach that is missing a marked crosswalk, where the desire line is located.

Image 10: Missing crosswalk on north east leg of intersection of Appleton Street at Beech Street.

1. Install a crosswalk, accessible curb ramps, and pedestrian signal indications on the northeast leg of the intersection across Beech Street;
2. Provide an accessible path on the southwest corner of the intersection. Consider curb extensions or relocating obstructions;
3. Evaluate sight distance on the southwest corner of the intersection and consider treatments to improve sightlines as necessary;
4. Install lane directional markings and advance intersection lane control signs on the Beech Street northbound approach;
5. Consider feasibility of an exclusive pedestrian phase;
6. Service the pedestrian signal indications and push buttons on the southeast and southwest corners of the intersection so they are operational; and
7. Adjust the height of the pedestrian signal head on southwest corner to meet MUTCD and accessibility requirements.

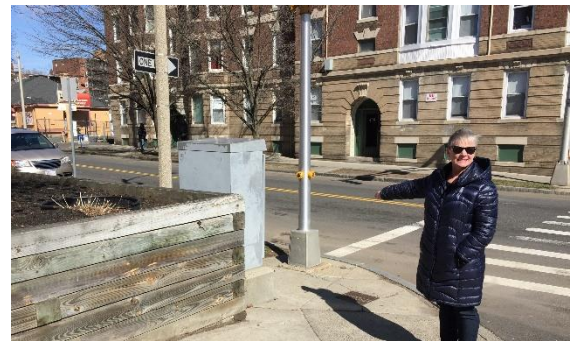
On the southwest corner of Appleton Street and Beech Street the existing signal controller box, retaining wall, landscaping, and light pole obstruct the sidewalk and reduce sightlines between northbound motorists on Beech Street and eastbound motorists on Appleton Street and there the sidewalk becomes narrow. Participants noted that there is poor visibility on the Beech Street approach because of the steep downhill grade.

On the southwest corner of the intersection the existing signal controller box, retaining wall, landscaping, and light pole obstruct the sidewalk and reduce sightlines between northbound motorists on Beech Street and eastbound motorists on Appleton Street.

Image 11: Sightline and sidewalk obstructions on southwest corner of Beech Street and Appleton Street.

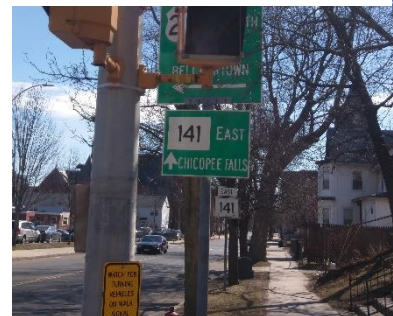
Team members also noted that when Beech Street northbound received the green signal, the pedestrians received a concurrent WALK signal for the east and west side crosswalks across Appleton Street. As shown in the reported crash data, there were six crashes with thru vehicles in the left lane and vehicles turning left from the right most lane, and one bicycle crash with a vehicle turning left from the right lane. A team members recommended considering lane directional markings and advance intersection lane control signs, as well as considering the feasibility of an exclusive pedestrian phase to separate the conflicts with left turning vehicles.

Image 12: Pedestrian signal is not operational on the southeast corner of the intersection.

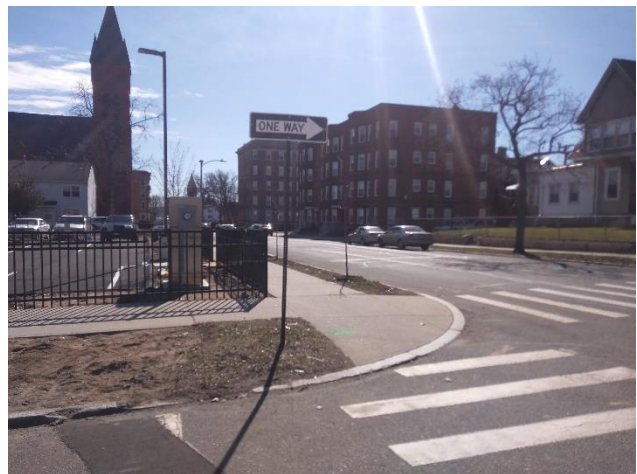
Members of the assessment team noted sightline issues on the southbound Pine Street approach due to a recently installed fence and transformer box inside of the fence.

Image 13: Sight lines on Pine Street approaching Appleton Street.

- A. Evaluate sight lines on the southbound Pine Street approach and consider constructing curb extensions and relocating the fence and transformer box to increase sight distance.

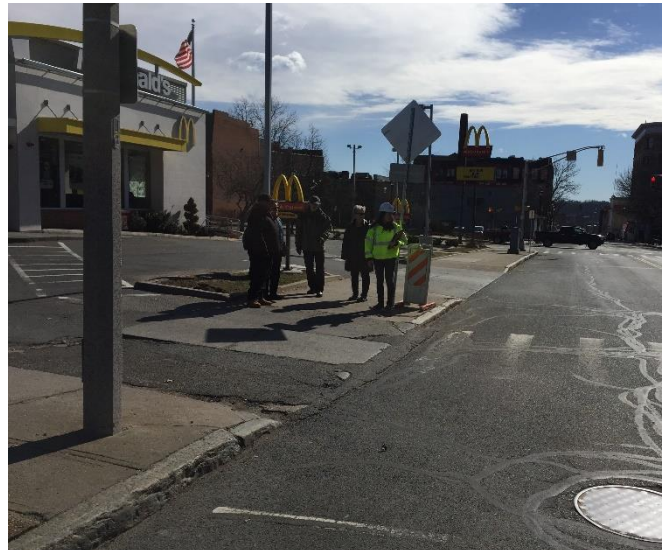
Approximately 140' east of the intersection of Appleton Street at Chestnut Street, assessment team members noted there is a faded crosswalk located within the McDonalds driveway which does not meet accessibility requirements. This crosswalk connects to an existing pedestrian alley. The team noted that either the crosswalk, or driveway should be relocated, however this location is a half-block outside of the study area.

Image 14: Faded crosswalk located within McDonald's driveway on Appleton Street east of Chestnut Street.

1. Relocate the existing crosswalk or McDonald's driveway curb cut just south of the intersection to provide an accessible crossing with compliant curb ramps; and
2. Restripe the crosswalk with high-visibility ladder-style pavement markings.

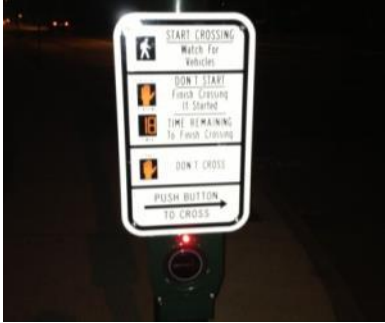
Facility Type	Description	Sample Photo
<p>Accessible Pedestrian Signals</p>	<p>Accessible pedestrian signals systems are the components used at a signalized intersection to alert pedestrians when they may cross a roadway. Accessible pedestrian signals may include audible and vibrating features to assist visually-impaired pedestrians.</p>

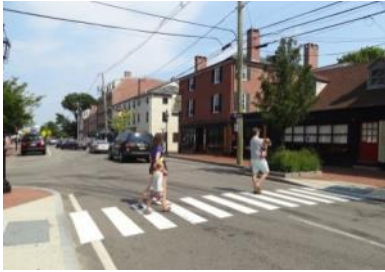
<p>Crosswalk</p>	<p>Crosswalks indicate to pedestrians the appropriate place to cross the street and inform drivers of potential pedestrian movements in the street.</p>

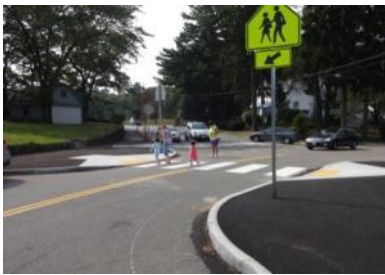
<p>Curb Extensions</p>	<p>A curb extension is an extension of the sidewalk at intersections or mid-block to reduce the pedestrian crossing distance and provide greater visibility for pedestrians waiting to cross a street.</p>

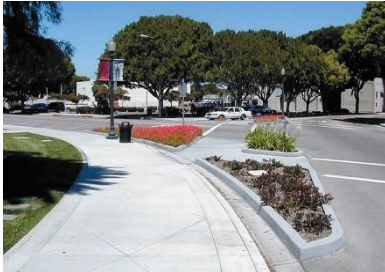
<p>Curb Radii</p>	<p>Modifications to curb lines or edges of the pavement at an intersection. These modifications typically are used to decrease crossing distances for pedestrians or to reduce vehicular speed by tightening the turning radii at the intersection corners.</p>

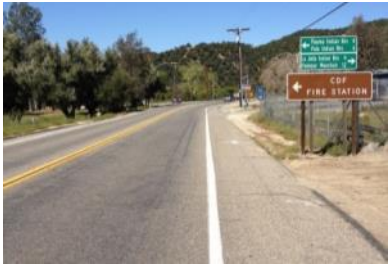
Facility Type	Description	Sample Photo
<p>Edge Lines</p>	<p>Edge lines are solid white lines painted along the roadside curb that defines the driving lane and visually narrows the travel lane. In some cases, edge lanes may be used to create bicycle lanes.</p>

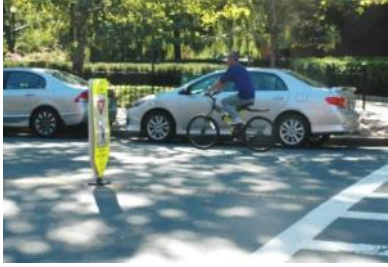
<p>In-Street Pedestrian Crossing Sign</p>	<p>A removable high-visibility sign placed on the centerline of a street prior to a crosswalk to alert motorists to yield when pedestrians are present in the crosswalk.</p>

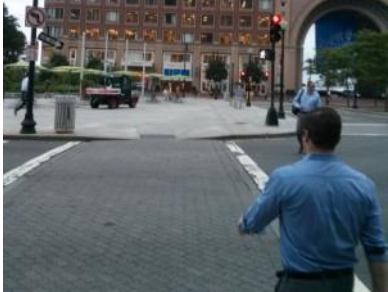
<p>Leading Pedestrian Interval</p>	<p>A pedestrian crossing indication that permits pedestrians to move into the intersection 3-7 seconds before a green light is given to turning motorists that may cross the crosswalk.</p>

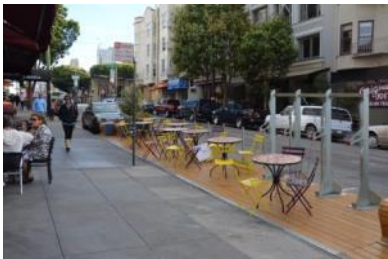
<p>Parklet</p>	<p>Permanent or temporary gathering area installed in the street adjacent to the curb as an extension of sidewalk space.</p>

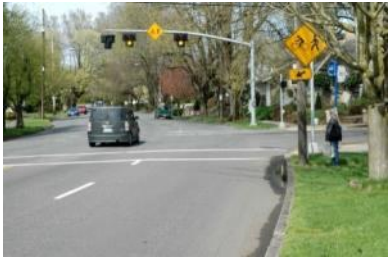
<p>Pedestrian Hybrid Beacon</p>	<p>An overhead flashing beacon activated by pedestrians. The flashing lights alert motorists to yield and increase visibility of pedestrians in the crosswalk.</p>

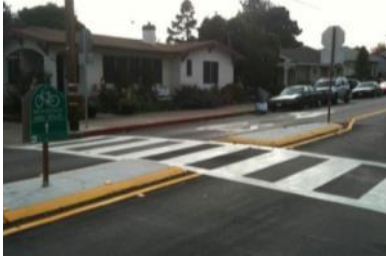
Facility Type	Description	Sample Photo
<p>Pedestrian Crossing Island</p>	<p>Raised median or island that provides in-street refuge at a pedestrian crossing. The crosswalk may be angled at refuge to encourage pedestrians to make eye contact with oncoming traffic.</p>

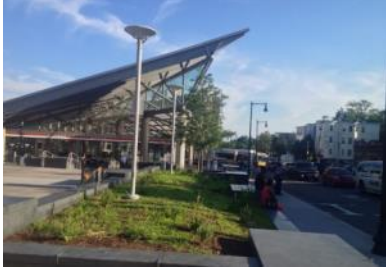
<p>Pedestrian-Scale Lighting</p>	<p>Light fixtures used to illuminate a sidewalk or pathway typically closer to the ground and placed closer together than roadway lighting.</p>

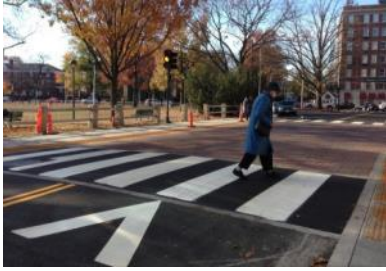
<p>Raised Intersection</p>	<p>A crosswalk or entire intersection raised from street-level to sidewalk-level. This elevated crossing increases pedestrian priority and visibility and slows approaching vehicles.</p>

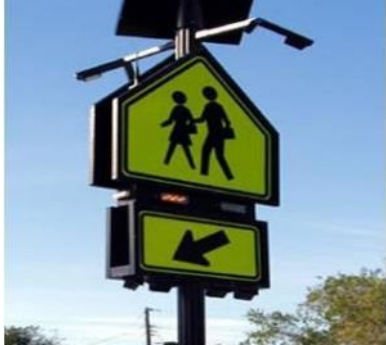
<p>Rectangular Rapid Flash Beacon</p>	<p>An on-demand activated flashing beacon with a “wig-wag” pattern that alerts motorists to pedestrians in the crosswalk. Typically used on lower volume and lower speed streets.</p>

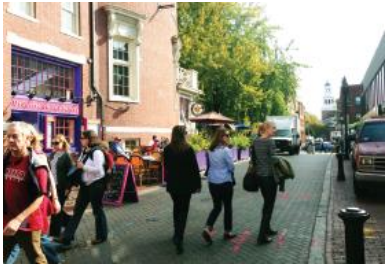
<p>Shared Street</p>	<p>The road surface is typically at the same level as the sidewalk surface to create a continuous pedestrian space. A shared street is for motorists, pedestrians, and bicyclists.</p>

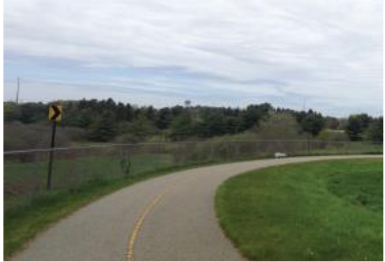
Facility Type	Description	Sample Photo
<p>Shared-use Path</p>	<p>A two-way path that is open for bicyclists, pedestrians, and other non-motorized users. The path is typically ADA-compliant and ranges between 10 to 14 feet wide.</p>

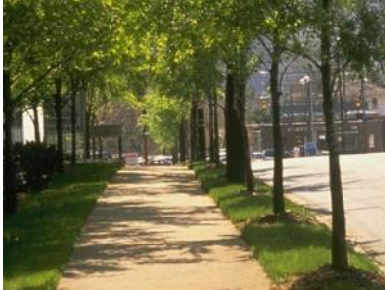
<p>Sidewalk</p>	<p>A concrete pathway adjacent to the roadway. Sidewalks must meet minimum dimensions and smoothness for ADA-compliance. They may have decorative paving or plantings and should be wider where high pedestrian volumes are present or desired.</p>

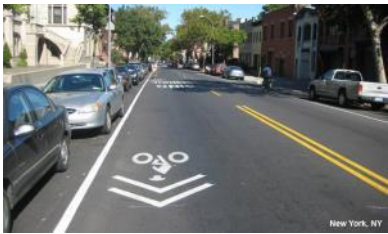
Facility Type	Description	Sample Photo
<p>Shared Lane Markings</p>	<p>Designate positioning for cyclists within shared travel lanes and alert drivers to the presence of cyclists. Shared lane markings should be considered temporary measures until future improvements can provide full bicycle facilities.</p>

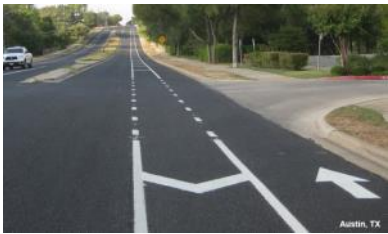
<p>Austin, TX</p>
<p>Buffered Bicycle Lane</p>	<p>Bicycle lane with a painted buffer separating cyclists from adjacent vehicle traffic and/or adjacent parking lanes.</p>

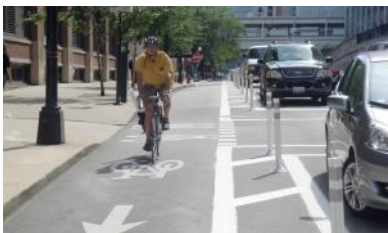
<p>Austin, TX</p>
<p>Separated Bicycle Lane</p>	<p>Bicycle lane protected from vehicle traffic by adjacent vertical elements, including flex posts, planters, parked cars, curbs, or raised medians.</p>

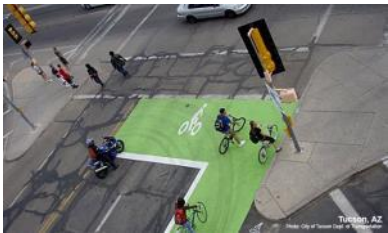
<p>Bicycle Box</p>	<p>Advance stop bar allows bicyclists to stop at a traffic signal ahead of vehicle traffic to increase visibility and allow for left turns.</p>

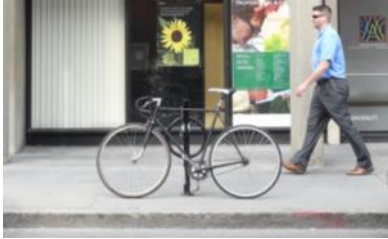
Facility Type	Description	Sample Photo
<p>Post and Ring Bicycle Parking</p>	<p>Individual bicycle racks typically placed along sidewalks to provide incremental bicycle parking throughout a larger area.</p>

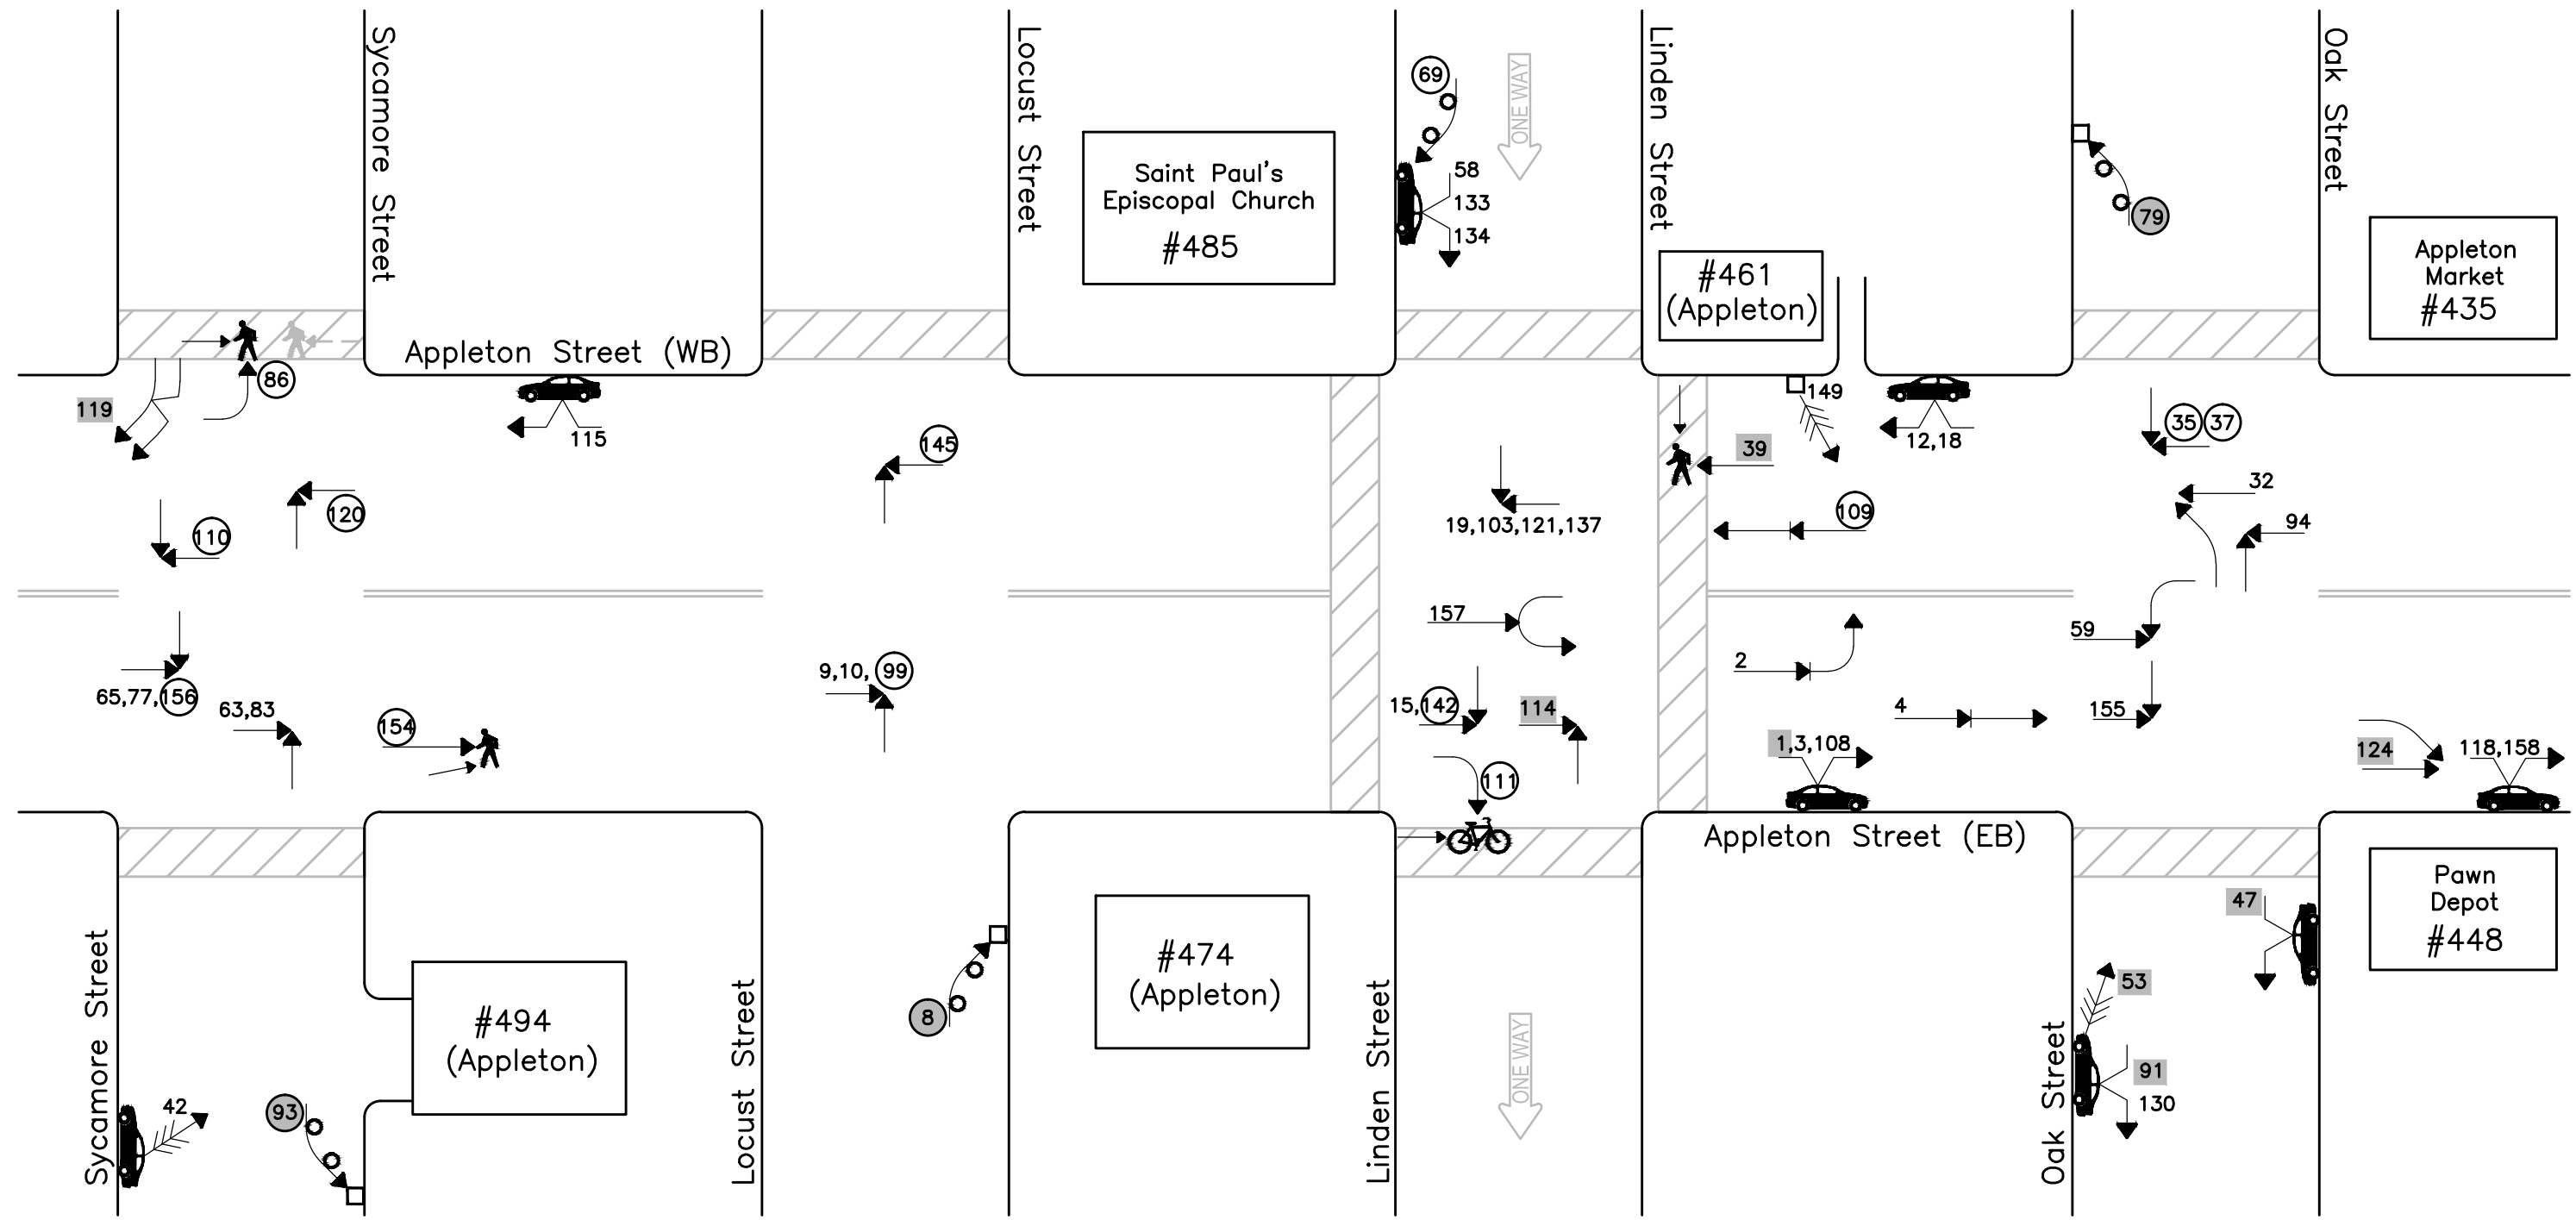
COLLISION DIAGRAM

TIME PERIOD ANALYZED: 2011-2015
 SOURCE OF CRASH REPORTS: HOLYOKE POLICE DEPARTMENT
 DATE PREPARED: 11/16/2016
 PREPARED BY: KUSH BHAGAT
