Downtown Walk Assessment Salem, MA

September 23, 2014

Massachusetts Department of Transportation
Bicycle and Pedestrian Safety Program
in partnership with Massachusetts Department of Public Health

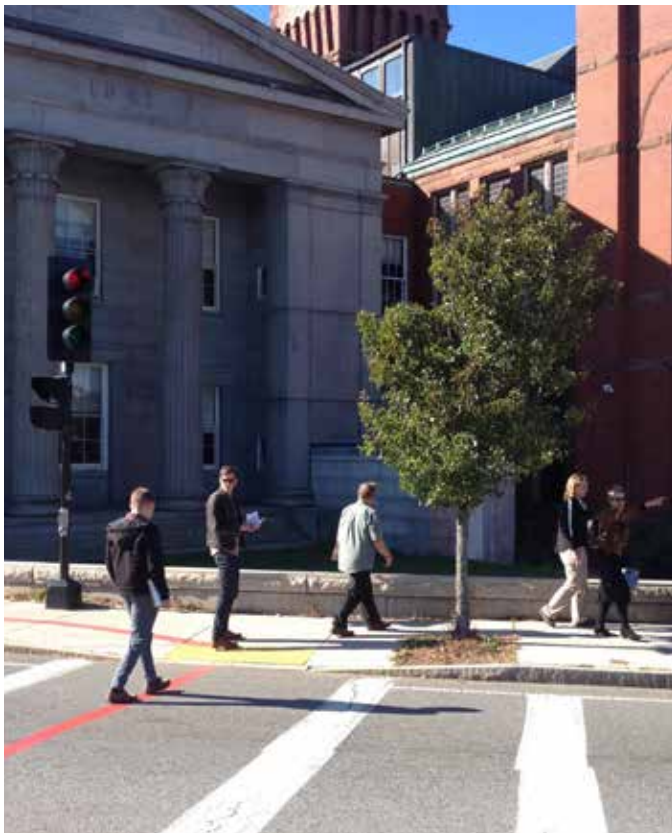
Participants cross the right turn slip lane at the Bridge Street/Washington Street intersection near the courthouse

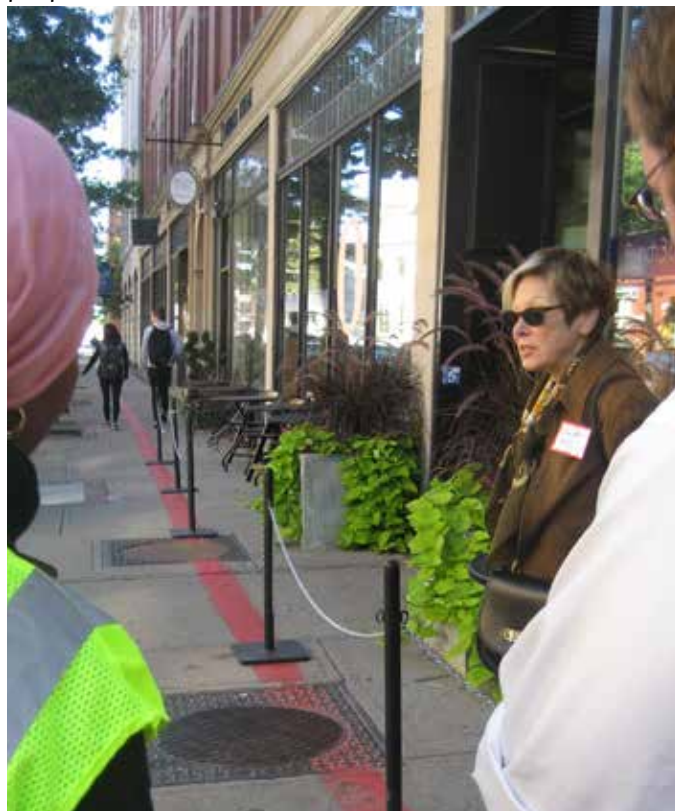
The tree-lined streetscape supports walkers with sidewalks on both sides of street. The sidewalks are a combination of concrete and brick with varying degrees of smoothness. The walking zone is adequate, although not generous given the volumes of pedestrians that use this corridor, particularly in October. Signs, bike racks and parking meters are grouped within the same zone as the trees, which help to keep the walking zone clear of obstructions. The Salem Heritage Trail – the red line painted on the sidewalk – runs along Washington Street connecting important historic and tourist destinations in Salem. The trail is mapped on several information kiosks in Salem, but there are few other signs that explain the purpose of the line.

Sidewalk tables and Salem Heritage Trail on Washington Street

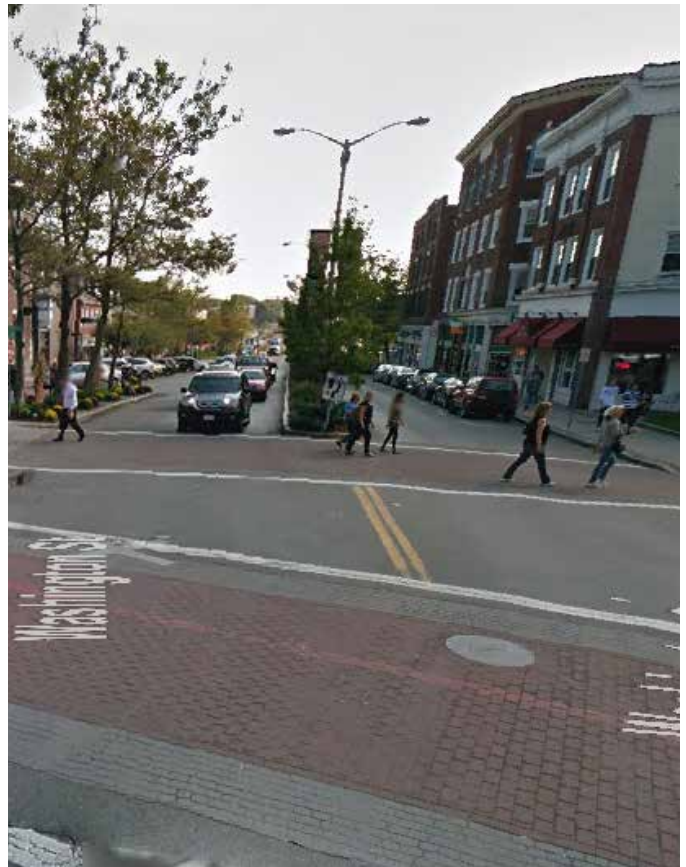
Double threat location at the Washington and Essex intersection

- Drivers use wide right-of-way to form two lanes when traveling northbound on Washington Street. Causes double threat location – one motorist stops to allow a pedestrian to cross, but motorist traveling in adjacent lane does not see the pedestrian in the crosswalk and does not stop
- Drivers use pedestrians crossing the street as shield to take left onto Washington Street from Essex Street

- Narrow northbound lane after angled parking ends before the Essex Street intersection to discourage use of width as two travel lanes
 - » Short-term: paint edge line or other pavement markings to delineate travel lane
 - » Long-term: move curb line out to narrow the travel lane
- Identify and relocate signs that block visibility of pedestrians in crosswalks; trim or remove vegetation that blocks visibility of oncoming traffic and pedestrians in the crosswalk
- Ensure that curb ramps meet ADA requirements; install detectable warning strips

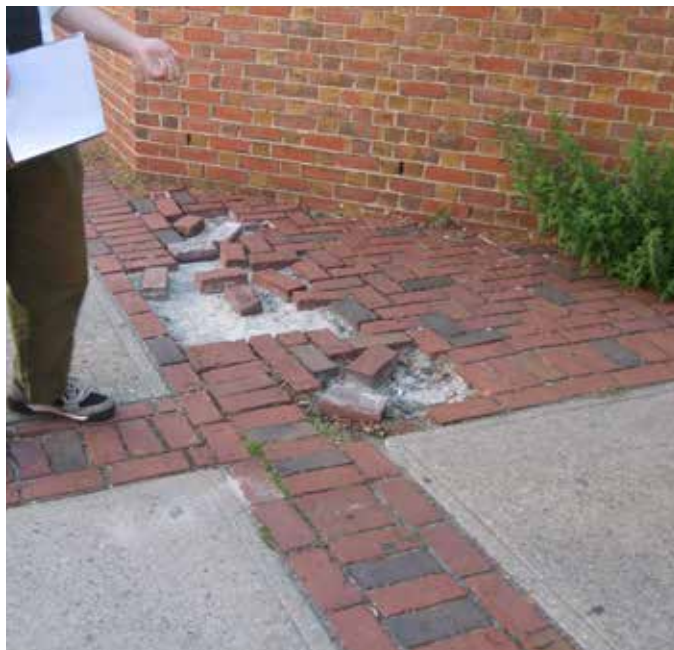
- Sidewalks vary in their condition: bricks loose, broken curbing, popped tree grates, overgrown vegetation, litter and trash

Loose bricks along Washington Street

- Evaluate sidewalk conditions on both sides of Washington Street and repair where needed

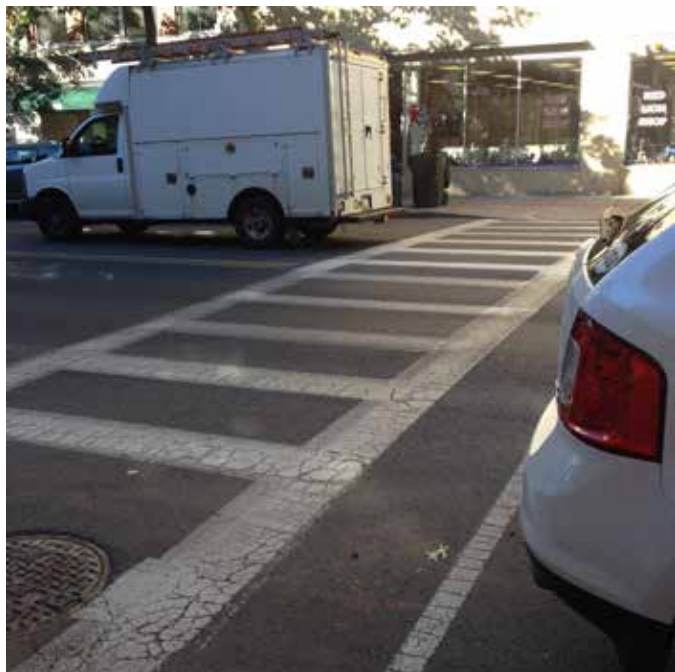
- Cars parked close to the crosswalk limit pedestrian visibility and drivers ability to see pedestrians
- Curb ramps are not ADA compliant – missing detectable warning strips and manhole cover at ramp entrance
- No pedestrian crossing signage alerting drivers to presence of crosswalk

Curb bump-outs would increase pedestrian visibility at this mid-block crossing on Washington Street

- Eliminate parking spaces within 20' of crosswalk
- Install curb extensions (bump-outs) to increase visibility of pedestrians; curb extensions also discourage parking too close to the crosswalk
- Redesign curb ramps to meet ADA standards
- Add pedestrian warning signs on both sides of Washington Street
- Evaluate intersection for Rectangular Rapid Flashing Beacon (RRFB) or High-Intensity Activated crossWalk beacon (HAWK) signal

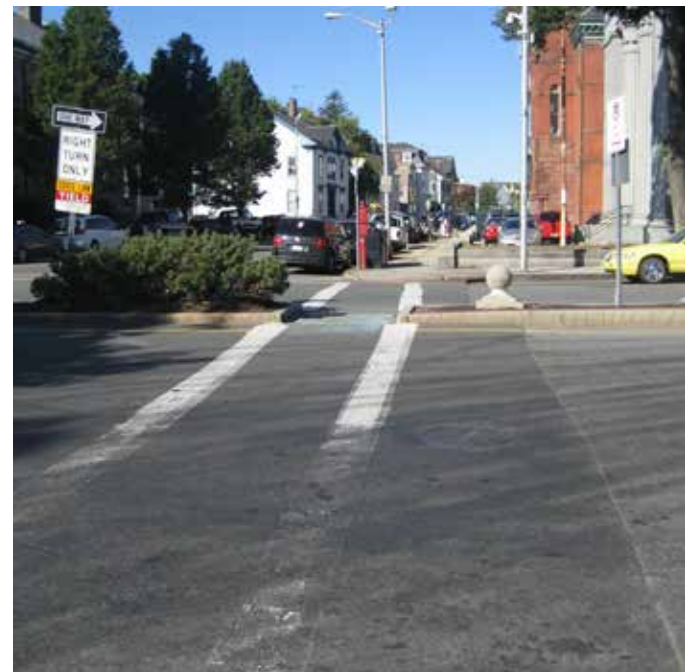
- No signage indicating lane changes along this section of Washington Street
- On-street parking on southbound side is too close to the crosswalk; limits pedestrian visibility
- Cars turning right out of Federal Street onto Washington Street are looking left for oncoming traffic and may accelerate into crosswalk before looking for pedestrians
- Crosswalk on north side of intersection is narrow; median is too narrow to function as a pedestrian refuge island; plants in median may obstruct views of pedestrians waiting in median to cross
- Road signs in median facing Federal Street are listing to the right; obstruct views
- No marked crosswalk across Federal Street at east side of Washington Street

Crosswalk and median at the intersection of Federal Street and Washington Street

- Install signage to warn drivers of lane changes along this section of Washington Street
- Remove parking spaces within 20' of crosswalk
- Assuming pedestrian volumes substantiate the need for a crosswalk on the north side of the intersection, improve the safety of this crossing:
 - » Crosswalks - improve pavement markings – widen crosswalk, paint ladder or continental design or use brick-colored style similar to other crossings on Washington Street
 - » Median - Short-term: trim vegetation in median to improve visibility; Long-term: redesign median to function as a pedestrian refuge island
- Repair road signs facing Federal Street; consider additional or improved “yield to pedestrian” signs
- Paint crosswalk across Federal Street on the east side of Washington Street

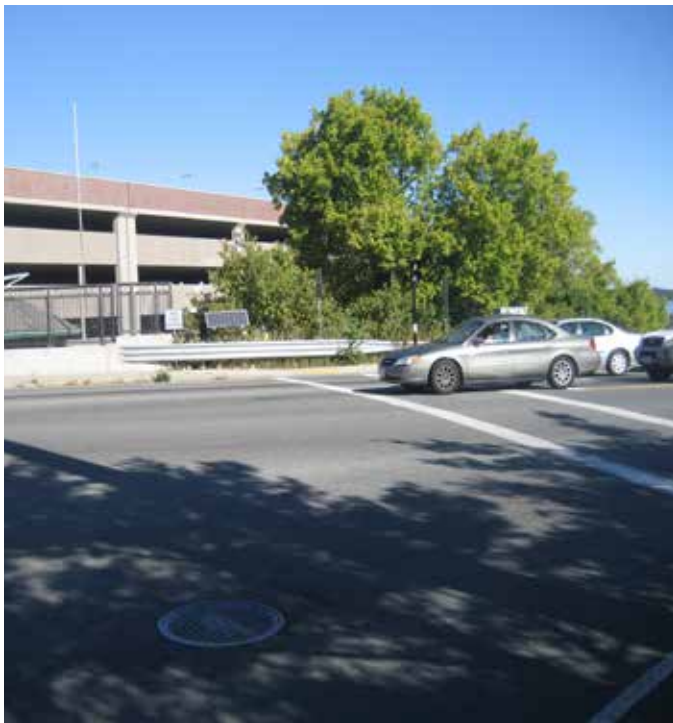
Pedestrian connection across Bridge Street to reach the Salem Commuter Rail Station from Washington Street

The pedestrian connection to the commuter rail station is on the north side of the Washington/Bridge Street intersection. The sidewalk of the northern side of Bridge Street seems narrow because of its location adjacent to the commuter rail station. The new MBTA parking structure and station entrance was under construction during the assessment, so pedestrian patterns were not representative of the future patterns to the station.

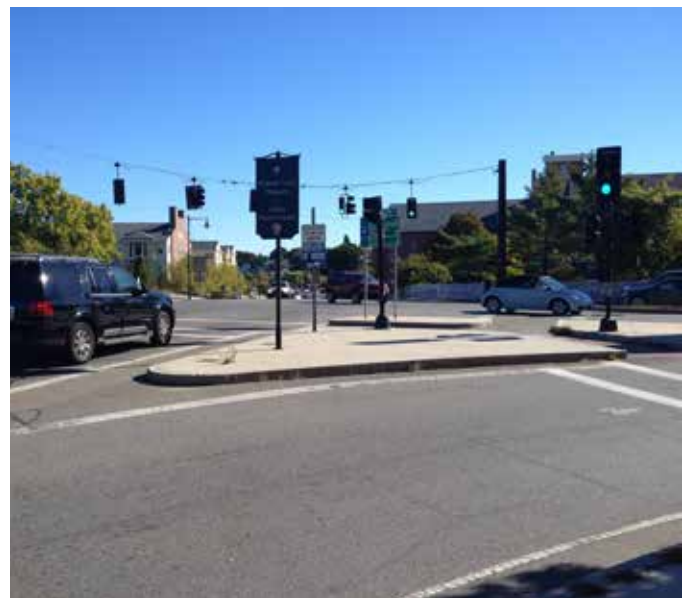
- Pedestrian crossing time seems short given distance to walk (5 travel lanes with no median) when crossing Bridge Street on east side of intersection
- Pavement markings on all sides of intersection are minimal - two parallel lines; could be more prominent given the predicted high volumes of pedestrians accessing the T station at this location
- Slip lane for eastbound traffic on Bridge Street to turn right onto Washington Street creates unsafe traffic pattern - drivers do not always respect RED signal and pedestrians think RED signal for drivers indicates a protected crossing for them. Right signal indication is blocked by a tree.
- Cars traveling northbound on Washington turn right quickly onto Bridge Street due to generous curb radii
- Few wayfinding signs to tourist or downtown Salem destinations for transit riders arriving on commuter rail
- Some traffic signs are faded

This right turn slip lane from Bridge Street onto Washington Street is confusing to pedestrians and drivers - it is unclear who has the right of way

- Evaluate the operation of the slip lane from Bridge Street to Washington Street. Consider prohibiting Right Turn on Red (RTOR) and sign the intersection appropriately. If RTOR continues to be allowed, consider installing an overhead sign that states drivers must yield to pedestrians or painting STOP on the pavement.
- Evaluate possibility of reducing curb radii to slow traffic down and shorten crossing distance to transit station entrance on the northside of Bridge Street
- Improve wayfinding to downtown retail/tourist district. Red line (Salem Heritage Trail) leads from commuter rail into downtown, however no obvious explanation for red line
- Replace faded traffic signs

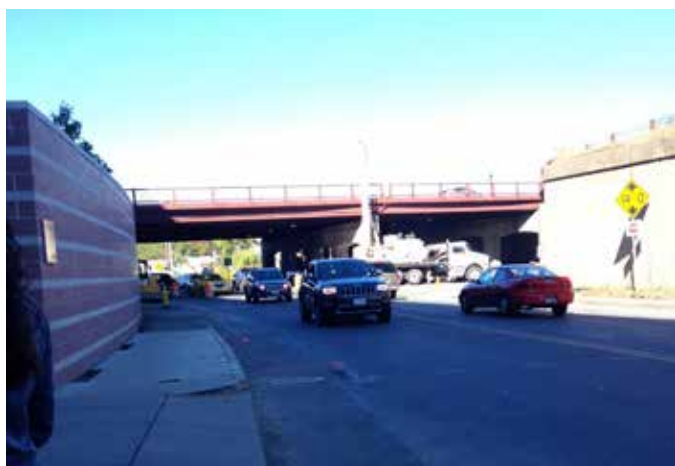
Bridge Street is walled in between the courthouse complex Rt. 114 ramps and overpass

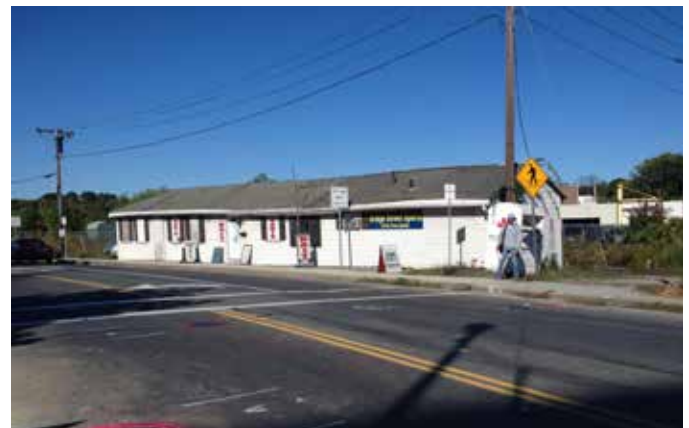
- Wide travel lane at previous location for “Kiss and Ride” drop-off zone. Signs are still posted, but it is unclear as to whether this location will be moved after construction ends
- Crosswalk located on eastside of Rt. 114 overpass is unprotected with minimal pavement markings
- Light conditions are dark due to overpass; crosswalk often in shadow, hard to see pedestrians in crosswalk
- Crosswalk on west side of Rt. 114 overpass has many pedestrians and cyclists that come from neighborhood to the north, and cross RR tracks and Bridge Street (in crosswalk) and proceed up informal pathway to reach the top of the hill at North Street; minimal pavement markings and no curb ramps
- Minimal pedestrian crossing signs; some needing maintenance – leaning, faded, etc.

Crosswalk pavement markings on Bridge Street are minimal

- Paint edge/fog lines on Bridge Street to narrow travel lanes
- Narrow travel lane on north side of Bridge Street
 - » Short term: if Kiss and Ride remains, improve pavement markings and signage
 - » Long-term: if Kiss and Ride remains, formalize drop off with curb extensions that define a pull-out/drop-off zone
- Supplement pavement markings on both crosswalks on either side of the overpass; crosswalks should be painted in ladder or continental design or similar to those in retail district
- Improve lighting under overpass for both pedestrians and drivers
- Consider additional pedestrian crossing signage at both crosswalks and in-street pedestrian signs

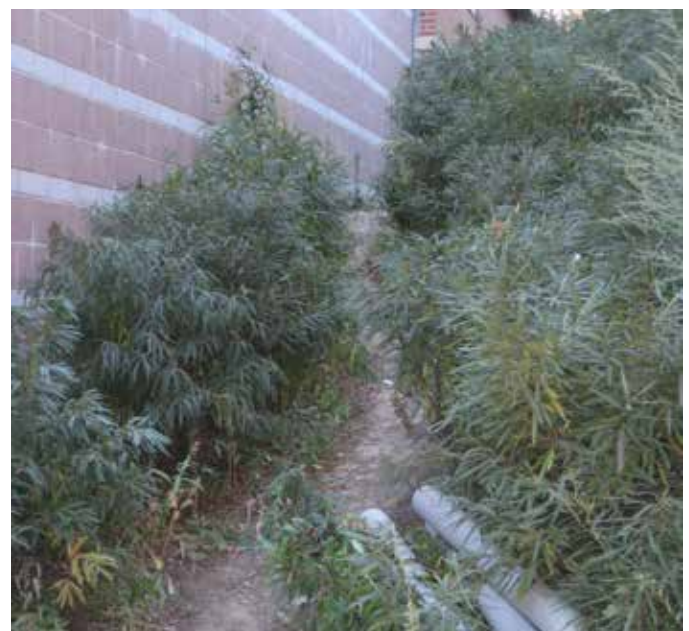
Informal pedestrian path from the courthouse complex down to Bridge Street - a desire line not satisfied by the current pedestrian network

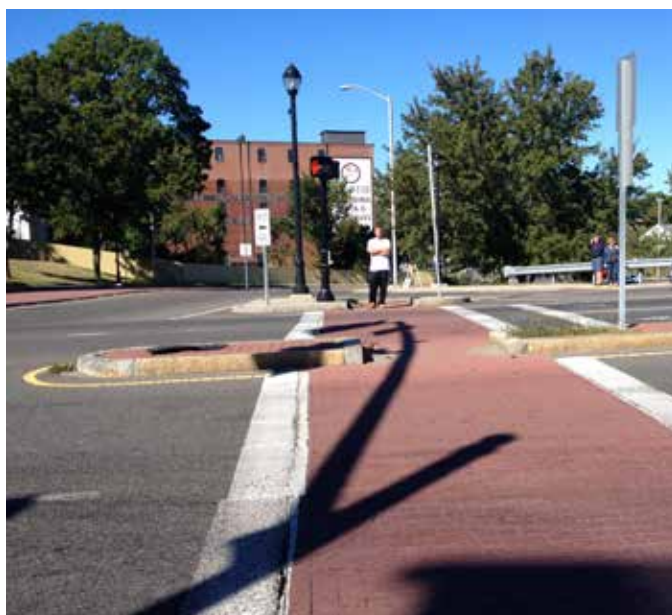
This is an unfortunate design that basically ignores movement on foot. This intersection was re-designed when the off-ramp from Rt. 114 – Bridge turning south onto North Street into Salem was discontinued, and this awkward series of roadways off the state road were built. The intersection looks like a highway interchange design rather than a residential scale intersection. Crossing the intersection is contorted; pedestrians cannot directly cross, but must go around the intersection. To cross legally would take close to 3 minutes.

North Street/Federal Street intersection is out of scale with residential district. The infrastructure does not facilitate pedestrian movements.

- Northeast corner of Federal street should be redesigned to reflect pedestrian desire lines
- Install pedestrian push button at right turn slip lane on northbound North Street exit to Bridge Street
- Evaluate safety of painting a marked crosswalk across ramp to and from Bridge Street at the intersection with North Street; may require redesign of the traffic medians
- Re-evaluate effectiveness of median blocking traffic from continuing into Federal Street neighborhood; clarify legal turning movements at and around the median
- Clarify the meaning of “Don’t Block the Box” pavement markings through signage or modification of markings
- Evaluate the pedestrian phase of traffic signal – currently exclusive, but some movements may allow concurrent phases that could increase pedestrian compliance

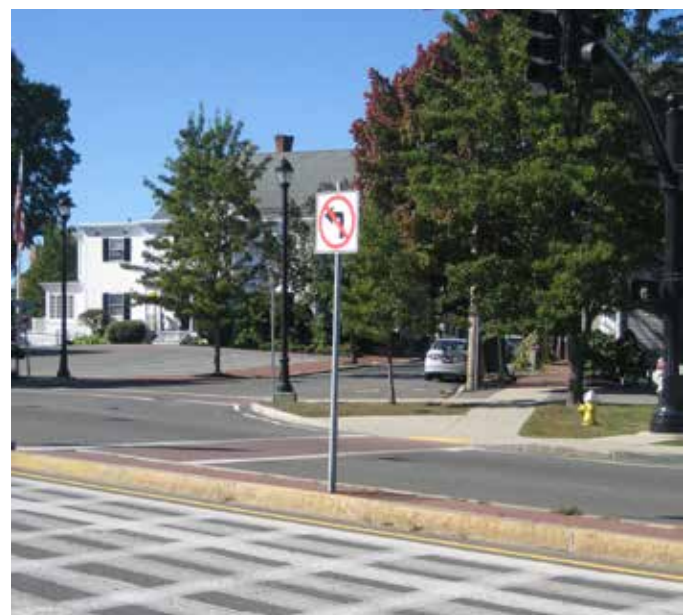
Upon observation, pavement markings and traffic median and sign do not manage traffic effectively at this intersection.

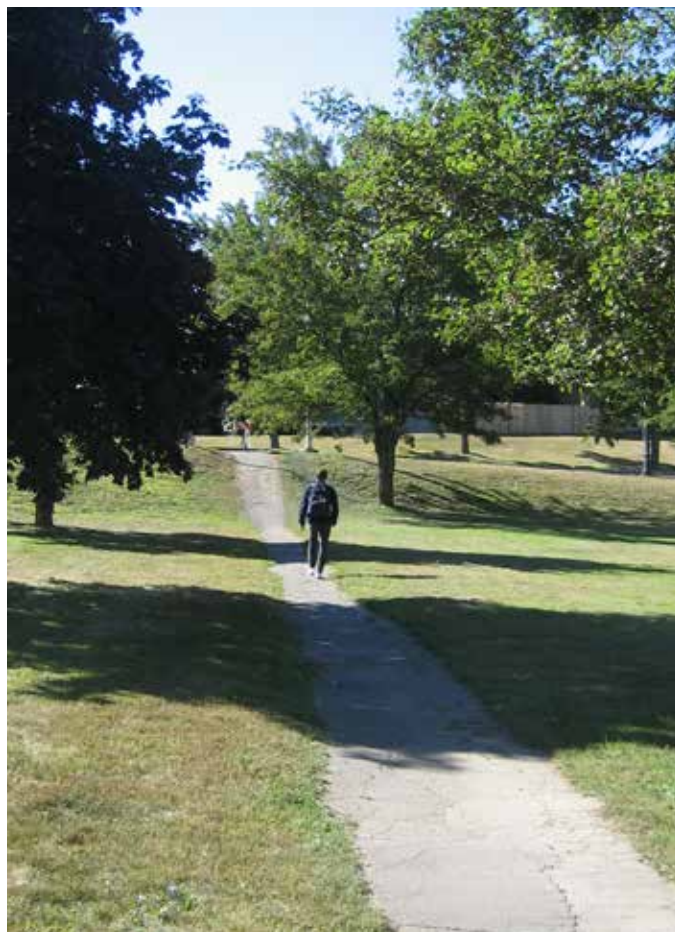
- No crosswalk across ramp from Bridge Street – no legal crossing from pedestrian island on east side of intersection; pedestrians cross mid-ramp where worn grass path intersects to reach Federal Street neighborhood “regularly” according to Salem participants

- Vegetation at northeast corner of Federal Street is worn due to foot traffic

Worn path leading from Bridge Street up to North/Federal Street intersection

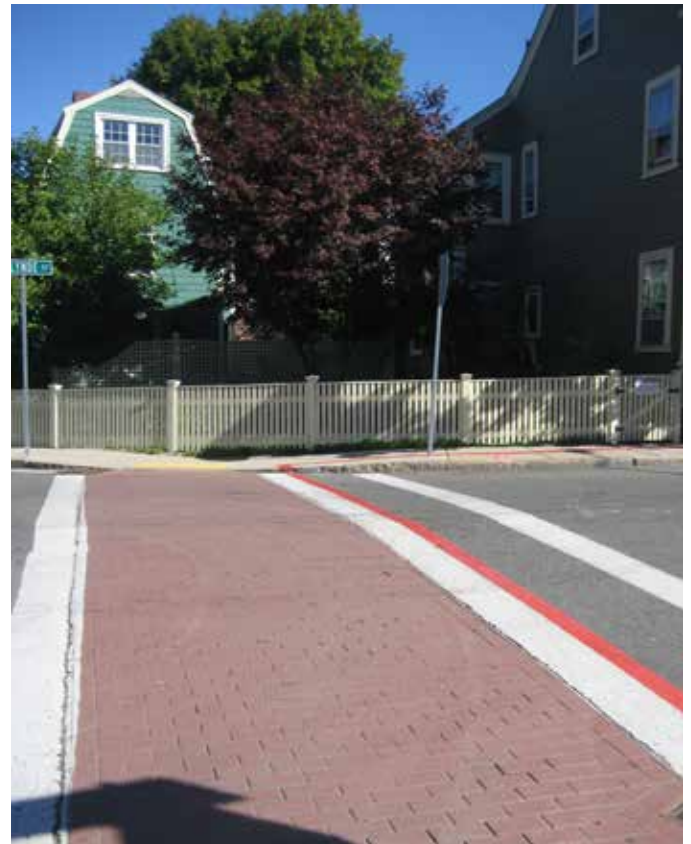
Lynde Street crossing could be shortened with curb extensions

- Tighten curb radii and consider curb extensions to reduce travel distance across Lynde Street

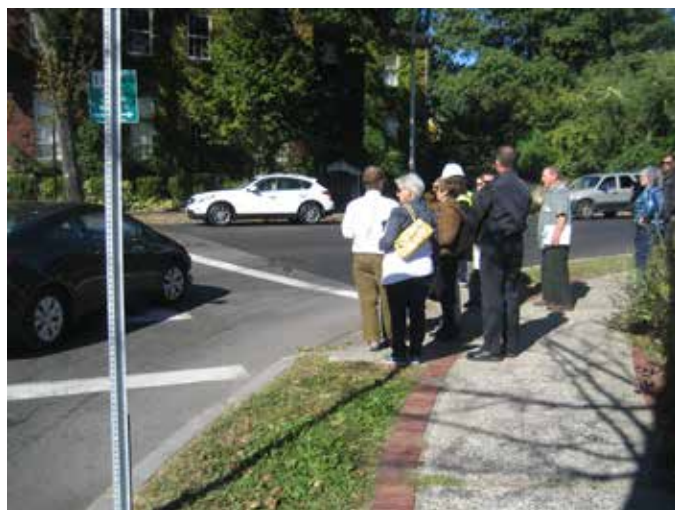
The high traffic volumes prohibit fast-moving traffic. The current intersection control may not meet the needs and expectations of drivers. Drivers attempting to turn left from Norman Street onto Summer Street have the most difficult movement, and often “barge and block” traffic lanes to make the turn. Drivers turning right from Norman Street often assume the right-of-way from drivers heading north on Summer Street. Pedestrians wait for a gap in traffic to cross – sometimes using the crosswalk, sometimes outside the crosswalk when traffic is at a halt.

Assessment participants watch traffic moving through the unsignalized intersection

Current infrastructure deficiencies:

- No pedestrian signals at the intersection
- Parking on east side of Summer Street south of Norman Street limit pedestrian visibility; light conditions and overhanging trees make it difficult to see people in the crosswalk
- Minimum pavement markings on all four crosswalks through the intersection
- Limited number of pedestrian crossing signs

Recommendations:

- Evaluate the current intersection control and update for improved safety, efficiency and expectations of all users
- Consider installing curb extensions on both northern and southern corners of Norman Street – make pedestrians more visible without changing traffic patterns – would require tightening of curb radii and narrowing travel lane
- Remove parking spaces proximate to crosswalk on eastern side of Summer Street
- Upgrade pavement markings to at least ladder or continental crosswalk; consider treating crosswalks like those in retail district – red stamped pavement or brick
- Install additional pedestrian crossing signs or yield to pedestrian warnings; add only if does not clutter intersection with signage – may not conform to goals of National Historic District

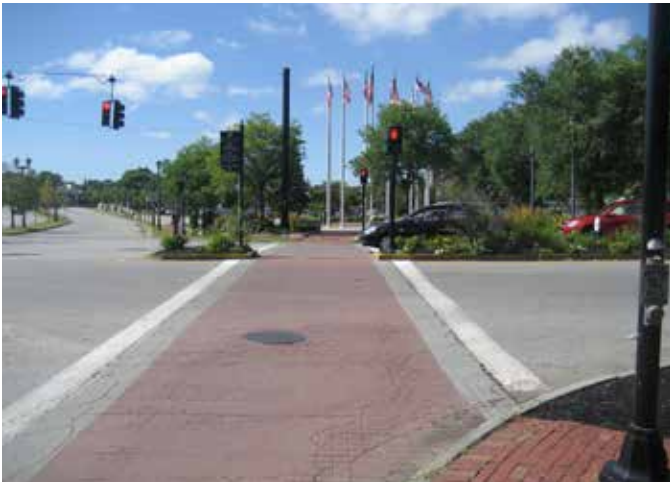
- Size of intersection and signal timing causes long wait times for exclusive pedestrian phase; pedestrian crossing time seems short; unclear if phase is designed as a two-phased crossing. If two-phased, pedestrians are not using the intersection that respects phased crossing.
- Curb ramps, but no detectable warning strips

New Derby Street and Washington Street intersection sees high volumes of cars and pedestrians

- Evaluate pedestrian signal timing to see if concurrent phasing is possible on some legs of intersection; consider automatic pedestrian phase
- Determine if pedestrian crossing time is adequate and meets code for two-phased or single phased crossing. Pedestrians want to cross the entire intersection in one phase.
- Install detectable warning strips where required

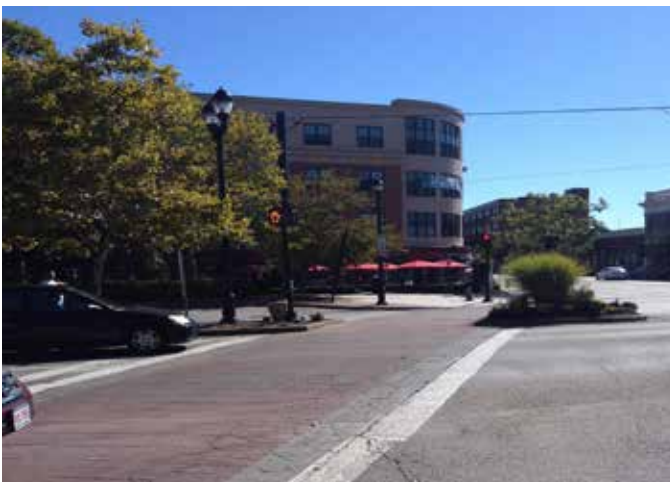
The length of the pedestrian phase at this crossing does not seem to allow the entire intersection to be crossed in one phase

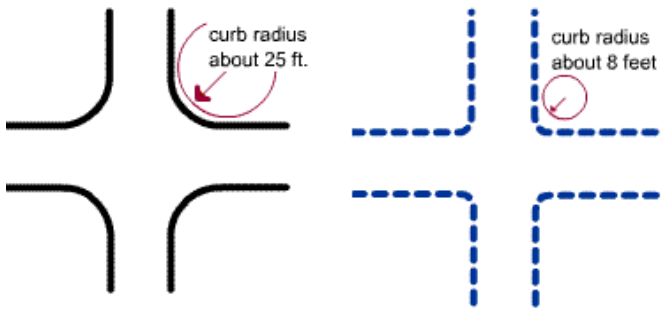
A longer curb radius (on the left in figure below) allows vehicles to turn more quickly and creates longer crossing distance for pedestrians. A shorter curb radius (on the right in the figure below) slows turning speeds and provides pedestrians shorter crossing distances.

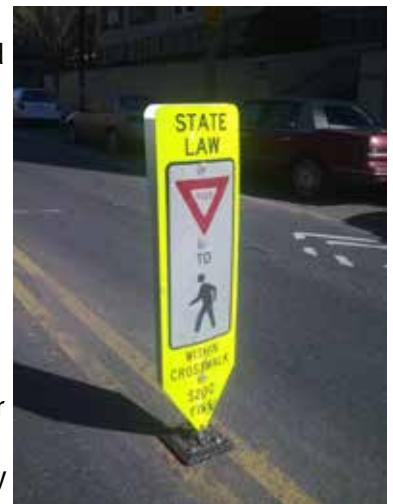
In-street pedestrian crossing signs are used at the road centerline within crosswalks to increase driver awareness of pedestrians in the area. These signs are a relatively low-cost, highly effective tool in slowing traffic by the narrowing travel lanes. They are popular with road maintenance departments since they can be easily moved for snow removal.

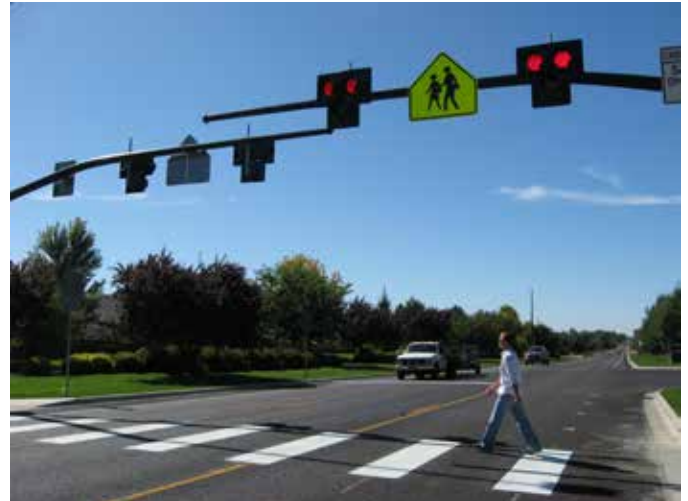
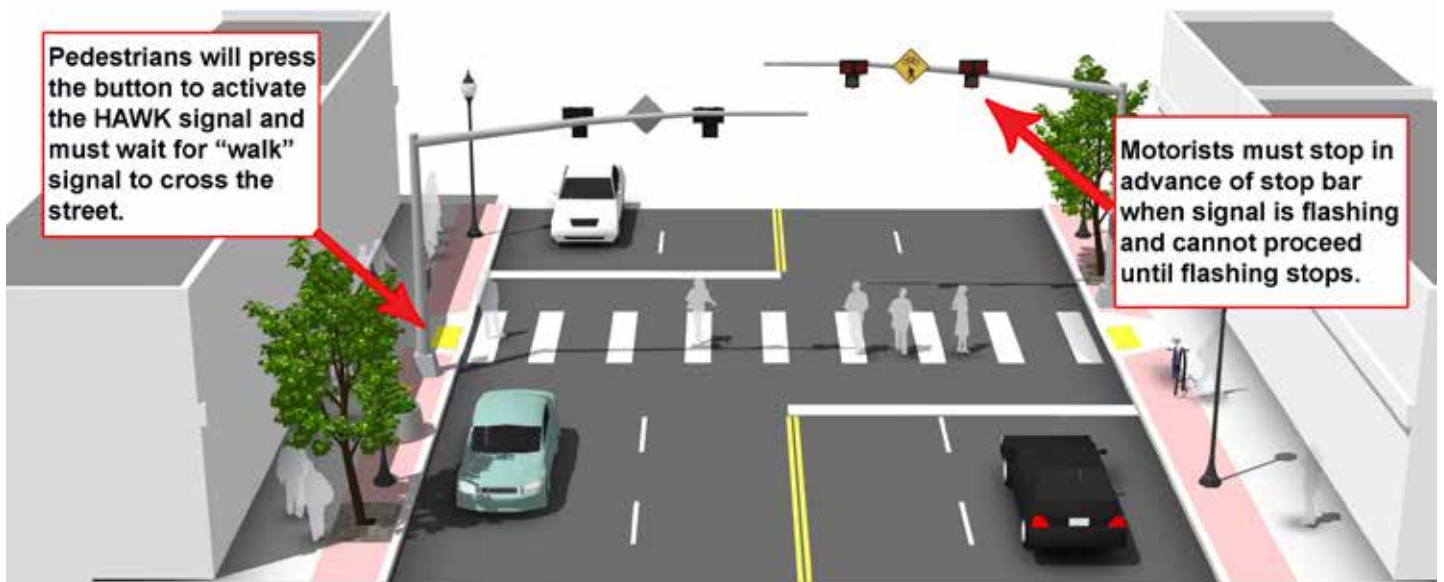
A HAWK beacon (High-Intensity Activated crossWalk beacon) is a traffic signal used to stop road traffic and allow pedestrians to cross safely. It is officially known as a Pedestrian Hybrid Beacon (PHB). The purpose of a HAWK beacon is to allow protected pedestrian crossings, stopping road traffic only as needed. Where standard traffic signal 'warrants' prevent the installation of standard three-color traffic signals, the HAWK beacon provides an alternative.

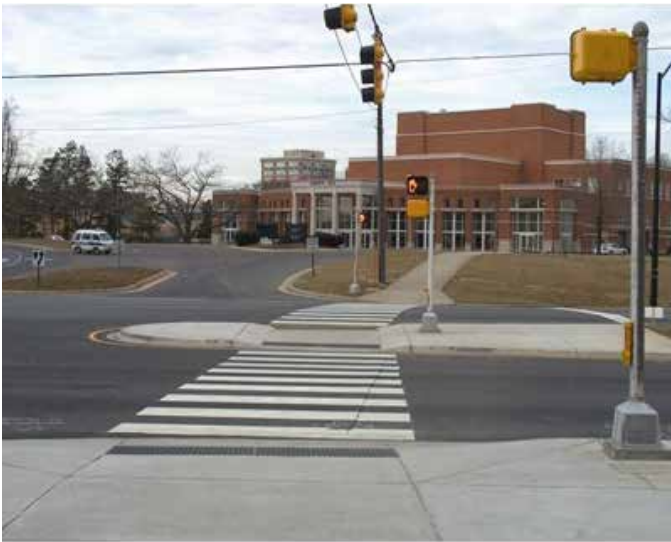
Pedestrian refuge island at a signalized crossing
Source: <http://safety.fhwa.dot.gov/intersection/resources/fhwasao6o16/images/fig95.jpg>
