Walk Assessment New Bedford, MA

October 29, 2014

Massachusetts Department of Transportation
Bicycle and Pedestrian Safety Program

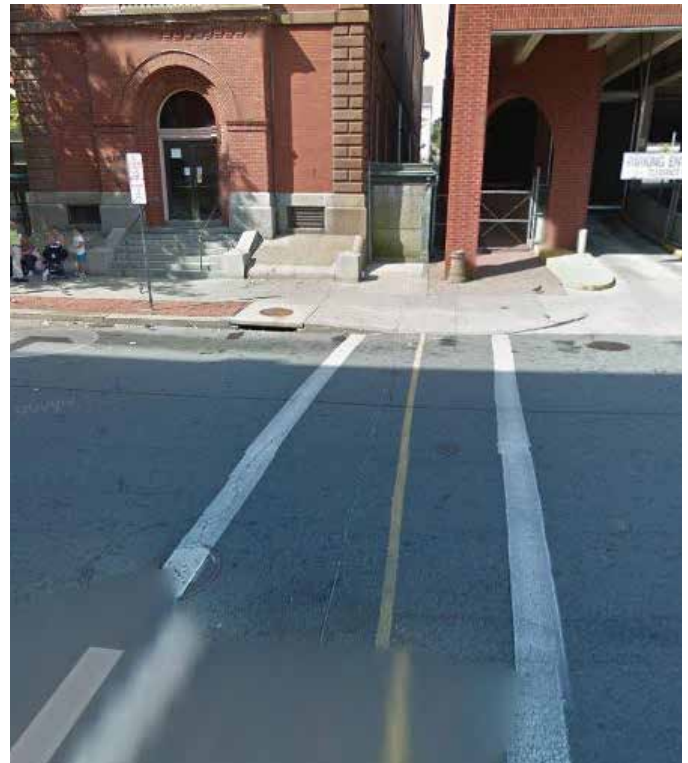
- No dashed lane line is painted on the street, nor is there an edge line (fog line) to identify travel paths for vehicles and to help slow through traffic. The lack of markings suggest there is one lane of travel, however Pleasant Street often functions as two lanes.
- An unprotected mid-block crosswalk serves the bus station at the intersection of Pleasant Street and Mechanics Lane. Crosswalk has minimal pavement markings especially when compared with other red bituminous crosswalks in the study area.
- Curb ramps do not meet ADA standards, which call for detectable warning strips.
- No pedestrian crossing signs or “yield to pedestrian” signs are located on Pleasant Street to forewarn drivers of pedestrians crossing the mid-block crosswalk.

Mid-block crossing near Mechanics Lane and Pleasant Street

- Paint a dashed white lane line down the middle of the two traffic lanes on Pleasant Street, and an edge (fog) lines along Pleasant Street to define and narrow travel lanes.

- Enhance existing crosswalk pavement markings at the Mechanics Lane mid-block pedestrian crossing with painted cross-strips in a “piano keys”, ladder, zebra or continental design. Consider enhancing the existing crosswalk by installation of red bituminous that identifies other downtown crosswalks or by painting. Crosswalk is the starting line for the New Bedford Half Marathon and could be designed to highlight this use.

- Upgrade curb ramps to ADA standards, including detectable warning strips.
- Install pedestrian crossing signs and/or “yield to pedestrian” signs on the Pleasant Street approach to the Mechanics Lane crosswalk to indicate that pedestrians might be crossing.

- Consider traffic calming measures to slow traffic on Pleasant Street, such as curb bump-outs.

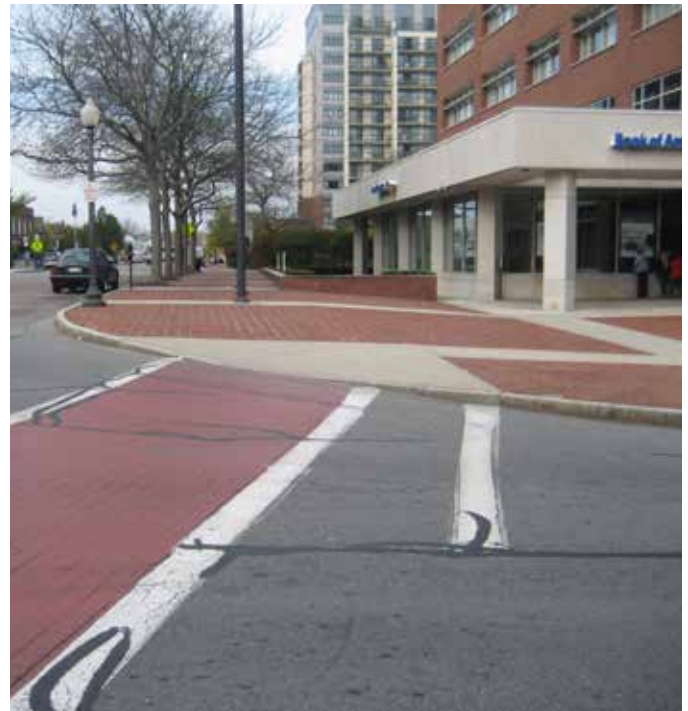
- Missing red colored bituminous crosswalk on the north side of the intersection, curb ramps missing for a north side crossing of the intersection.
- The curb radius on the northeast corner of the intersection is very wide, encouraging fast-moving traffic and endangering pedestrians crossing the street.
- Wide pavement with no signage or street paint lines on the Pleasant Street approach to the intersection may suggest motorists can drive fast heading toward the “Octopus.”
- A single sign indicates the one-way status of Pleasant Street. No signs show that Elm Street is one-way to the west of the intersection and two-way to the east.
- Curb ramps do not meet ADA standards, which call for detectable warning strips.
- Distances across the Pleasant Street intersection are significantly difficult for pedestrians to cross in the absence of traffic signals or signs.

Wide curb radius at northeast corner of Pleasant Street/Elm Street intersection

- Consider adding a crosswalk and curb ramps on the north side of the intersection.
- Replace the curb and tighten the curb radius at the northeast corner of the intersection to make it similar to the other 3 corners and discourage fast-moving turns.
- Consider installing additional regulatory signage such as one-way and do-not-enter signs to indicate travel direction of both Pleasant Street and Elm Street.
- Upgrade curb ramps to ADA standards, including detectable warning strips.
- Consider adding bump-outs at crosswalks on the two corners on south side of Elm Street at the Pleasant Street intersection to narrow distances pedestrians must cross and to make them more visible to motorists.

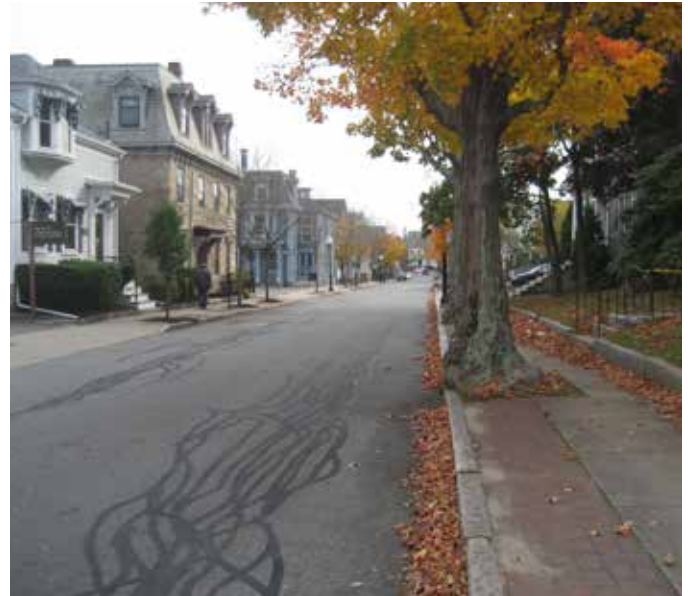
- No travel lane markings on pavement.
- Insufficient signage to indicate direction of Elm Street mid-block, at Pleasant Street, or at North Sixth Street.
- Red bituminous crosswalk at Eighth Street extends east-west only at the intersection of Eighth Street.
- No north-south crosswalk over Elm Street at intersection with Eighth Street and no curb ramp on the north side.

Eighth Street looking from Elm Street towards Mechanics Lane

- Add edge (fog) line on south side of street to slow traffic or to provide a bicycle lane.
- Add one-way signs and other regulatory signage such as do-not-enter signs to indicate the direction of Elm Street, especially at intersections.
- Consider adding crosswalk over Elm Street at intersection with Eighth Street.

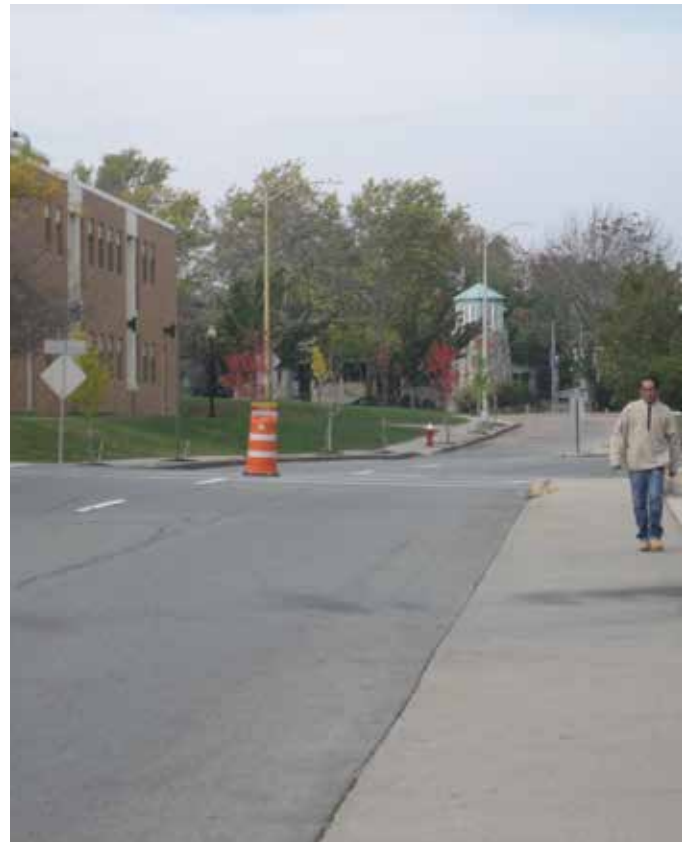
- Crosswalk north of this intersection at North Sixth and Middle Streets is insufficiently marked; an in-street pedestrian sign provides some indication of pedestrians crossing the heavy traffic southbound on North Sixth Street after leaving the “Octopus.”

In-street pedestrian traffic barrel draws attention to crosswalk on N 6th Street connecting a parking lot used by Post Office employees to the Post Office

- Traffic on North Sixth Street should be slowed as it approaches this intersection in the central business district, using advance signage leading into the intersections on Elm Street and William Street.
- Consider installing additional one-way signs to indicate travel direction of both North Sixth Street and Elm Street.
- Consider installing curb bump-outs to reduce traffic speeds and to shorten crossing distance across N Sixth Street.
- Paint an aligned centerline down the middle of the two traffic lanes on North Sixth Street, along with edge lines (fog lines) on both sides of the street to narrow travel lanes and provide additional safety for pedestrians.
- Paint edge (fog) lines along Elm Street to narrow the single travel lane as a safety measure.
- Upgrade curb ramps to ADA standards, including detectable warning strips.

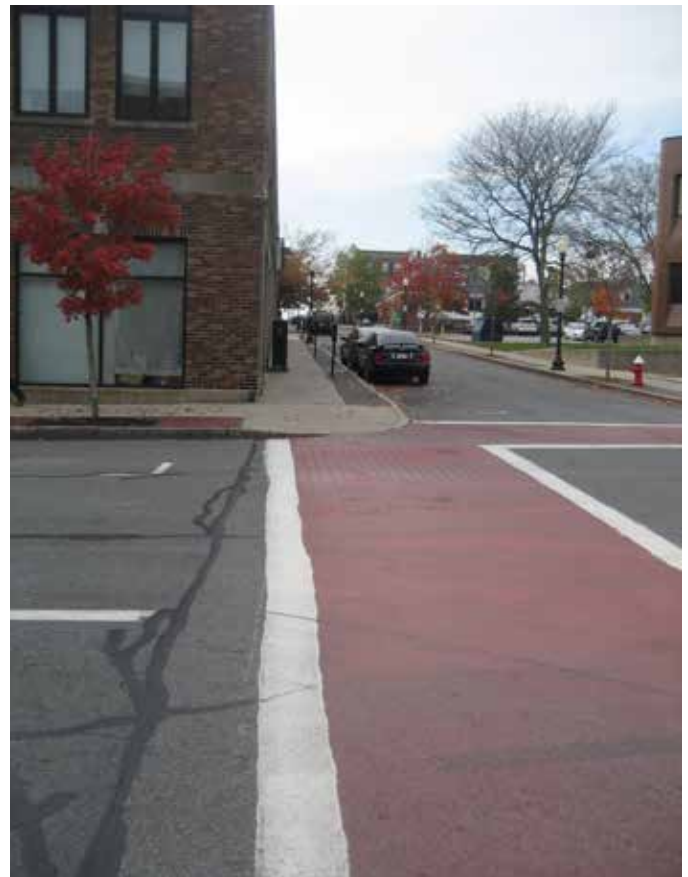
- A single sign indicates the one-way status of North Sixth Street. Few signs show that Elm Street is one-way westbound.
- Travel lanes are wide on North Sixth Street, making crossing distances at the Elm Street intersection long for pedestrians to cross in the absence of traffic signals or signs. Wide lanes also support high speeds departing the Octopus.

Crossing distances are long across N 6th Street at the Elm Street intersection

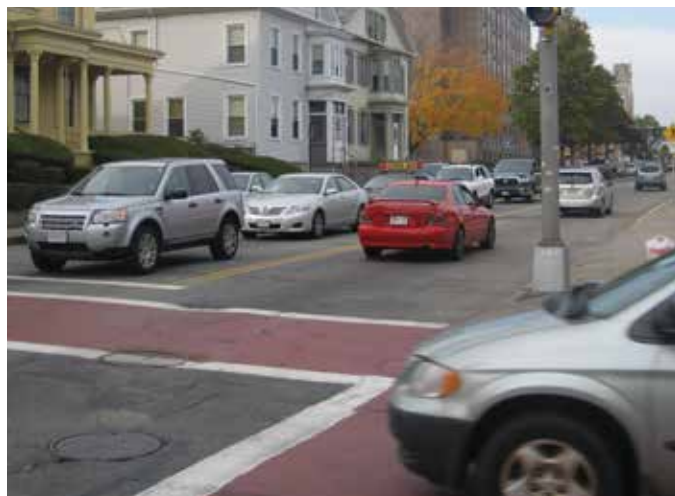
- North-south red bituminous crosswalks show signs of wear from vehicle traffic.
- Pedestrians crossing signals cover only two paths across the intersection – one on north side of Elm Street facing south, another on south side of Elm Street facing east. Existing signal heads are not functioning and have no working push buttons.
- Curb ramps do not meet ADA standards, which call for detectable warning strips.
- A single sign indicates the one-way status of Elm Street.
- McDonalds entrance and egress at the corner of Elm and County further complicate turning movements and contribute to vehicle stacking issues at the intersection. Drivers entering and exiting the driveway are more concerned with vehicular traffic and tend to overlook pedestrians.

Missing pedestrian signal and heavy traffic at Elm/County intersection

- Repair red bituminous crosswalks so they are more visible to County Street traffic.
- Provide working pedestrian countdown signals and push buttons for all approaches.
- Upgrade curb ramps to ADA standards, including detectable warning strips.
- Install additional one-way signs and do-not-enter signs to indicate travel direction of Elm Street.
- Review McDonalds site plan for potential improvements to vehicular circulation patterns; increase enforcement of illegal turning movements.

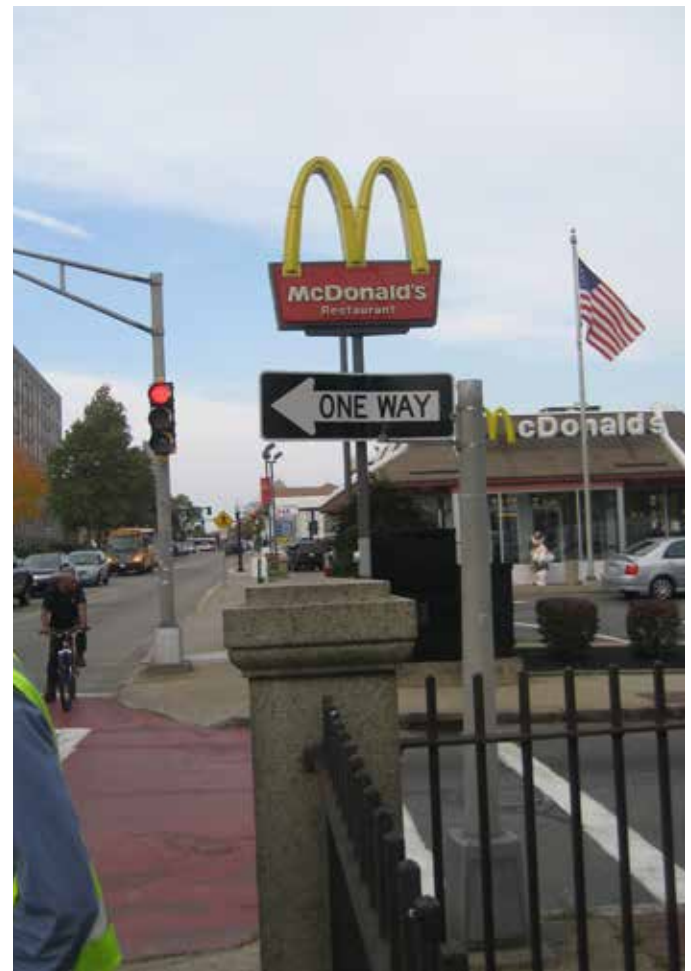
McDonalds drive-thru and parking circulation patterns complicate turning movements at the Elm/County intersection

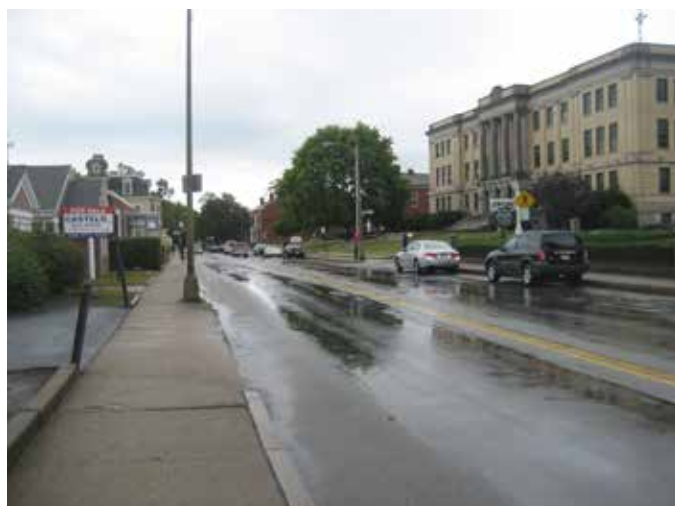
County Street corridor looking south towards Union Street

- Crosswalks – North-south crosswalks at Morgan and Court Streets marked by double white lines between curb ramps. A red bituminous crosswalk leads east-west across County Street in front of New Bedford School Department building (between Morgan and Court Streets) where it joins the end of William Street. A red bituminous crosswalk runs north-south across William Street. Each crosswalk has curb cuts.

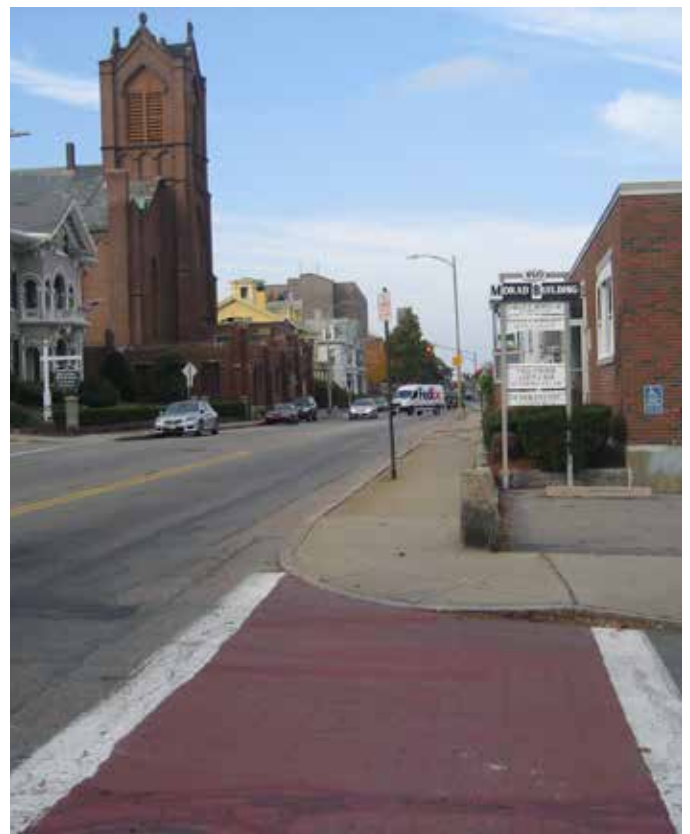
- No painted lines to denote the parking lane along County Street.
- Travel lanes are wide on County Street, marked a double yellow center line, but lacking an edge (fog) line.
- Distance between crosswalks is extensive – a 600'-distance separates Elm Street crosswalks from the mid-block crosswalk at the courthouse, and a 400'-distance separates Union Street crosswalks from the mid-block crosswalk at the courthouse.
- Crosswalks have curb ramps that do not meet ADA standards calling for detectable warning strips.

Crosswalk at County Street and William Street

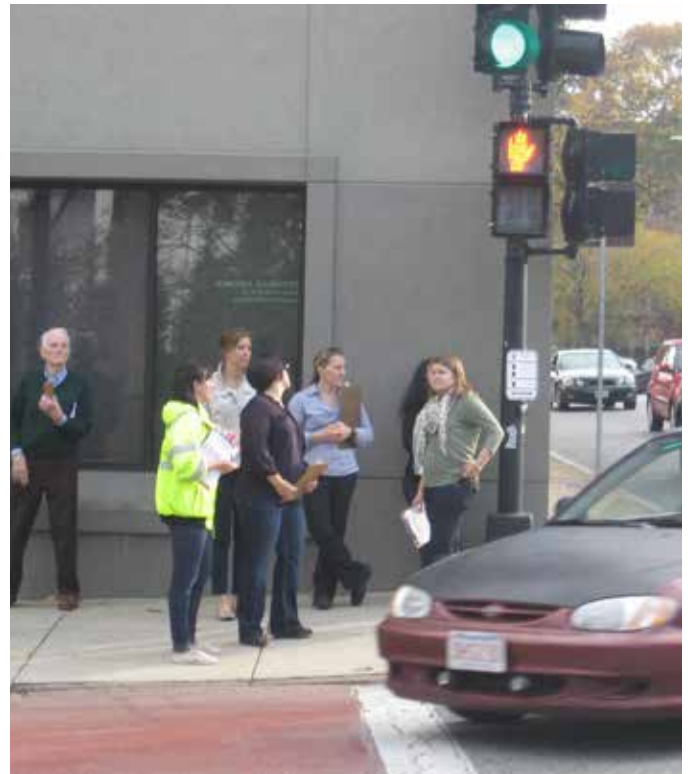
- North-south red bituminous crosswalks show signs of wear from County Street vehicular traffic.
- Pedestrian signal timing seems somewhat limited in terms of amount of time provided for crossing safely.
- Curb ramps do not meet ADA standards, which call for detectable warning strips.

Participants test the signal phasing at the County and Union Street intersection

- Repair red bituminous crosswalks as needed.
- Lengthen pedestrian signal timing to make crossing safer; consider leading pedestrian indicators.
- Upgrade curb ramps to ADA standards, including detectable warning strips.

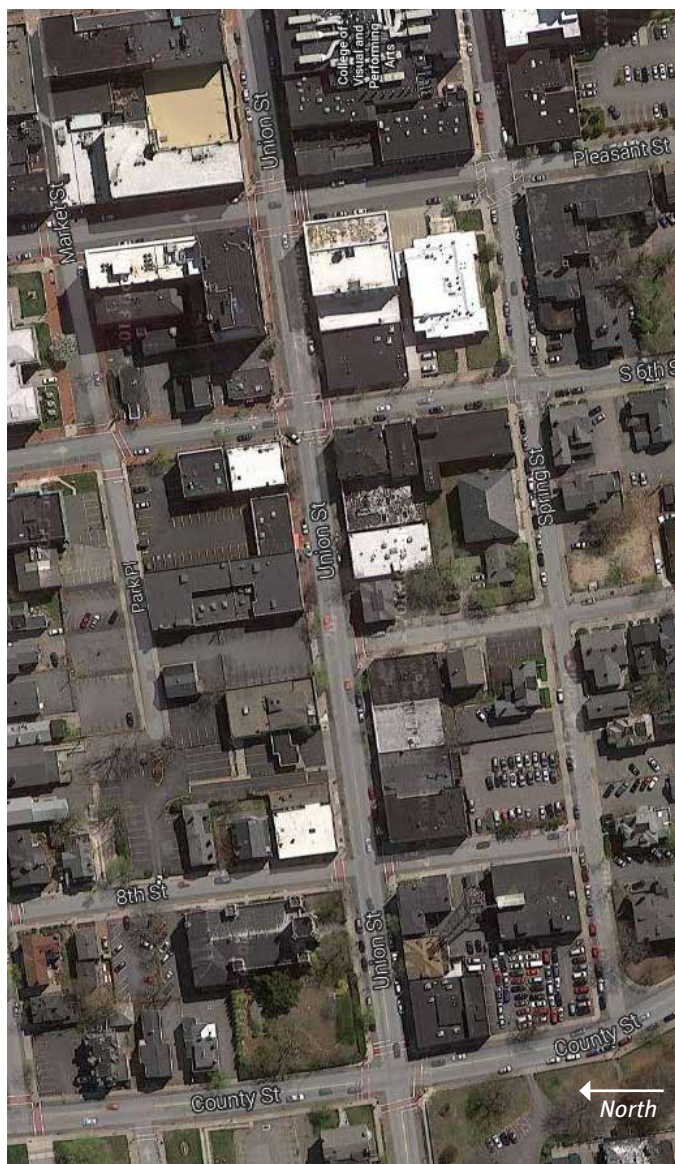
There are few marked crosswalks between County St and 6th Street along Union Street

- Consider adding a mid-block crossing of Union Street at the intersections of Seventh Street and Eighth Street.
- Install curb ramps and detectable warning strips at the Seventh Street crosswalk.
- Consider adding edge (fog) lines or bike lanes along both sides of the Union Street.

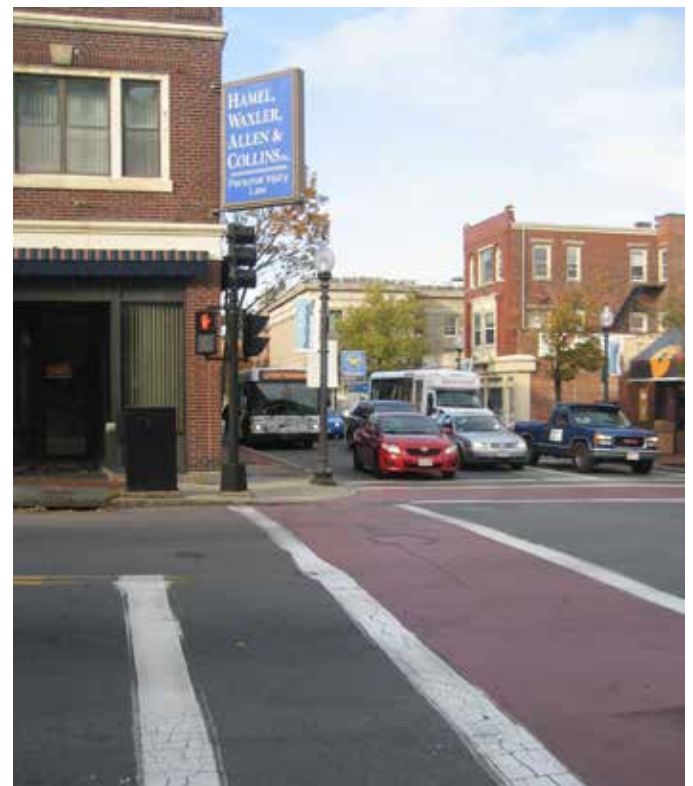
- Paint designating parking spaces on North Sixth Street is faded.
- Pedestrian signal missing on southwest corner of the intersection.
- Curb ramps do not meet ADA standards, which call for detectable warning strips.

Union Street and N 6th Street is home to a busy Dunkin' Donuts which generates significant pedestrian traffic

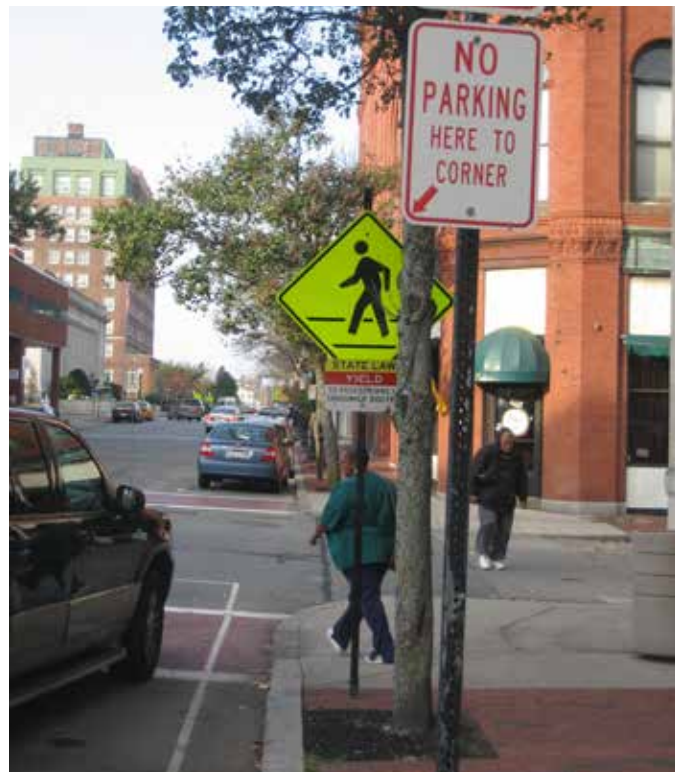
Pedestrian signage at Union Street and Pleasant Street

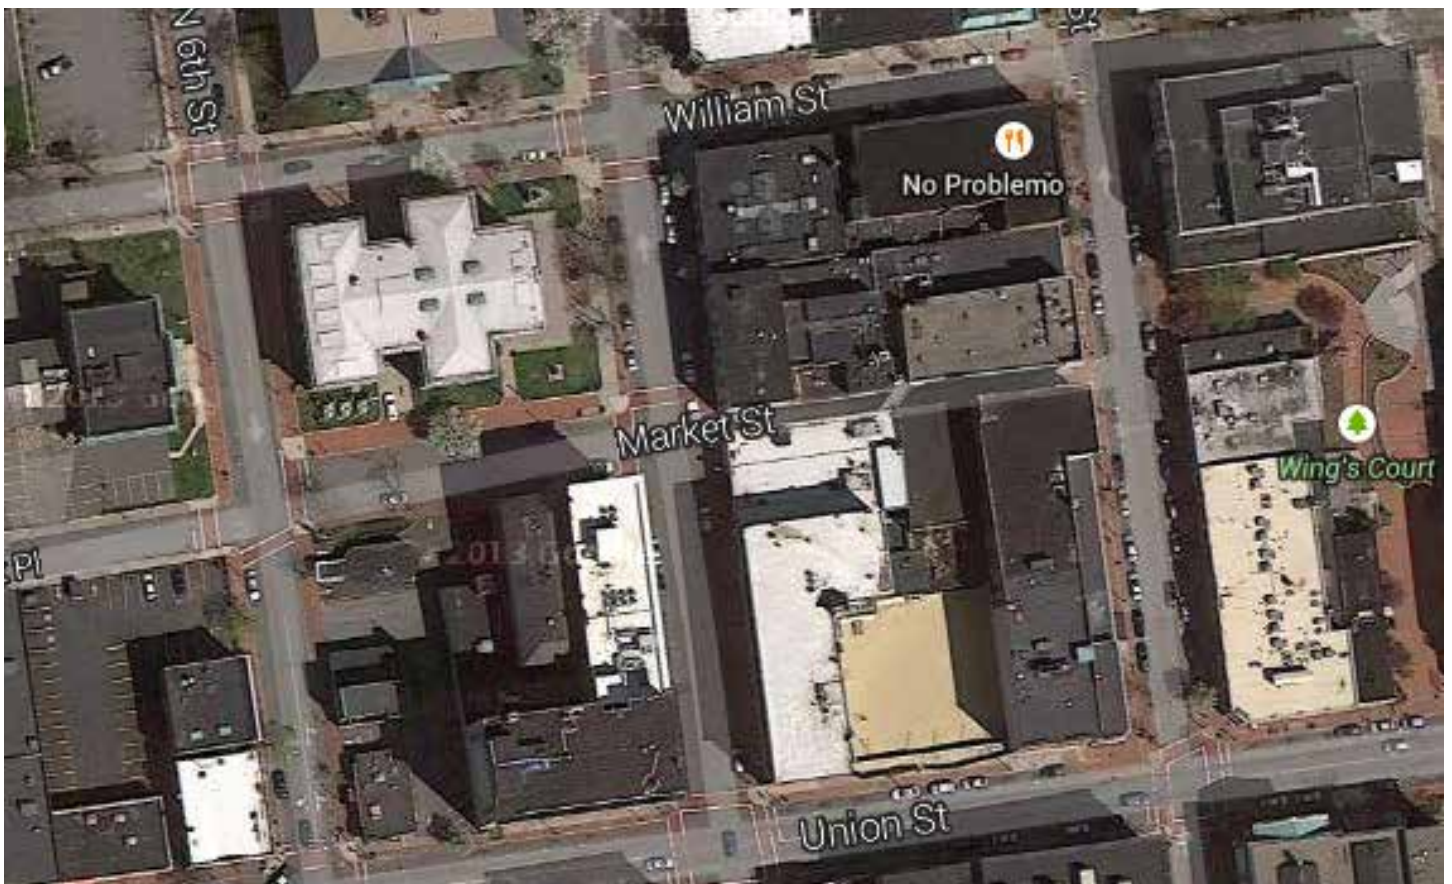
Municipal buildings, including the library and City Hall, line Pleasant Street between William and Union Streets

- Consider adding mid-street warning signs at intersection of Market Street.
- Consider adding edge (fog) lines on both sides of the street or bike lanes along one side of the street.
- Consider repainting parking spaces for police vehicle away from crosswalk.
- Upgrade curb ramps to ADA standards, including detectable warning strips.

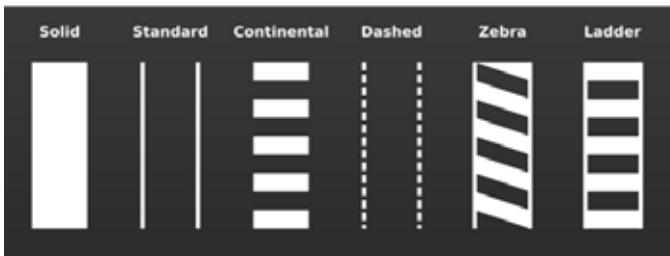
Crosswalks can be painted in a variety of ways, some of which are more effective in warning drivers of pedestrians. Crosswalks are usually accompanied with stop lines. These lines act as the legally mandated stopping point for vehicles, and discourage drivers from stopping in the middle of the crosswalk.

Crosswalk patterns
Source: USFHA

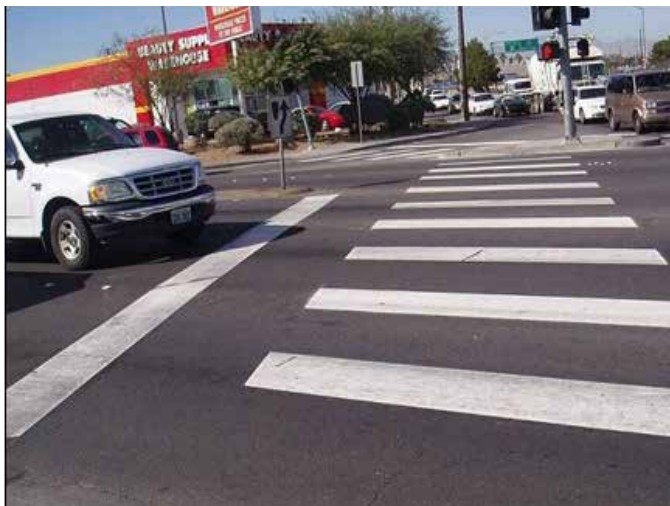
Crosswalk and stop line
Source: http://safety.fhwa.dot.gov/ped_bike/tools_solve/ped_scdproj/sys_impact_rpt/images/fig16.jpg

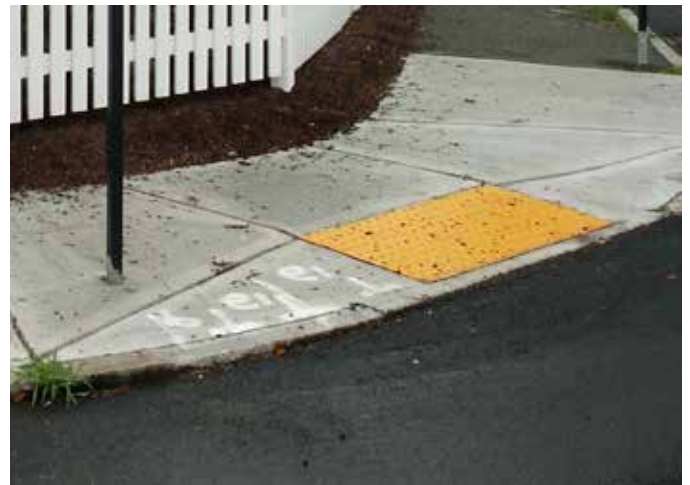
Curb ramps provide access from the sidewalk to the street for people using wheel chairs and strollers. They are most commonly found at intersections. While curb ramps have improved access for wheelchair-bound people, they are problematic for visually impaired people who use the curb as an indication of the side of the street. Detectable warning strips, a distinctive surface pattern of domes detectable by cane or underfoot, are now used to alert people with vision impairments of their approach to streets and hazardous drop-offs.

Curb ramp and detectable warning strip in Woburn, MA

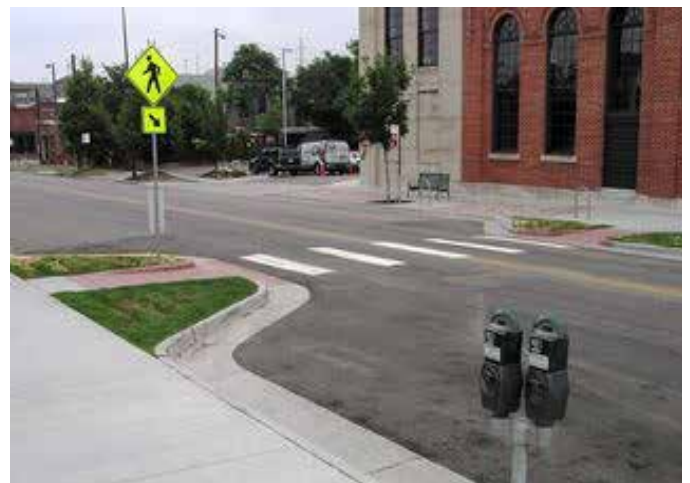
A sidewalk extension into the street (into the parking lane) shortens crossing distance, increases visibility for walkers and encourages eye contact between drivers and walkers.

Curb extensions are often associated with mid-block crossings

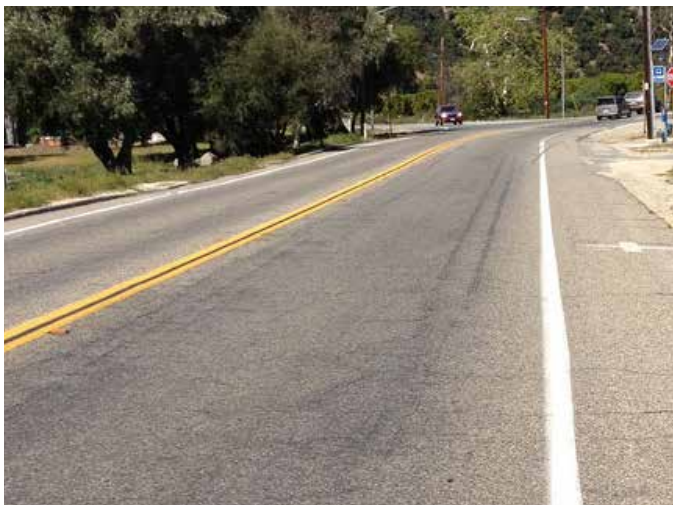
An edge line is a solid white line painted along the roadside curb that defines the driving lane and narrows the driver's perspective. Edge lines are most often used in suburban and rural locations, but may be appropriate in some urban conditions.

Edge lines delineate the vehicular driving zone on wide roadways.

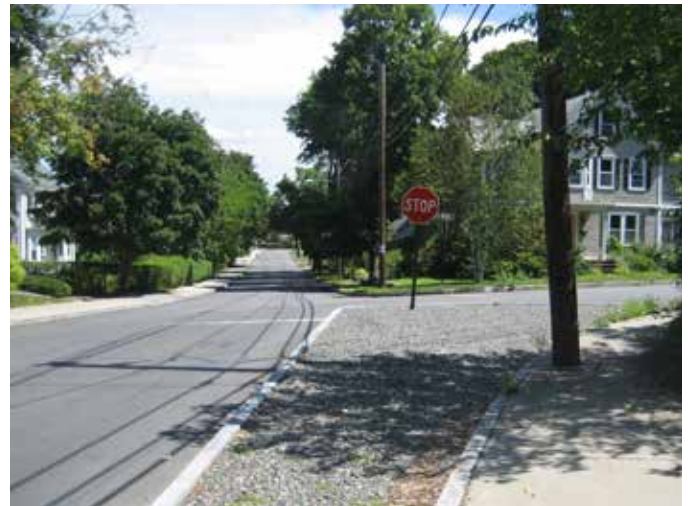
There are two excellent examples of the shortening of curb radii in Woburn, MA. The first (A) is a low-cost solution using a gravel-filled zone between the original curb line and the newly established road edge. The second is a higher-cost solution using grass and trees and extending the sidewalks to the new curb. Both work to slow traffic.

(A) Gravel-filled curb extension

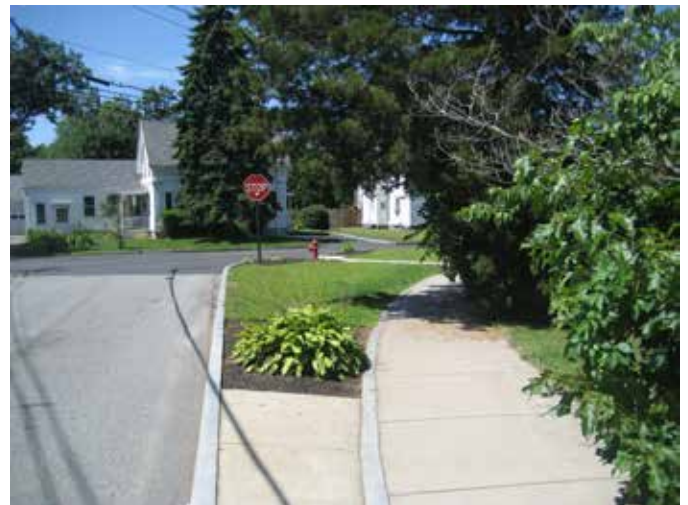
(B) Grass, trees and extended sidewalk in curb extension

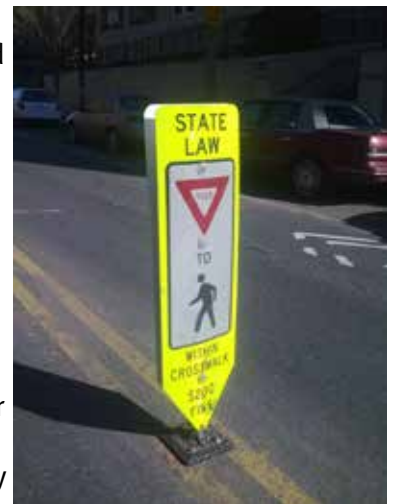
In-street pedestrian crossing signs are used at the road centerline within crosswalks to increase driver awareness of pedestrians in the area. These signs are a relatively low-cost, highly effective tool in slowing traffic by the narrowing travel lanes. They are popular with road maintenance departments since they can be easily moved for snow removal.

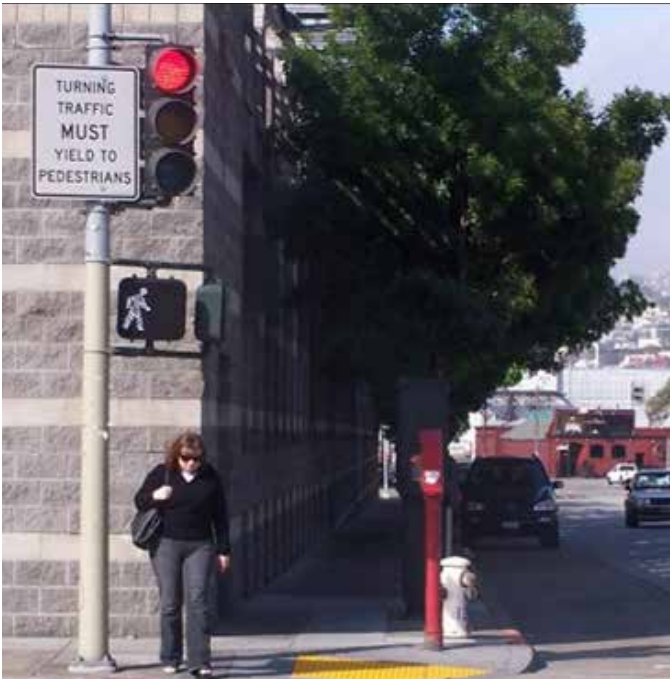
A leading pedestrian indicator gives pedestrians an advance walk signal before motorists get a green signal, giving the pedestrian several seconds to start walking in the crosswalk before a concurrent signal is provided to vehicles. This makes pedestrians more visible to motorists and motorists more likely to yield to them. Typical LPI settings provide 3 to 6 seconds of advance walk time.

Walker taking advantage of leading pedestrian interval
Source: http://safety.fhwa.dot.gov/ped_bike/tools_solve/ped_scdproj/sys_impact_rpt/images/fig34.jpg

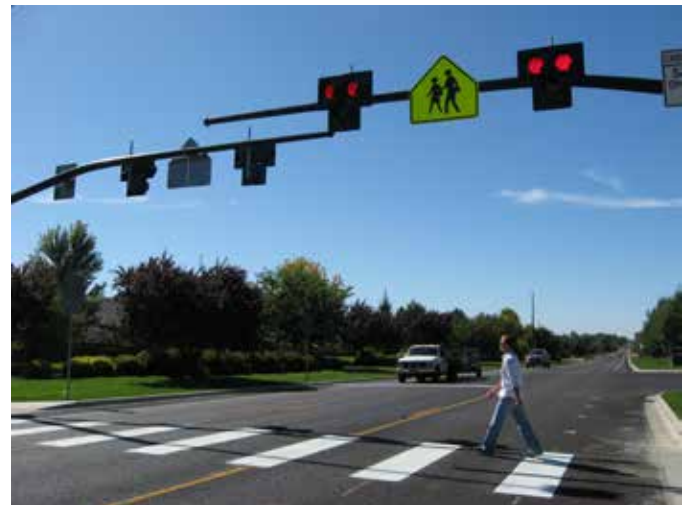
A HAWK beacon (High-Intensity Activated crossWalk beacon) is a traffic signal used to stop road traffic and allow pedestrians to cross safely. It is officially known as a Pedestrian Hybrid Beacon (PHB). The purpose of a HAWK beacon is to allow protected pedestrian crossings, stopping road traffic only as needed. Where standard traffic signal 'warrants' prevent the installation of standard three-color traffic signals, the HAWK beacon provides an alternative.

Walker crosses roadway after activating the HAWK beacon
Source: <http://www.achdidaho.org/Projects/Images/NewHawkSignal092209%20014.jpg>

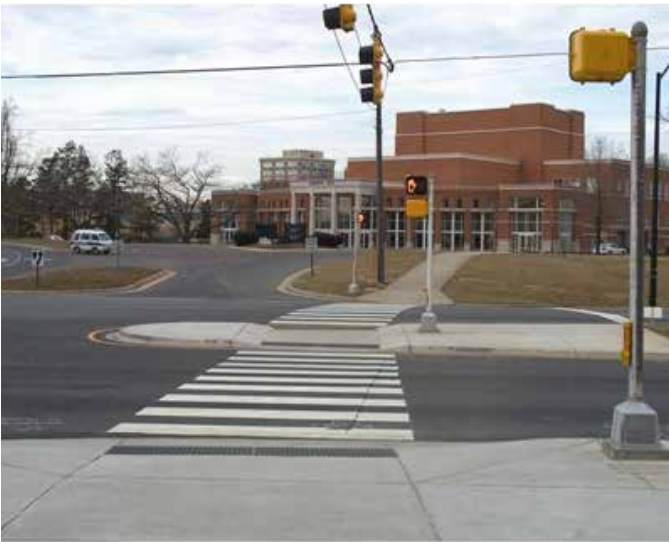
Pedestrian refuge islands are protected areas where people may safely pause or wait while crossing a street. Pedestrian refuge islands are particularly helpful as resting areas for seniors, persons with disabilities, children, and others who may be less able to cross the street in one stage. At signalized intersections, they allow slow moving pedestrians to cross in two phases. At unsignalized locations, they simplify the act of finding a gap in traffic to cross since vehicles from only one direction must be reckoned with at a time.

Pedestrian refuge island at a signalized crossing
Source: <http://safety.fhwa.dot.gov/intersection/resources/fhwasao6o16/images/fig95.jpg>
