## Niagara Senior Center Walk Audit Fall River, MA

July 9, 2014

## Background on Niagara Senior Center

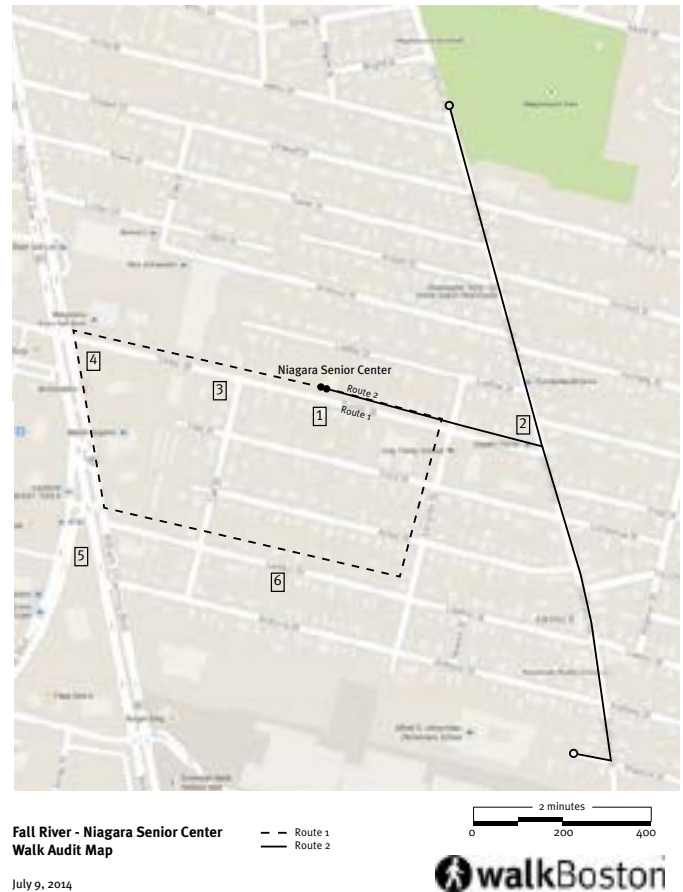
## Walk Audit Map

Based on field observations, WalkBoston recommends that safety improvements be made at each of the locations described below (and numbered on the Route Map):

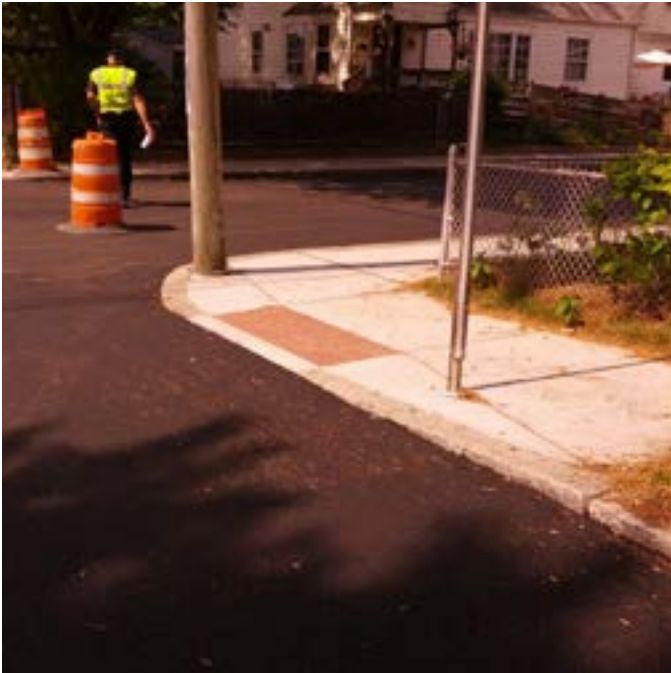
*New curb ramp being installed in neighborhood*

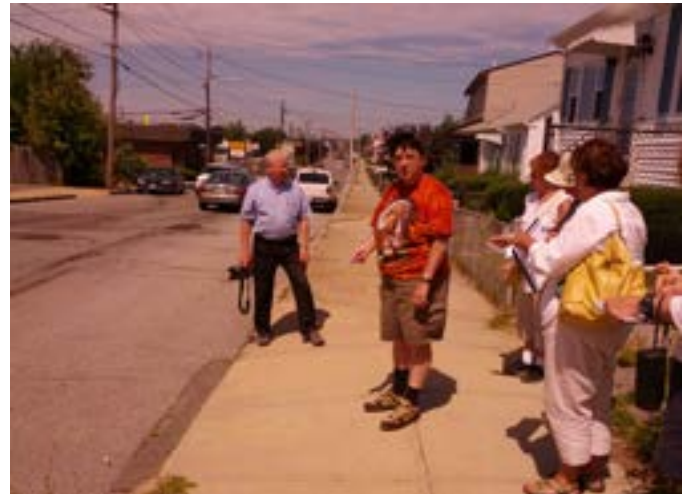
*Sloped sidewalk at driveway on Tucker Street*

- Repair sidewalks that pose tripping hazards to walkers. Several new sidewalks and curb ramps were being installed on some of the neighborhoods side streets.
- Replace faded or disappeared crosswalks at all intersections with new zebra stripe crosswalks.
- Replace sloping driveways with flat sidewalks with steeper driveway ramps when sidewalks are being replaced. This is especially important for winter walking when sloped sidewalks that are snowy or icy pose fall hazards.

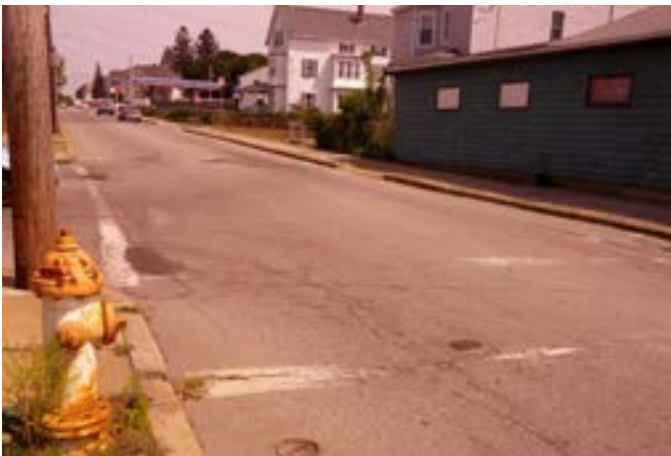
*Faded crosswalk at bus stop on Stafford Street*

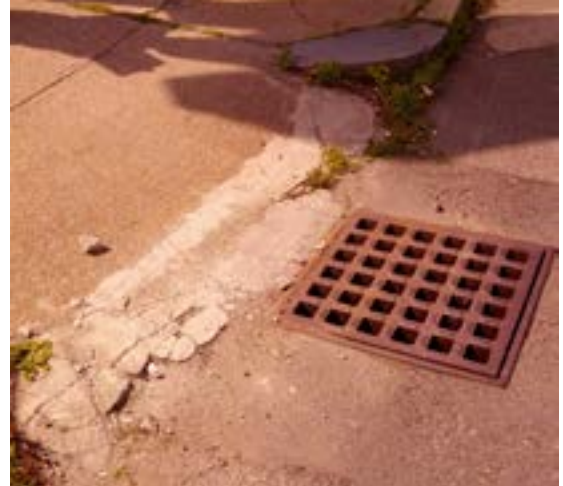
*Broken curb ramp and storm drain*

- Missing or non-ADA compliant curb ramps exist at many of the neighborhood's corners, and need repair or replacement.
- Cars are travelling at relatively high speed on all of the neighborhood's main streets. The City should consider painting fog lines to reduce the apparent lane width, and add bulb outs to slow traffic and shorten crossing distances.

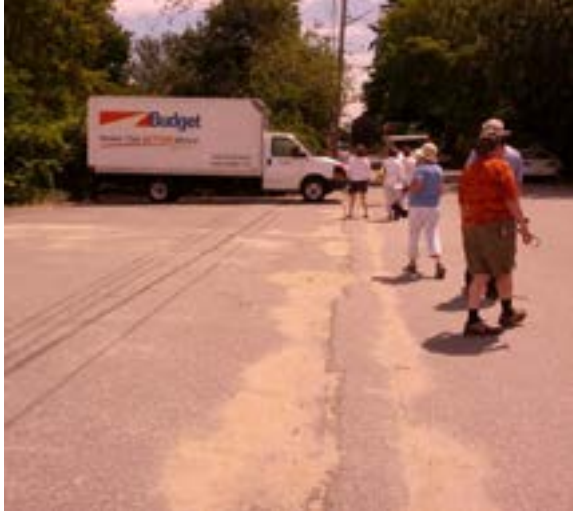
*Continuous curb cut on Lawton Street*

- Narrowing wide curb cuts and tightening the turning radii at business entrances would protect pedestrians and slow turning vehicles.
- More street trees would both add shade and provide a more attractive walking environment.
- Benches should be added where possible, in particular at bus stops and on the nice, shady grounds of the Senior Center.

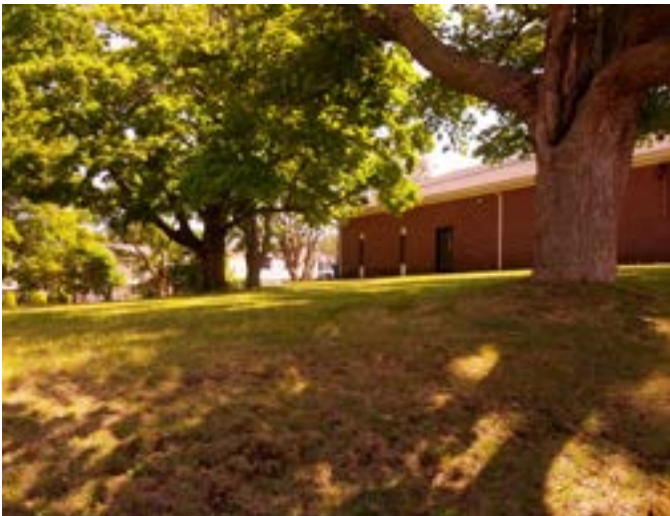
*Niagara Senior Center grounds*

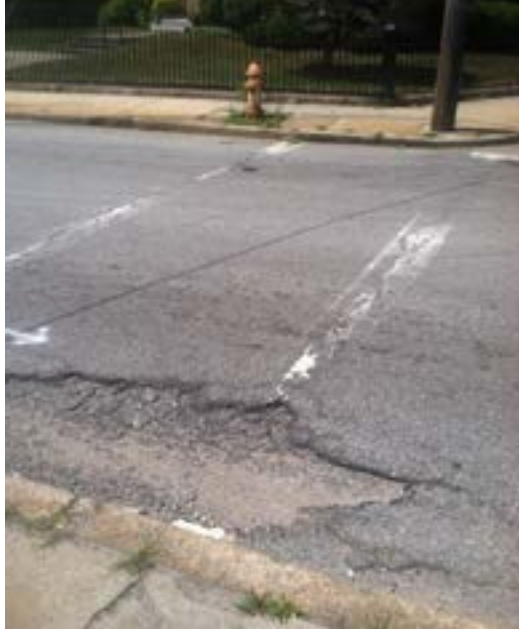
Due to the angle at which Tucker Street enters Stafford Road, vehicles turning from Tucker onto Stafford have obstructed sight lines. Vehicles move at high speeds on Stafford Road as they approach Tucker Street coming down the hill. Pedestrians crossing at this location are not clearly visible to drivers and the crossing felt quite hazardous to the walk audit participants.

*Faded crosswalk with pothole at Stafford and Tucket Streets*

- Short-term
  - » Re-paint all of the crosswalks at the intersection
  - » Add watch for pedestrian signs in advance of the intersection on both streets
  - » Provide a “Yield to Pedestrians” mid-street cone on the Stafford Road center line
- Long-term
  - » Consider addition of stop signs on both Stafford Road approaches to Tucker Street to create a three-way stop. This would both slow traffic and protect both pedestrians and drivers exiting Tucker Street onto Stafford.

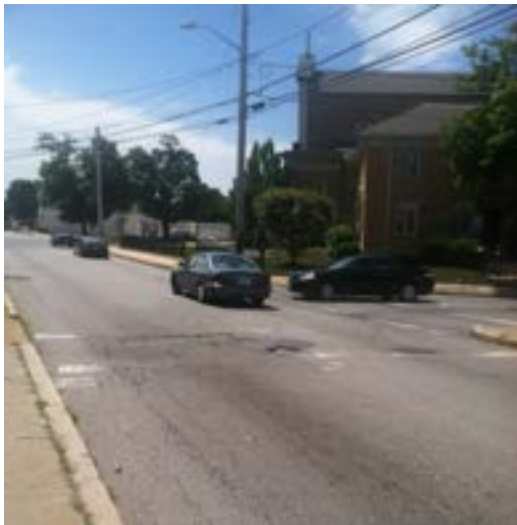
*Faded crosswalk at proposed three-way stop at Stafford and Tucker Streets*

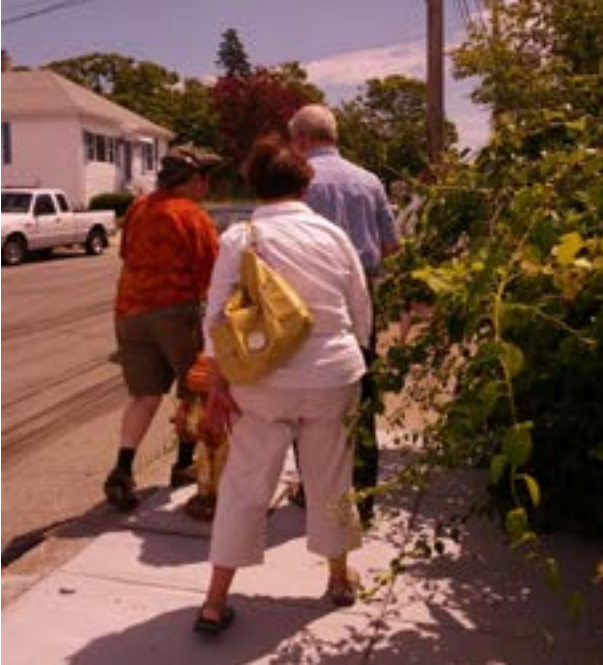
*Overgrowth on sidewalk across from day care center on Tucker Street*

- Short-term
  - » Repaint the completely faded crosswalk across Tucker Street with zebra striped marking
  - » Install curb ramps serving the crosswalk
  - » Trim the bushes that block the sidewalk on Tucker Street on the far side of Carl Street from the Daycare Center
  - » Paint “bulb-outs” on the pavement, with no parking posted 20’ back from the crossing on either side
  - » Provide in-street pedestrian crossing signs on the street center line

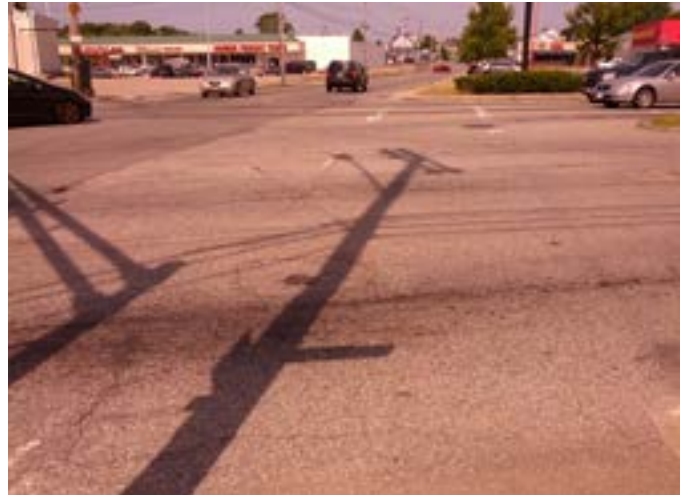
(2) a left turn arrow from Canning, and (3) a right turn arrow from Canning. All of the crosswalk markings are faded completely, and the curb ramps are not ADA compliant.

*Faded crosswalk at Canning Boulevard*

- Short-term
  - » Repaint all of the crosswalks with zebra striped marking
  - » Re-time the signal to eliminate the right-turn arrow and add a yield to pedestrians sign at the corner
- Long-term
  - » Provide new signal heads with countdown pedestrian crossing signals
  - » Fix all of the curb ramps
  - » Consider narrowing the travel lanes on Canning Boulevard to shorten the crossing distances

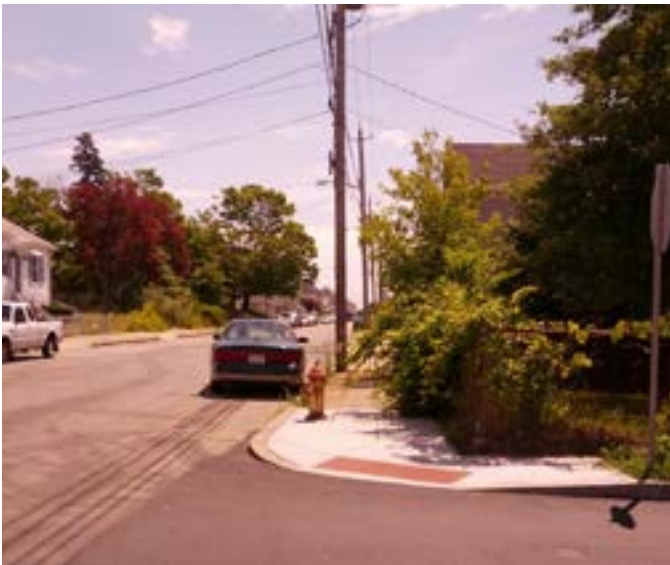
*Curb cut blocked by overgrown shrubs*

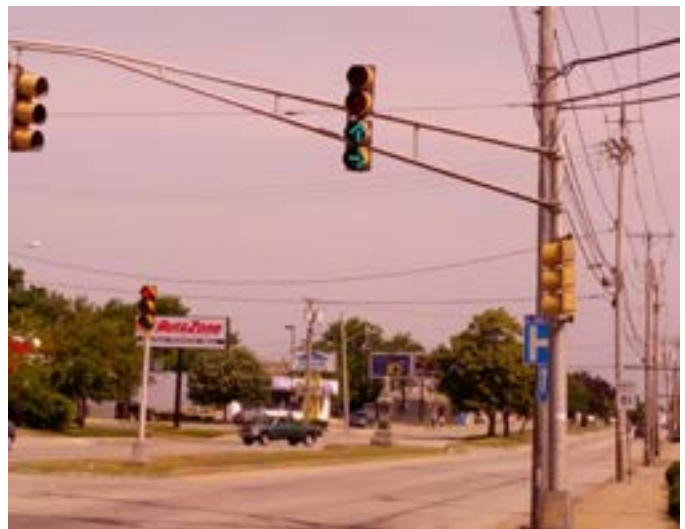
The traffic signal at this intersection does not have a pedestrian signal head, and the timing does not provide any protected crossing of Tucker Street. There are three signal phases: (1) a through green on Tucker,

*Signal that does not provide any walk time*

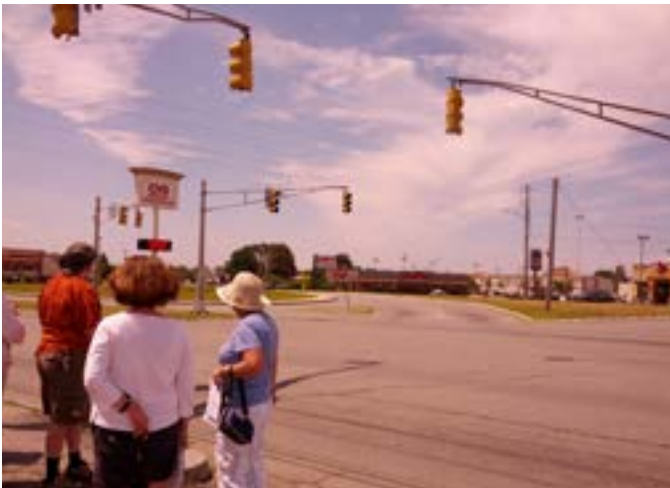
As described by the Fall River participants, children from the north side of this intersection attend school on the south side of Canning Boulevard. The children must be provided with bus transportation because the intersection does not provide any pedestrian accommodation, and the roadway geometry designed is to accommodate vehicles and no pedestrian crosswalks. Pedestrians were observed in the median of Canning Boulevard and crossing the roadway in the vicinity of this intersection, clearly suggesting that there are pedestrians who need to cross the road in this area.

*Intersection of Mariano Bishop and Canning Boulevards*

- Due to the complexity of the roadway geometry and the lack of a clear route for pedestrians, WalkBoston cannot provide specific recommendations for this location. A traffic engineering review would be required to undertake changes at the intersection.

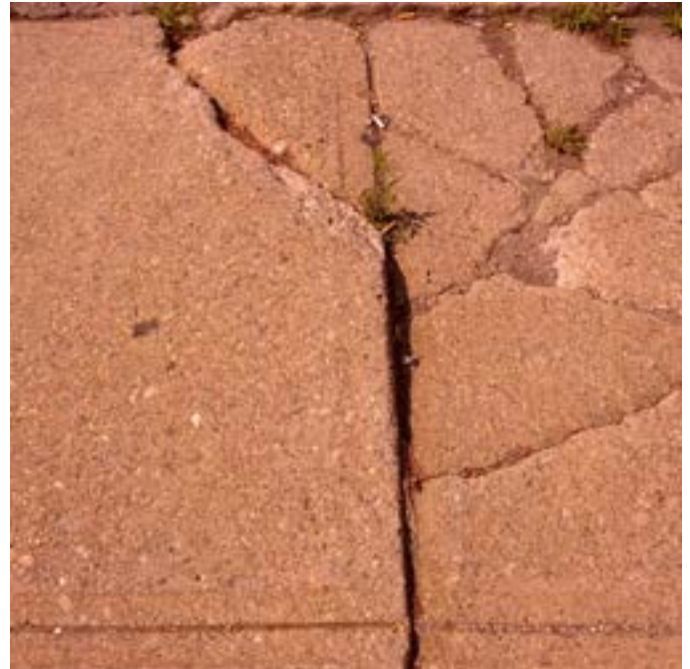
*Uneven sidewalk*

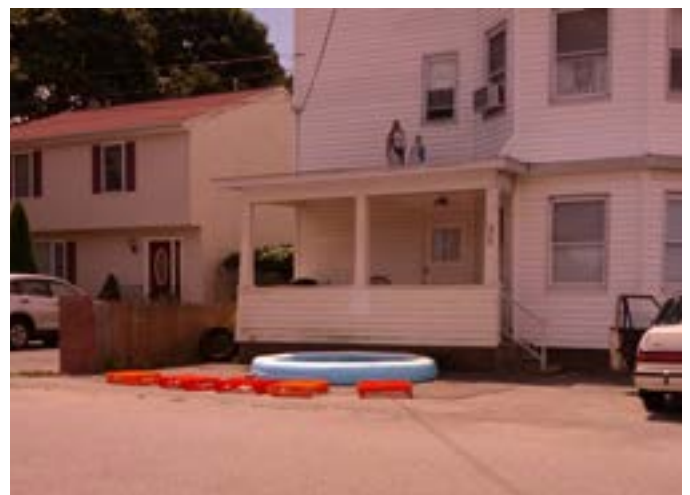
Lawton Street is a primarily residential side street just south of the senior center. It merges with Canning Boulevard, and experiences some fast traffic. Given high traffic speed and the presence of children, extra measure should be taken to ensure safety on Lawton Street.

*Protecting a kiddie pool where there is no curb*

- A curb should be added at Lawton Street to protect the play space that is being used in front of the house. Residents have tried to protect the space by putting out plastic bumpers.

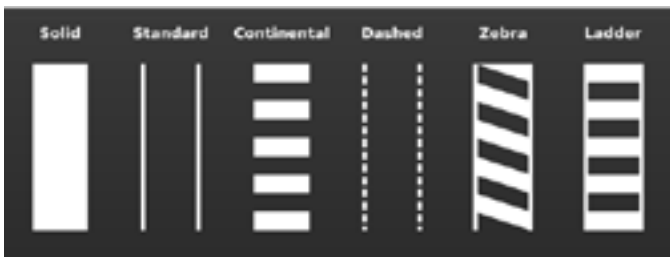
Crosswalks can be painted in a variety of ways, some of which are more effective in warning drivers of pedestrians. Crosswalks are usually accompanied with stop lines. These lines act as the legally mandated stopping point for vehicles, and discourage drivers from stopping in the middle of the crosswalk.

Crosswalk patterns  
Source: USFHA

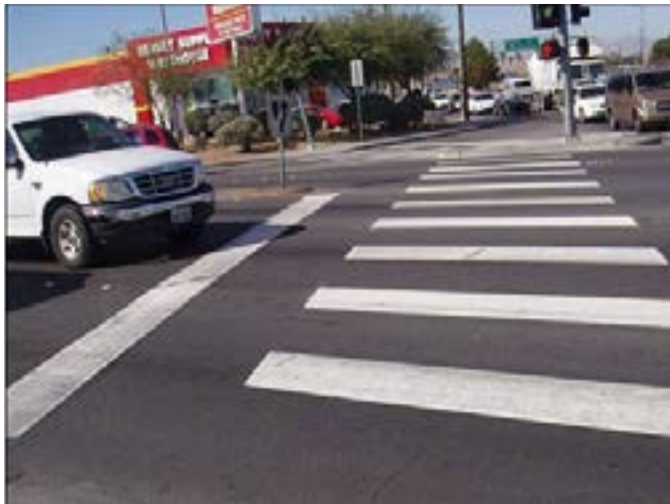
Crosswalk and stop line  
Source: [http://safety.fhwa.dot.gov/ped\\_bike/tools\\_solve/ped\\_scdproj/sys\\_impact\\_rpt/images/fig16.jpg](http://safety.fhwa.dot.gov/ped_bike/tools_solve/ped_scdproj/sys_impact_rpt/images/fig16.jpg)

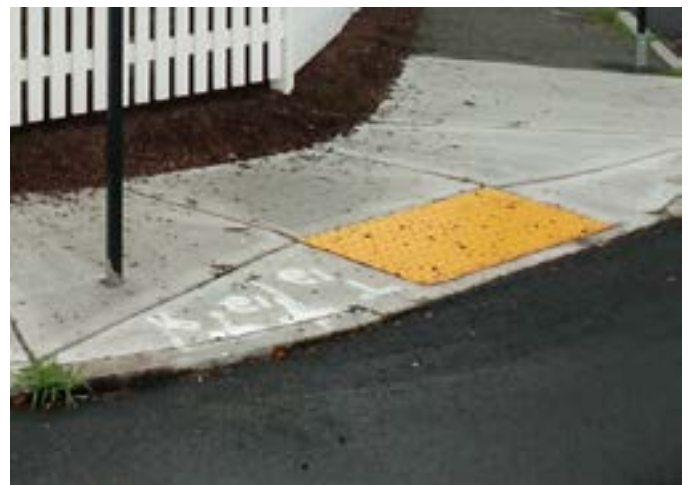
Curb ramps provide access from the sidewalk to the street for people using wheel chairs and strollers. They are most commonly found at intersections. While curb ramps have improved access for wheelchair-bound people, they are problematic for visually impaired people who use the curb as an indication of the side of the street. Detectable warning strips, a distinctive surface pattern of domes detectable by cane or underfoot, are now used to alert people with vision impairments of their approach to streets and hazardous drop-offs.

Curb ramp and detectable warning strip in Woburn, MA

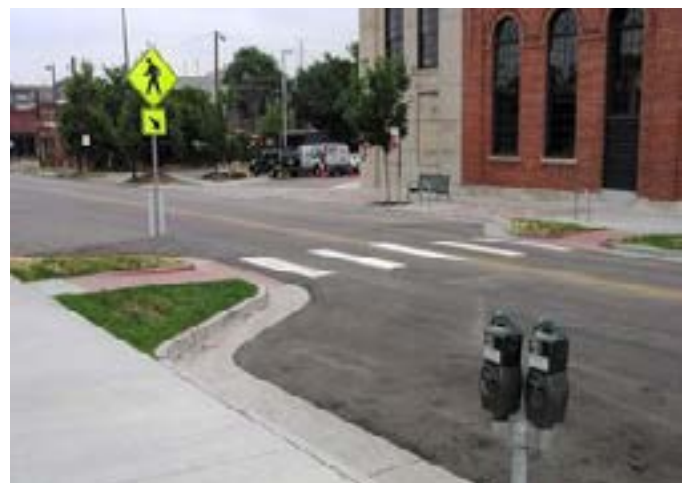
A sidewalk extension into the street (into the parking lane) shortens crossing distance, increases visibility for walkers and encourages eye contact between drivers and walkers.

Curb extensions are often associated with mid-block crossings

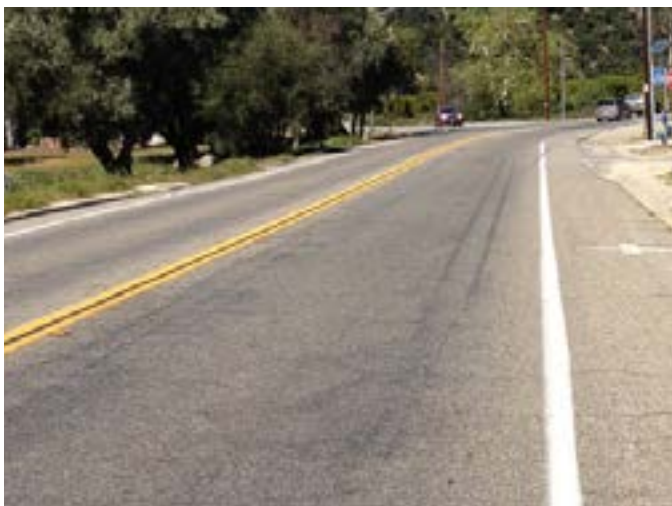
A fog line is a solid white line painted along the roadside curb that defines the driving lane and narrows the driver's perspective. Fog lines are most often used in suburban and rural locations, but may be appropriate in some urban conditions.

*Fog lines delineate the vehicular driving zone on wide roadways.*

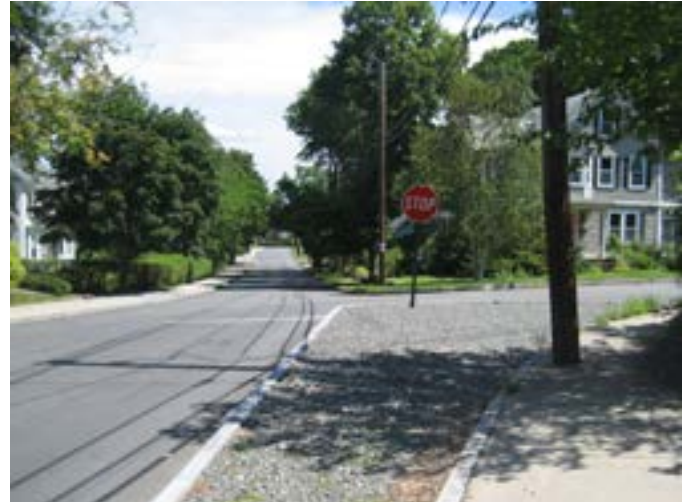
*(A) Gravel-filled curb extension*

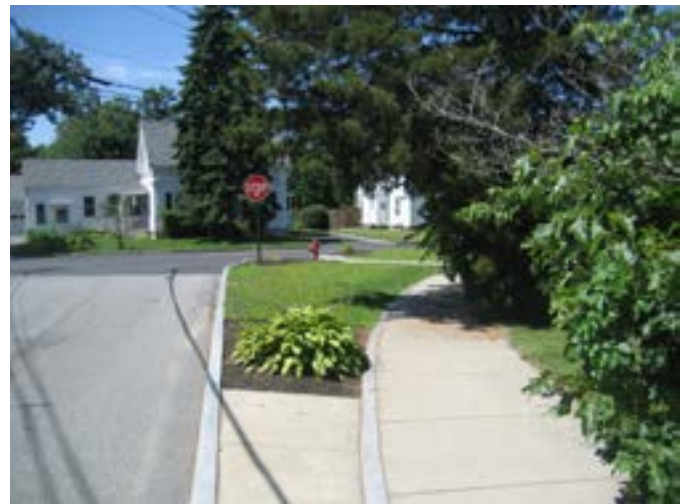
*(B) Grass, trees and extended sidewalk in curb extension*

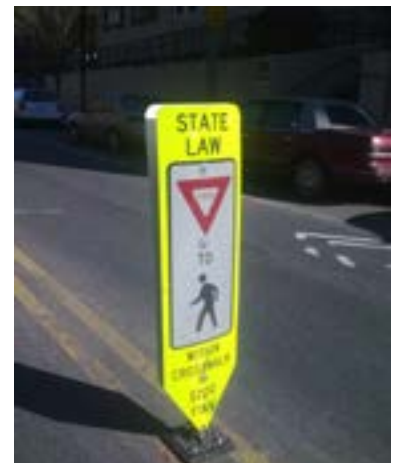
In-street pedestrian crossing signs are used at the road centerline within crosswalks to increase driver awareness of pedestrians in the area. These signs are a relatively low-cost, highly effective tool in slowing traffic by the narrowing travel lanes. They are popular with road maintenance departments since they can be easily moved for snow removal.

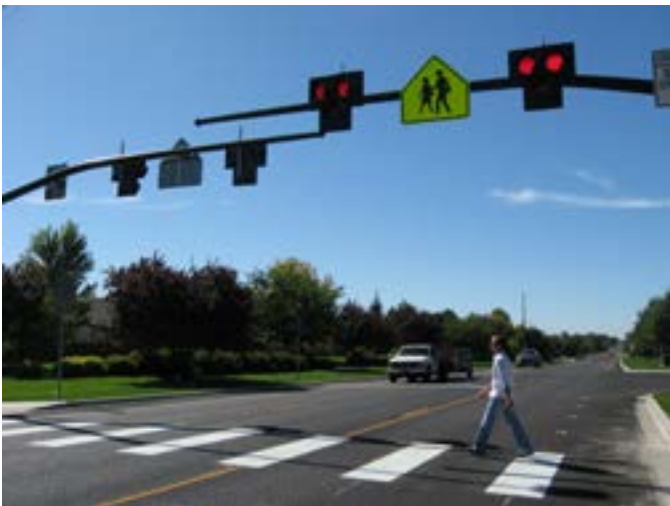
Source: <http://www.achdidaho.org/Projects/Images/NewHawkSignal092209%20014.jpg>

A HAWK beacon (High-Intensity Activated crossWalk beacon) is a traffic signal used to stop road traffic and allow pedestrians to cross safely. It is officially known as a Pedestrian Hybrid Beacon (PHB). The purpose of a HAWK beacon is to allow protected pedestrian crossings, stopping road traffic only as needed. Where standard traffic signal 'warrants' prevent the installation of standard three-color traffic signals, the HAWK beacon provides an alternative.
