# Woburn Safe Routes to School

## Walkability Assessments

# Introduction

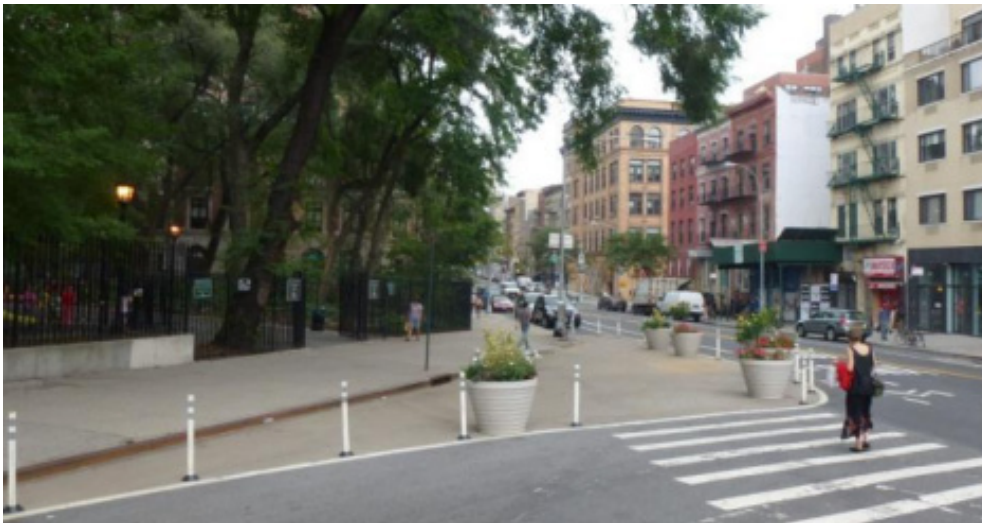
A painted curb extension with planters and flexible delineators (white posts)

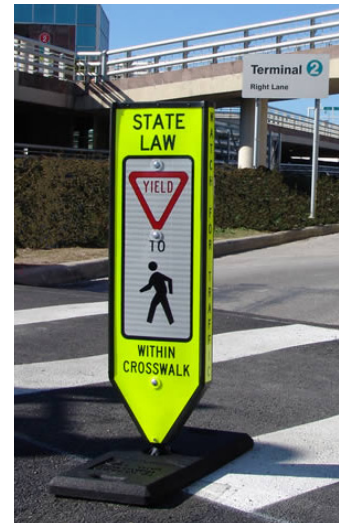
In-street pedestrian crossing sign

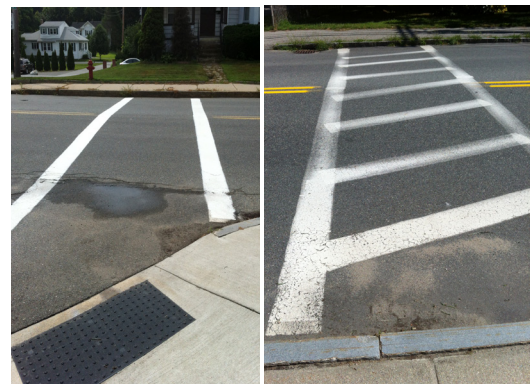
The parallel lines (left) are adequate for low-traffic areas, while the ladder (right) is more visible and should be used in higher-traffic areas.

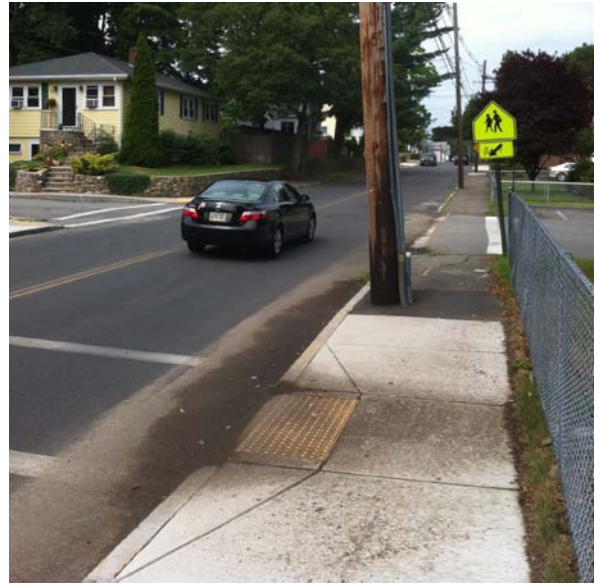
Figure 1

**a.** On the north side of Green Street, a pedestrian crossing sign is placed several feet west of the crosswalk by the western entrance to the parking lot. (See Figure 1)

**Recommendations:** The sign should be placed farther east on Green Street in advance of the crosswalk. This crosswalk, currently two parallel lines, should be improved to a ladder crosswalk. Ladder crosswalks are more visible especially at night or in low light conditions, such as rain or fog.

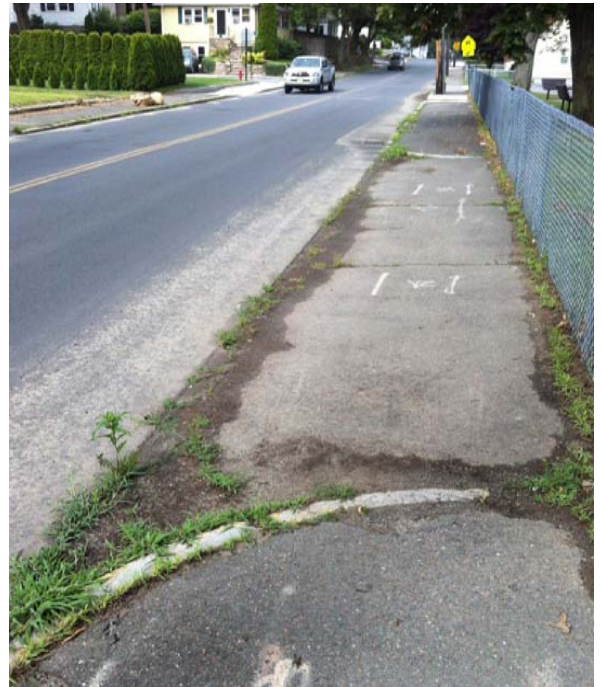
Figure 2

The sidewalk on the north side of Green Street has a wide curb cut that serves no purpose. (See Figure 2)

**Recommendations:** The curb cut should be removed, and sidewalk should be improved to be a continuous, level walking surface with a full curb along the street.

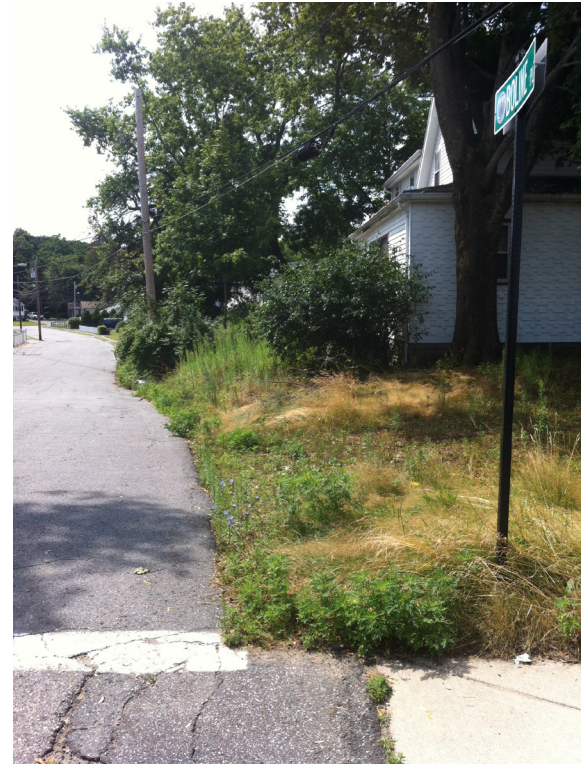
Figure 3

The sidewalk along Boline Street comes to an abrupt end approximately 150 feet before it intersects with Montvale Avenue. Parked vehicles and overgrown vegetation make this a difficult area to walk, especially because it is an uphill walk to Montvale Avenue from Boline Street. (See Figure 3)

**Recommendations:** Extend the sidewalk from Montvale Avenue to where the sidewalk ends on Boline Street.

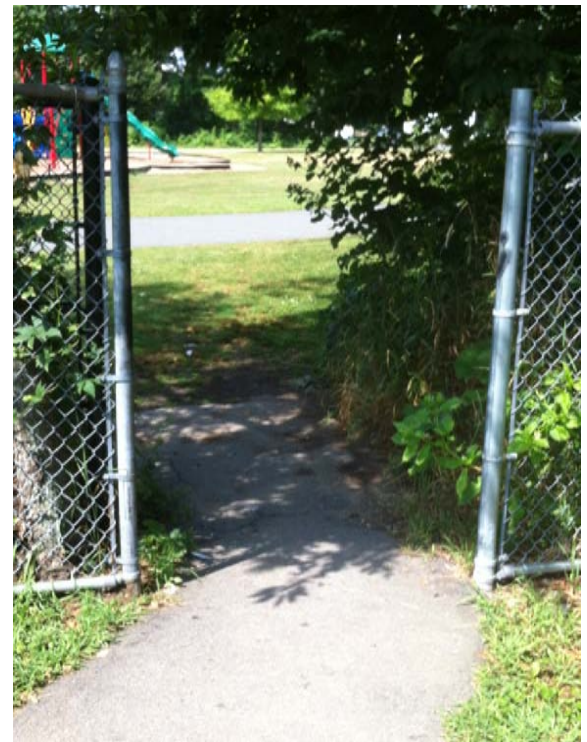
Figure 4

The path that connects the housing development east of the Shamrock school grounds abruptly ends, forcing pedestrians using this access point to walk through grass and dirt. This would be especially challenging during inclement weather, or for anyone with a mobility impairment. (See Figure 4)

**Recommendations:** Continue the path another ~15 feet to where it would meet the paved path that connects the school's rear driveway with the front of the school. Cut the vegetation back from the edges of the path, to make it easier to pass through the narrow opening in the fence.

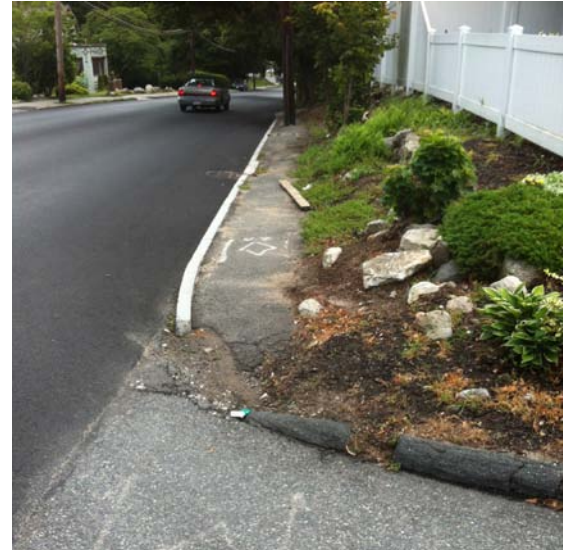
Figure 5

The sidewalk on the south side of Salem Street effectively ends after Hilltop Terrace: there is no ramp, the sidewalk becomes very narrow, and it is partially covered in rocks, dirt and other debris (perhaps because it's unused). (See Figure 5)

**Recommendations:** A long-term/larger-investment improvement would be to re-establish the sidewalk and to maintain a clear walking path. A short-term/smaller-investment improvement would be to improve the crosswalk at the intersection of Salem Street, Hilltop Terrace and Sedgwick because it's necessary to cross here if walking east on Salem.

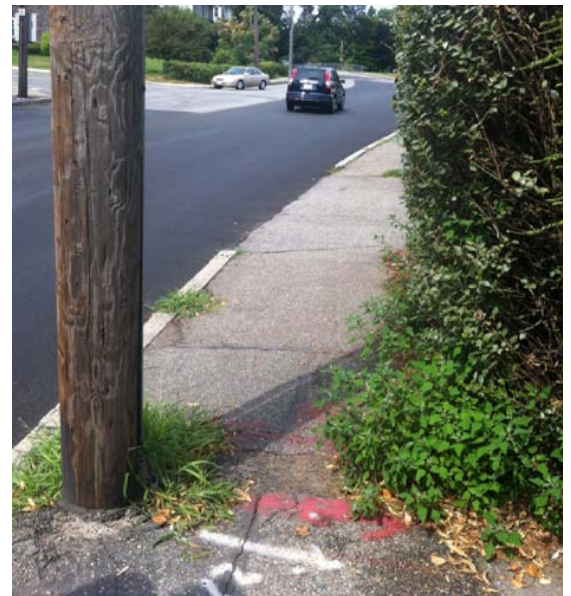
Figure 6

There is a utility pole installed in the sidewalk of the north side of Salem Street between Beach Street and Bow Street, which is directly next to a wall of overgrown hedges. This arrangement makes the sidewalk barely passable and causes pedestrians to step into the roadway to pass by. (See Figure 6)

**Recommendations:** Trim back vegetation that blocks sidewalks. Where appropriate, add asphalt (See Figure 7) to the inside edge of the sidewalks (this may not be possible because of stones and fences).

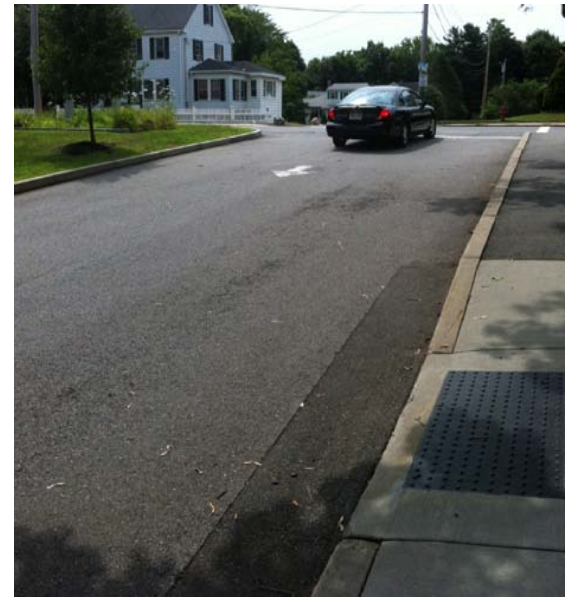
Figure 8

The driveway that leads to the tennis courts beside Woburn High School has two major issues (See Figure 8):

a. Halfway down the driveway there are two adjacent accessible curb ramps that have not been connected with a marked crosswalk.

b. The driveway's traffic pattern may confuse motorists as well as pedestrians. It is marked as a one way, but arrows pointing in the opposite direction of the sign are painted on the roadway. This makes it difficult to determine who has right of way.

**Recommendations:** Mark a crosswalk that connects the two ramps. While this driveway may only serve limited traffic, the existence of a crosswalk serves as a reminder to drivers that pedestrians may be present here.

**Recommendations:** Determine whether this needs to be a one-way driveway, and install the appropriate signage and

pavement markings based on the outcome of that decision. If it should become a two-way, remove the one-way markings.

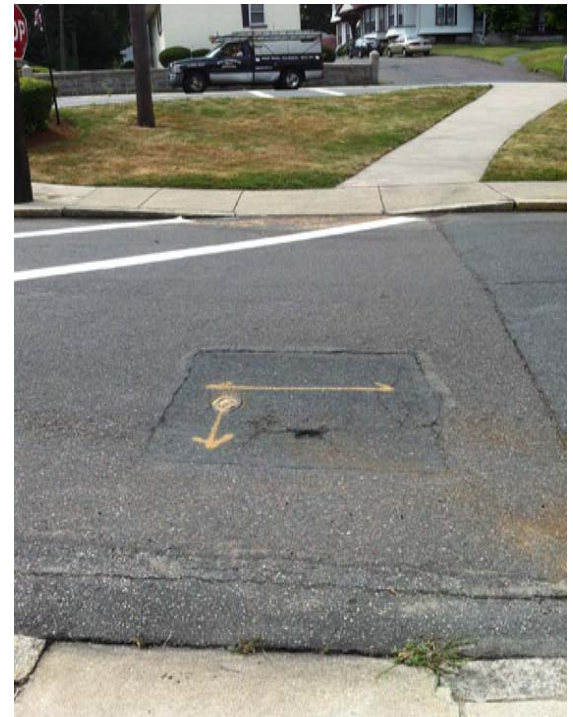
Figure 9

There is a curb ramp directly across Campbell Street from the ramp at the end of the path across the grassy area, yet the crosswalk leads to a driveway instead. (See Figure 9)

**Recommendations:** Re-align the crosswalk so that it connects two curb ramps, not a curb ramp and a driveway.

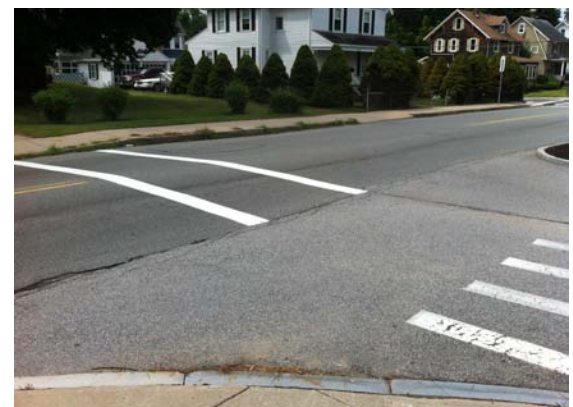
Figure 10

An awkwardly-placed crosswalk near Woburn High School's main entrance directs pedestrians crossing Montvale Avenue directly into the center of the high school driveway. This would be far from the safest place to cross, given the amount of traffic one can expect to use the school's main driveway. There are no curb ramps on the south side of Montvale Avenue across from the High School. (See Figure 10)

**Recommendations:** Install an accessible curb ramp at the east side of the school driveway, which has a generous sidewalk that leads to the main entrance of the school, and directly across from the east side of the high school driveway. Move the crosswalk so that it connects the two curb ramps. Because Montvale Avenue accommodates heavy traffic, a radar speed limit sign (driver feedback sign) would help reduce speeds near Woburn High not only during school hours but at all times of day. The added benefit to doing so might also help calm traffic speeds as vehicles approach Downtown Woburn.

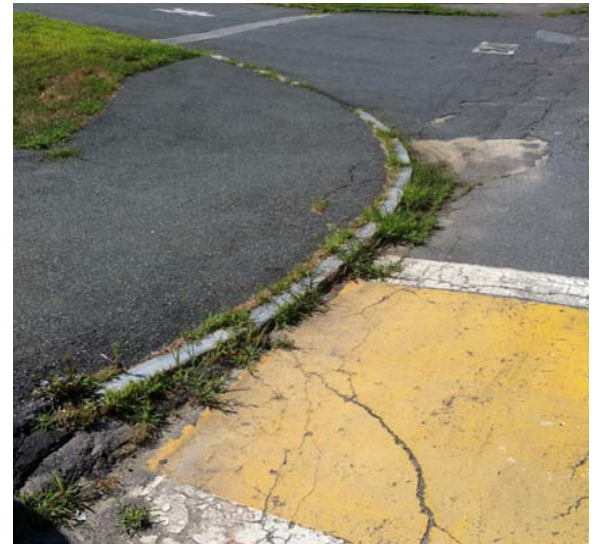
Figure 11

The crosswalks in front of Kennedy Middle School that cross Middle Street lead directly into solid curbs with no curb ramps. (See Figure 11)

**Recommendations:** Add curb ramps.

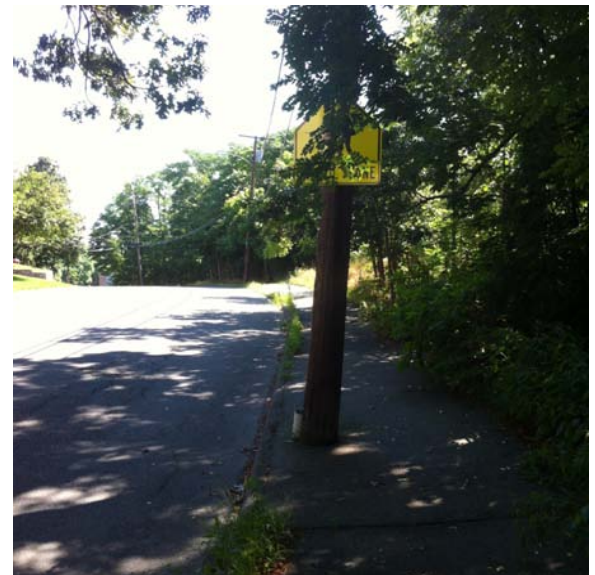
Figure 12

West of the school grounds, there is vegetation encroaching on the sidewalk and “SCHOOL ZONE” signage along Middle Street. Because this is only sidewalk (just on the south side of Middle Street) it should be maintained as well as possible. (See Figure 12)

**Recommendations:** Trim back the brush and tree branches along Middle Street so that the sidewalks are passable and the signage is visible.

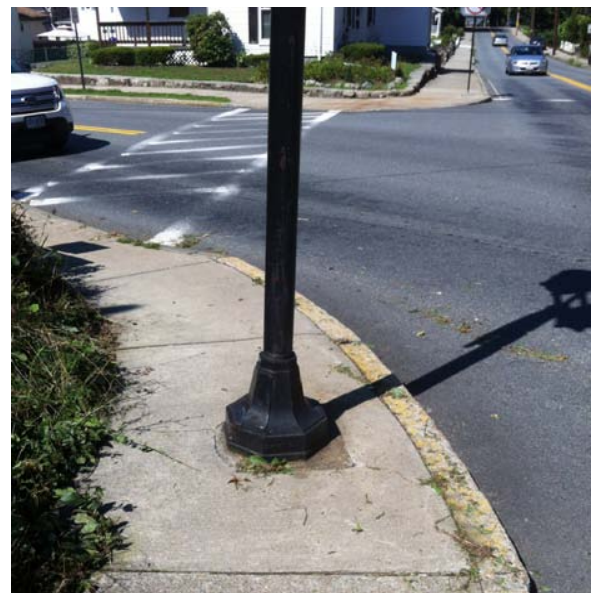
Figure 13

a. Traffic signal posts are installed where ideally curb ramps would be, and their placement in the middle of narrow sidewalks makes these points difficult to pass. (See Figure 13)

**Recommendations:** The geometry of this intersection would make widening sidewalks difficult. Instead, signal posts could be removed from the sidewalks and traffic signals could possibly be suspended over center of intersection. The base of such a suspension system might be installed wherever there is the greatest surface area on an existing sidewalk or set into land outside the sidewalk if the right of way is available to avoid blocking the sidewalk as it is currently.

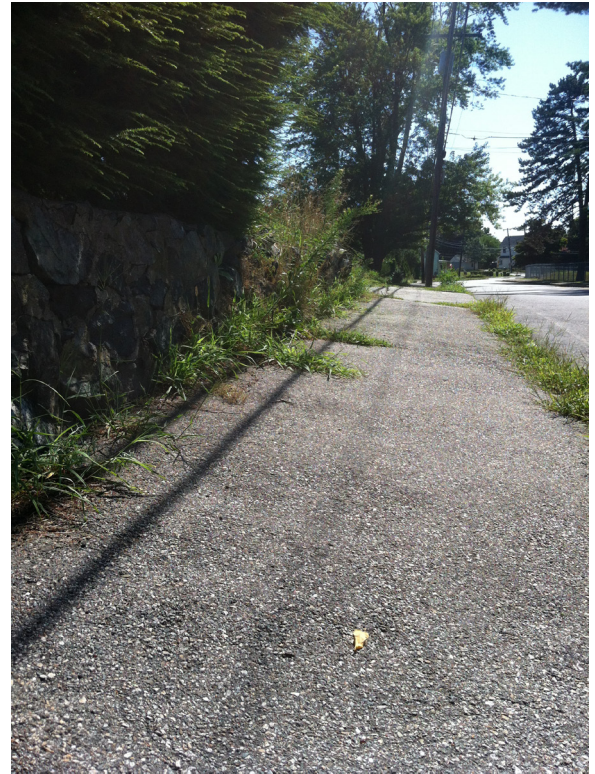
Figure 14

Just east of the intersection of Maywood and Beach, across from the cemetery, the sidewalk on the north side of Beach Street adjacent to the stone wall is severely sloped. This sidewalk would be especially difficult to use in winter. (See Figure 14)

**Recommendations:** The sloped portion of the sidewalk should be leveled and reconstructed.

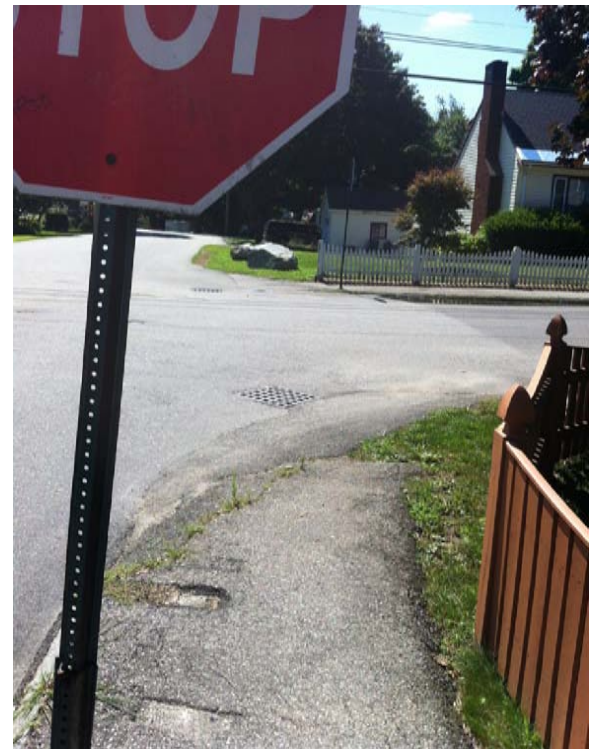
Figure 15

The stop sign on the northwest leg of the 4-way intersection at Maple Avenue and Lillian Street is too low. According to the Manual of Uniform Traffic Control Devices (MUTCD), the bottom of a sign mounted where pedestrians can be expected should be no lower than 7 feet. (See Figure 15)

**Recommendations:** Raise the sign so that it complies with the MUTCD.

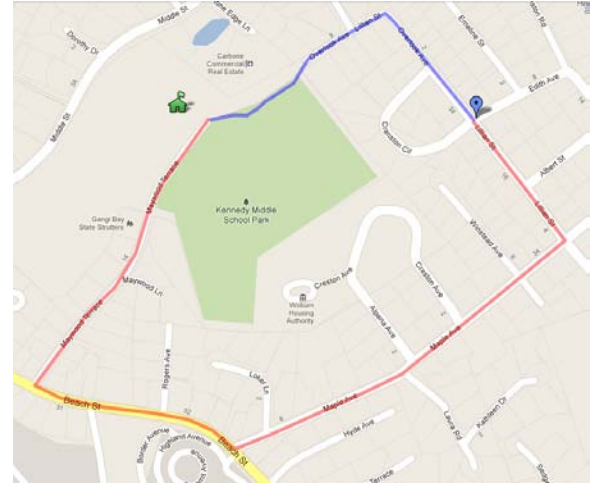
Figure 16

The neighborhood east of Kennedy Middle School, which is connected to Beach Street by Maple Street, is close to the rear of school “as the crow flies,” but it is a long walk because of the lack of street connectivity. (See Figure 16)

**Recommendations:** An informal path through the wooded area between Overlook Terrace at the western edge of the aforementioned neighborhood should be cleared, improved, and perhaps lighted. This would provide a safe connection to the school grounds that would be much shorter for people trying to walk or bike to Kennedy Middle School, and increases the likelihood that children from this neighborhood would choose to walk or bike to school.

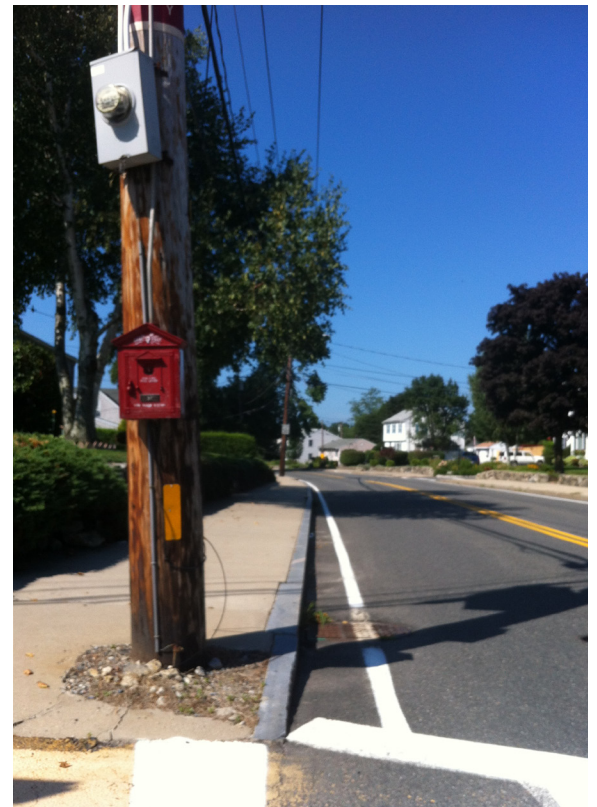
Figure 17

The crosswalk at Houghton Street and Bedford Road provides less than optimal visibility for pedestrians crossing Bedford Road, especially those crossing toward the Hurld School. Bedford Road bends slightly, to the west of the crosswalk, so pedestrians would be unable to predict if a vehicle were approaching from their left. The problem is made worse by tall hedges at the edge of one of the properties on the south side of Bedford Road. This crosswalk is also missing a curb ramp on the north side of Bedford Road. (See Figure 17)

**Recommendations:** Remove this crosswalk and place a new crosswalk to the east where pedestrians would have better visibility and a more direct connection to the school grounds. This new crosswalk should be a highly visible ladder style, not simply a pair of parallel white lines. Accessible ramps should also be installed, as well as brightly-colored pedestrian crossing signage. This would be the only crosswalk in the school zone, so it should be made as visible as possible.

Also, consider installing a driver feedback sign to the west of the crosswalk that shows not only the speed limit but also tells drivers their current speed. These signs are proven to slow down most drivers.

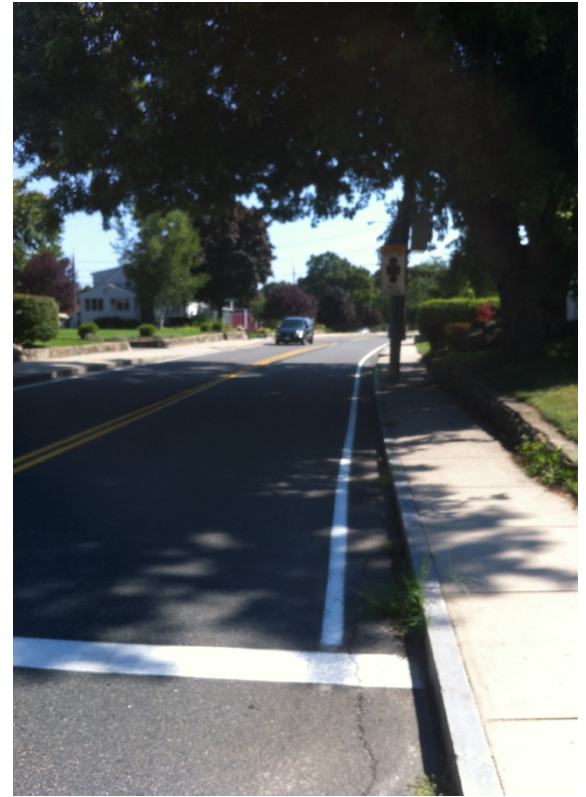
Figure 18

The crosswalk just to the east of the intersection of Bedford Road and Rock Street has poor visibility to the east, especially for pedestrians crossing Bedford Road south to north. This crosswalk is also lacking curb ramps. (See Figure 18)

**Recommendations:** Remove the crosswalk entirely. This is not a place where people should cross the street. Crosswalks should be installed only where it is safe to cross. There are plenty of other safe places to cross Bedford Road.

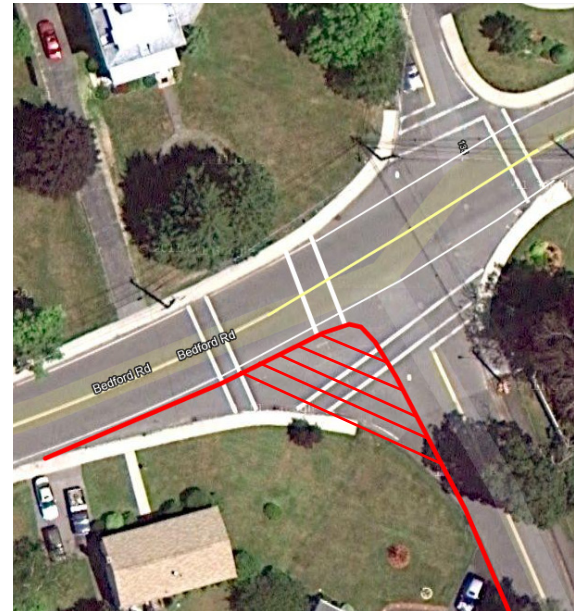
Figure 19

The intersection of Bedford Road and Burlington Street is quite large. The crossings of the three legs of this intersection are mostly adequate, but on the southeastern corner of the intersection the curb radius is quite large. Because of this, the distances

across Bedford Road west of Burlington Street, as well as Burlington Street south of Bedford Road, are longer than they need to be. As a result, pedestrians are “exposed” to traffic for more time than necessary. Furthermore, the large turning radius allows drivers turning right onto Burlington (south of Bedford Road) to do so at a faster speed than they would if the corner were sharper. (See Figure 19)

**Recommendations:** Painting curb extensions and installing flexible delineators would effectively narrow traffic lanes and shorten crossing distances. This would also slow vehicle speeds around corners.

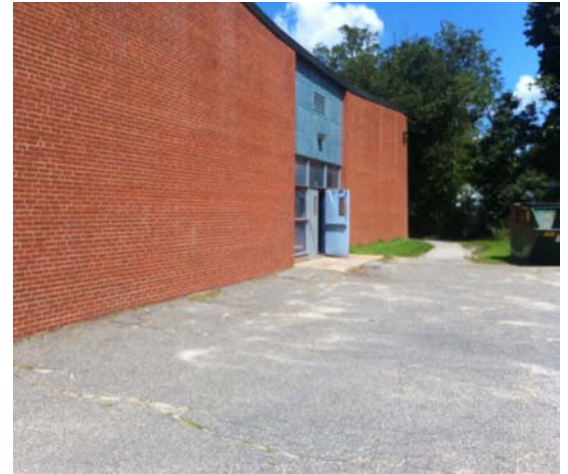
Figure 20

Where the path from Sheridan Street connects to the parking lot at the Hurd School there is not currently a sidewalk immediately adjacent to the school building itself. There ought to be a protected area for pedestrians here, especially because it is in a parking lot where vehicles could be backing up and there is limited visibility when parked cars are present. If not a concrete sidewalk, perhaps paint and bollards could be used to indicate the pedestrian space. (See Figure 20)

**Recommendations:** Short-term/small-investment: Using paint, designate a pedestrian area around the building from the end of the path that leads to the main entrance. Separate the pedestrian area from the parking lot’s circulation using flexible delineators or other easily seen object (such as large planters) that would separate the pedestrian area from the parking area. Long-term/large-investment: Build a sidewalk around the building that connects the path to the front entrance to the school.

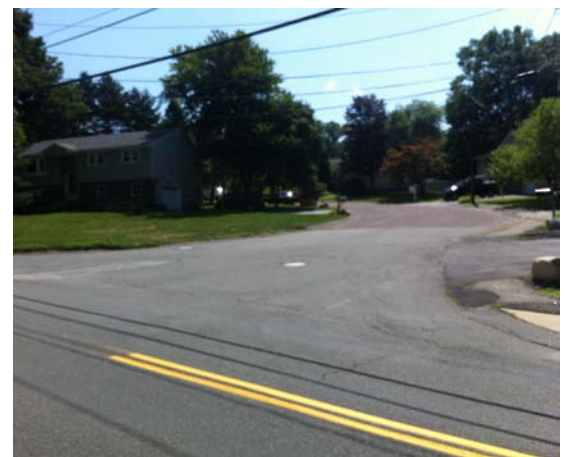
Figure 21

Rag Rock Drive becomes very wide at the intersection with Bedford Road. It isn't necessary for a small residential street (not even a through way) to have such a large curb radius. This intersection is also missing a crosswalk parallel to Bedford Road. Across the street, the intersection of Bedford Road and Elijah Street has a much shorter crossing distance and a marked crosswalk. (See Figure 21)

**Recommendations:** Ideally the intersection of Rag Rock and Bedford should be more like Elijah and Bedford. Shortening the crossing distance by narrowing the width of Rag Rock may be costly. At very least, a crosswalk should be painted and a School Zone / Pedestrians Crossing sign should be installed to remind drivers headed toward Bedford to expect (young) pedestrians.

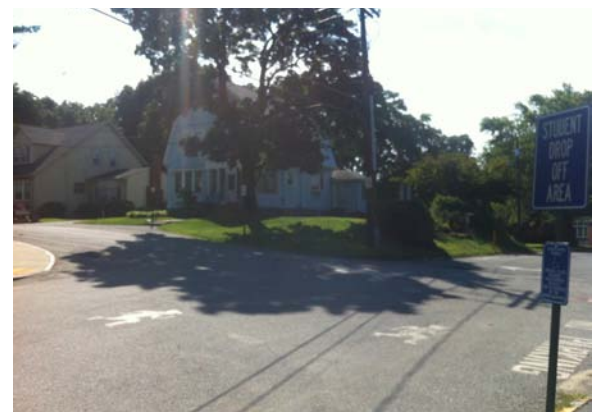
Figure 22

The area east of the school grounds where Newbury Street intersects with the school driveway is potentially dangerous. This is a student drop-off area marked for buses transporting students with disabilities. There is also a bus drop-off to the south, where more large vehicles could limit visibility. Currently there are white icons painted on the pavement that appear to indicate that this is a school zone. (See Figure 22)

**Recommendations:** Replace the icons with a high-visibility crosswalk and pedestrian crossing signage. The crosswalk should connect from Newbury Street to the walkway that leads to the door at the rear of the school.

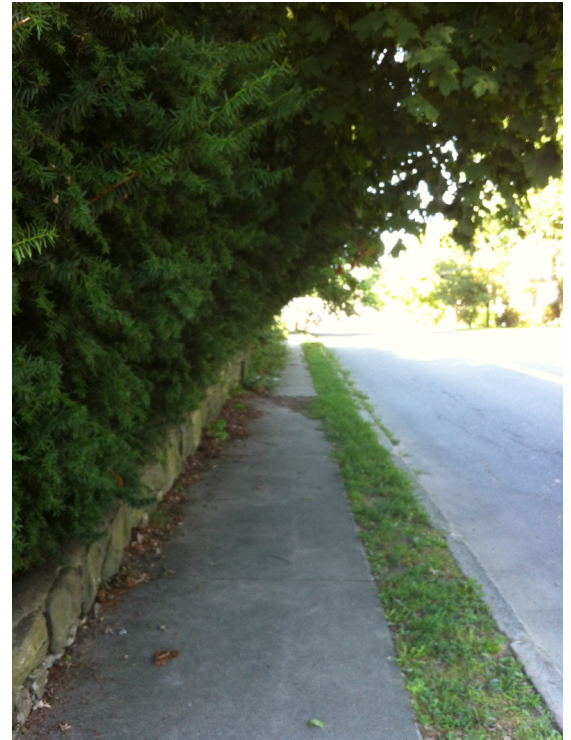
Figure 23

The sidewalk east of the Wyman School grounds (south side of Eaton Avenue) is crowded with vegetation and low hanging tree branches. (See Figure 23)

**Recommendations:** Trim back the weeds and tree branches so the sidewalk remains passable.

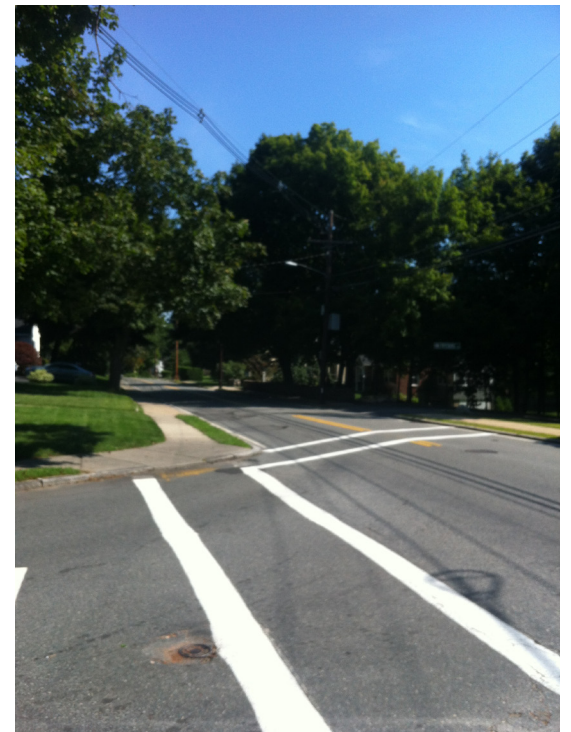
Figure 24

The crosswalk at Eaton Avenue and Mishawum Road (across Mishawum) has very limited visibility to the southwest, where vehicles are known to exceed the speed limit. A passer-by elaborated on how dangerous this crossing is in his view. This crossing is also missing curb ramps. (See Figure 24)

**Recommendations:** Because we know many people use this crosswalk, it may not be advisable to remove it or move it to another location. Instead traffic must be calmed heading downhill toward this crosswalk with an appropriate traffic control device. Perhaps a push-button activated rapid-flash beacon with bright green pedestrian crossing signage to alert drivers that pedestrians are present. If speeding is a persistent problem along this stretch of Mishawum Road, a radar speed limit sign could be installed to help slow traffic.

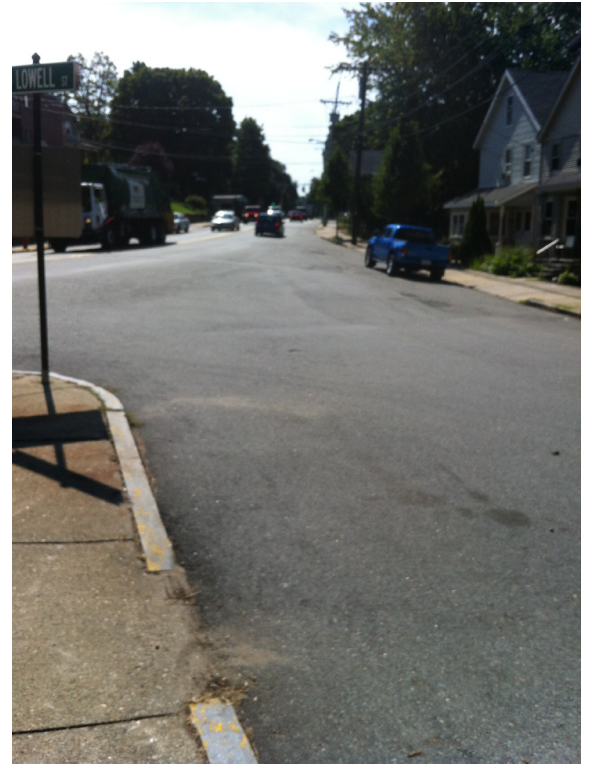
**Figure 25**

a. The distance across Lowell Street where it intersects Main Street is very long. Pedestrians crossing Lowell Street here are “exposed” for quite a long time. (See Figure 25)

**Recommendations:** At very least, a high visibility crosswalk should be added here, especially since it is so close to a school. If the City were to take on a more ambitious project, curb extensions could be installed (in addition to a crosswalk) to shorten the crossing distance, or the intersection’s geometry could be altered to force vehicles to take turns here more slowly.
