## ***Brightwood Neighborhood Walk Assessment Springfield, MA***

November 18, 2015

**MAKING MASSACHUSETTS MORE WALKABLE**

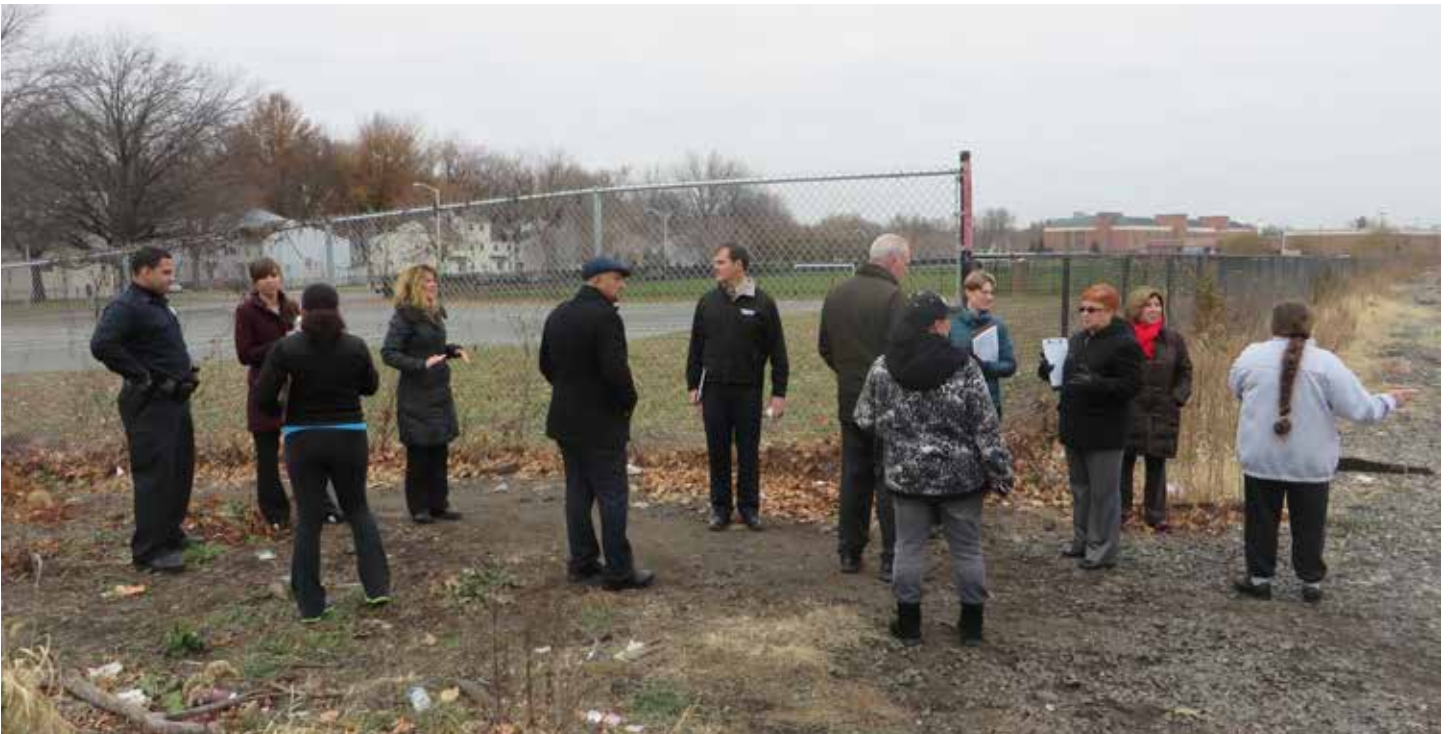
*Walk audit participants assess the conditions of the railroad crossing between Plainfield Street and Birnie Avenue.*

A narrow, unmarked dirt path across railroad tracks and through overgrown and trash-strewn lots with a high prevalence of drug activity is one of the only ways for pedestrians to enter and leave the Brightwood neighborhood and access Birnie Avenue and Main Street. Many students and their families currently use this unsafe crossing to get to and from Chestnut Middle School. The City of Springfield currently provides police presence and periodic clearing of overgrowth and trash along the railroad crossing path, but a long-term infrastructure solution is necessary to ensure safe passage for pedestrians. Expecting pedestrians to walk along Plainfield Street all the way to Route 20 to get to Main Street is not a viable solution, given the long distance involved to access desired destinations and the significant pedestrian safety challenges at the convergence of Plainfield Street and Route 20, which are documented elsewhere in this report.

WalkBoston recommends that the City continue to work with MassDOT to advocate for the proposed underground Amtrak railroad crossing. The City should also work to ensure that both ends of the underground passageway have safe, aesthetically pleasing and easily navigable connections to Birnie Avenue, Plainfield Street and the broader Brightwood community. The passageway must also be well lit at all hours.

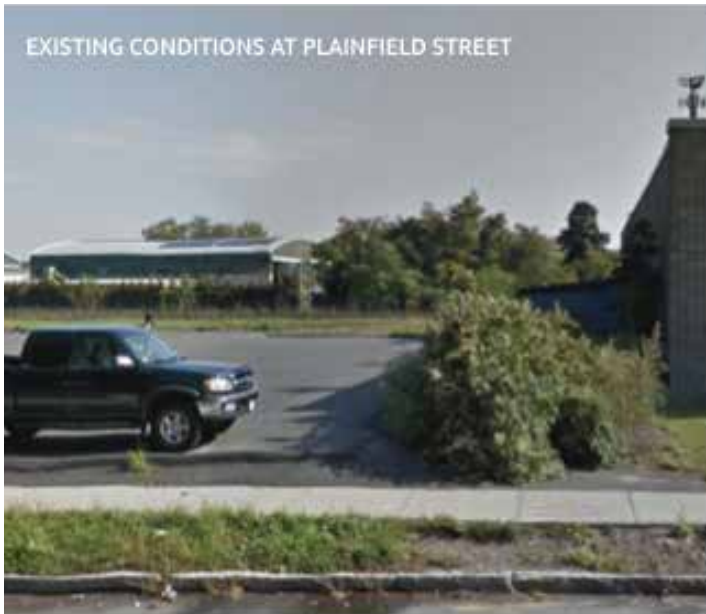
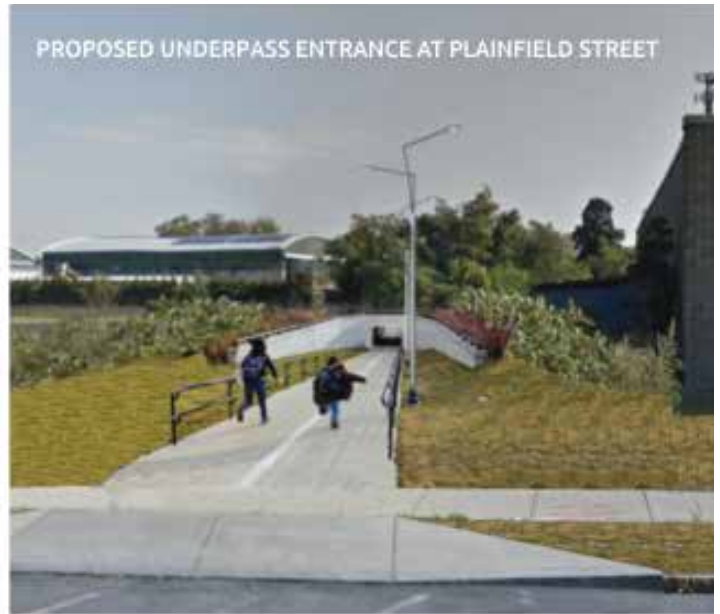
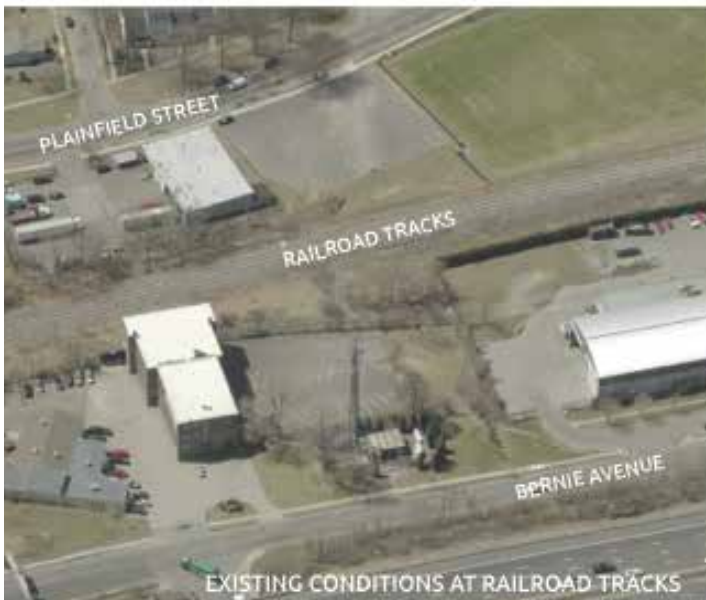
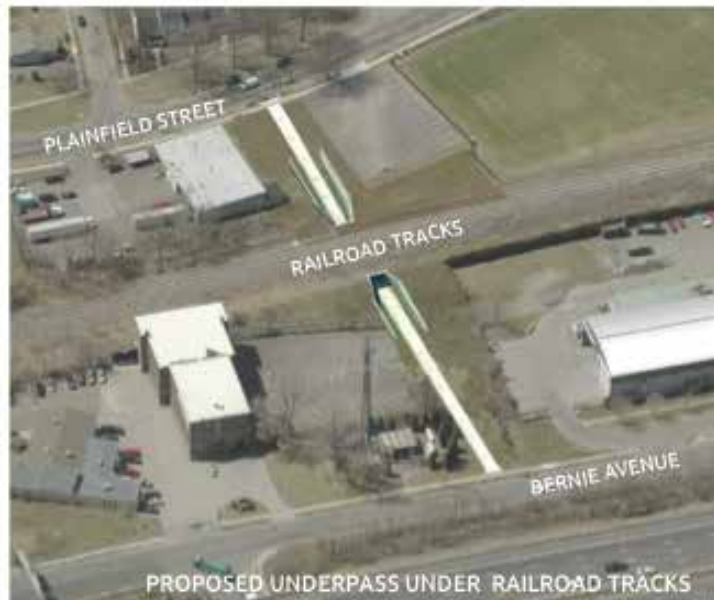
*MassDOT's proposed plans for a railroad underpass between Plainfield Street and Birnie Avenue will significantly improve walking conditions and connectivity for Brightwood residents. The project is slated to be built in 2017-2018. (Source: MassDOT)*
